**Asbestos Containing Materials Survey
And
Register
Karama Shopping Plaza**

Property Name: Karama Shopping Centre
Property Address: Kalymnos Drive Karama NT 0820
Prepared for: Peter LaPira

Prepared by: Tracy Allen
Northern Trade Solutions

Date: 27.03.2015
Number of Structures 1
Register No: NTS304
Register Version: 01

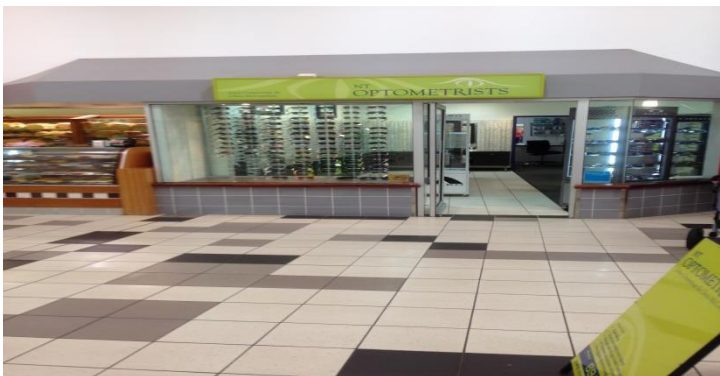
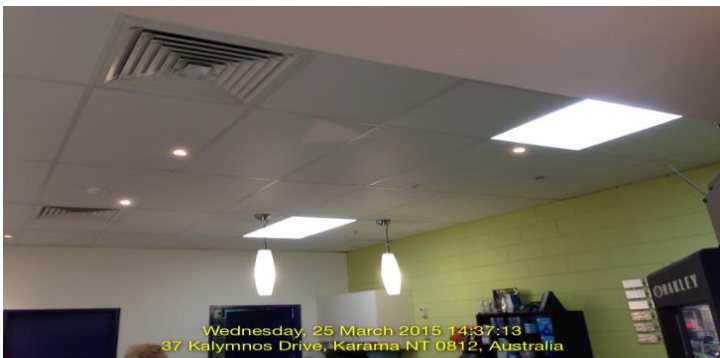
DATE OF ASSESSMENT	27.03.2015	Photo I.D. KSC004

<p>Wednesday, 25 March 2015 14:37:13 37 Kalymnos Drive, Karama NT 0812, Australia</p>
LOCATION	Karama Shopping Plaza Kalymnos Drive, Karama	
SAMPLE I.D	NA	
LOCATION DETAILS	NT Optometrist	
BUILDING MATERIAL BUILDING TYPE	Gyprock	
MATERIAL CONDITION	New	
ASSESSOR	Tracy Allen NTWS-AA-439630

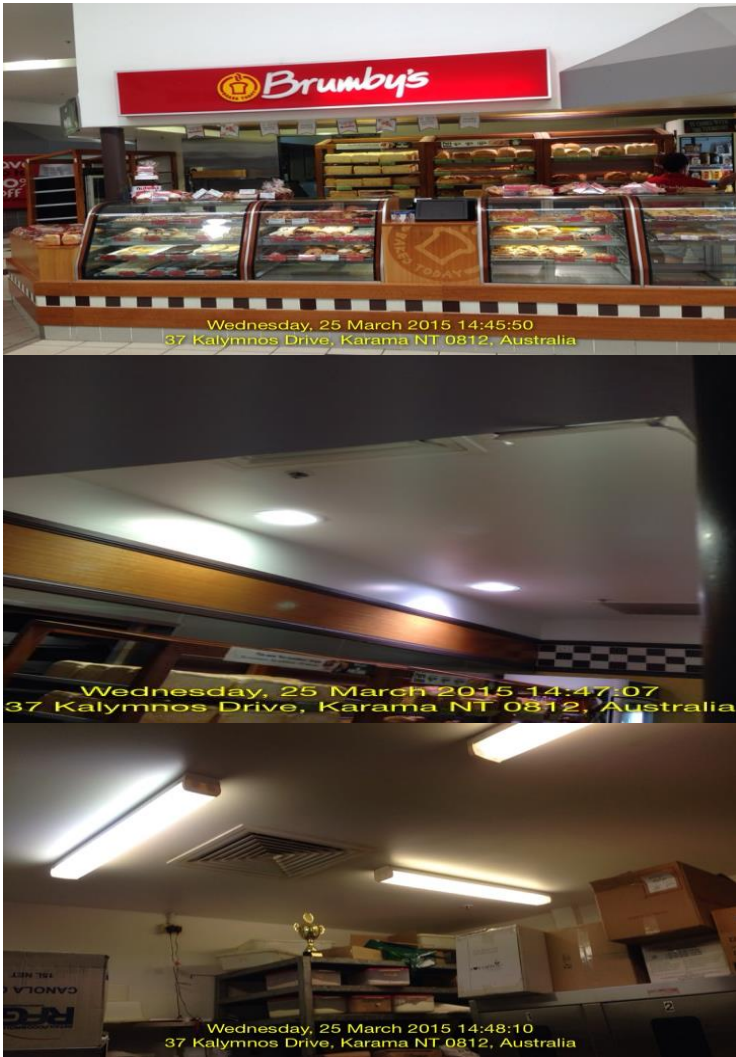
DATE OF ASSESSMENT	27.03.2015	Photo I.D. KSC006

LOCATION	Karama Shopping Plaza Kalymnos Drive, Karama	
SAMPLE I.D	NA	
LOCATION DETAILS	Brumbys	
BUILDING MATERIAL BUILDING TYPE	Gyprock	
MATERIAL CONDITION	New	
ASSESSOR	Tracy Allen NTWS-AA-439630

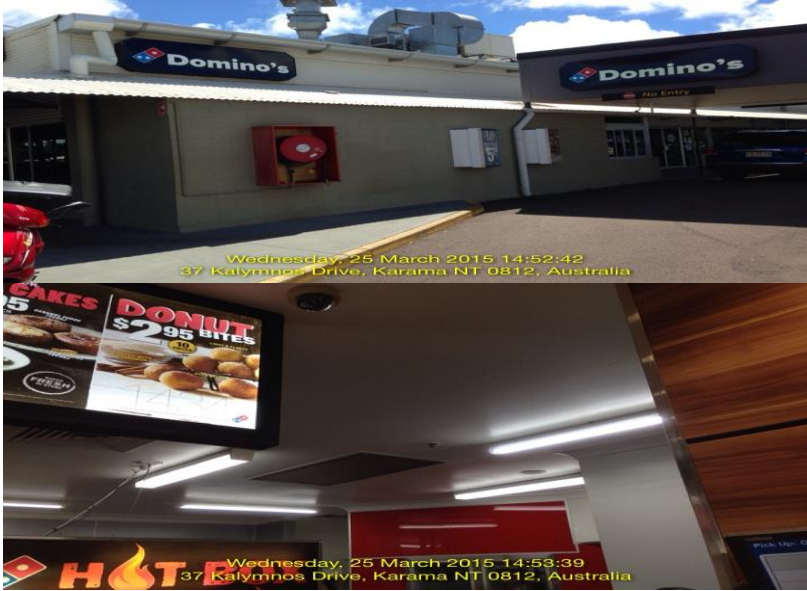
DATE OF ASSESSMENT	27.03.2015	Photo I.D. KSC009

LOCATION	Karama Shopping Plaza Kalymnos Drive, Karama	
SAMPLE I.D	NA	
LOCATION DETAILS	Dominos	
BUILDING MATERIAL BUILDING TYPE	Gyprock	
MATERIAL CONDITION	New	
ASSESSOR	Tracy Allen NTWS-AA-439630

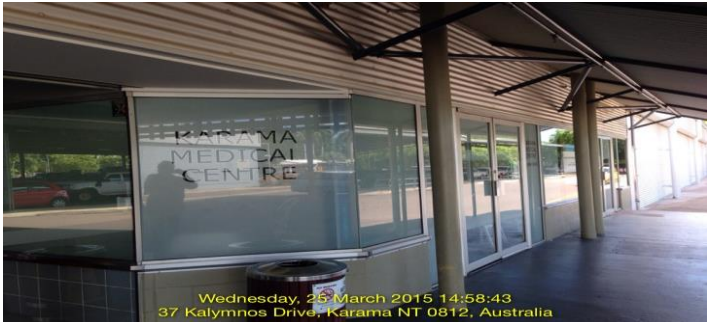
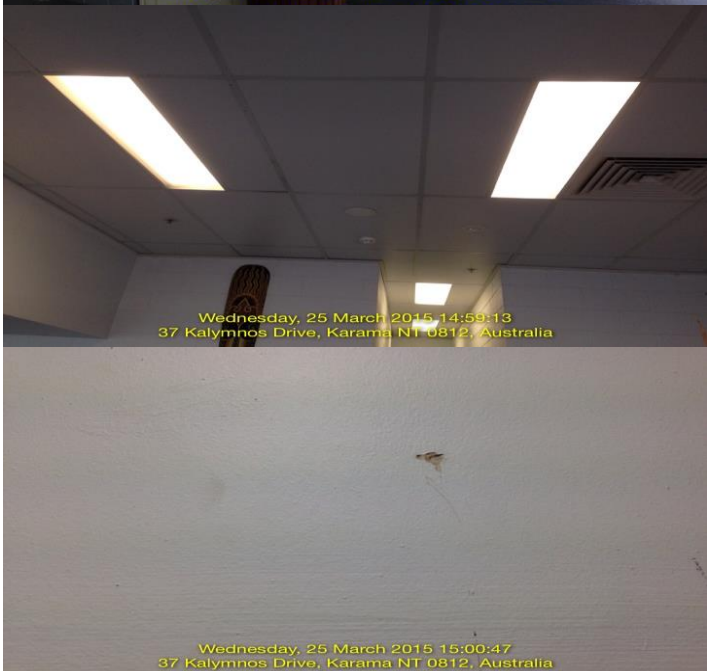
DATE OF ASSESSMENT	27.03.2015	Photo I.D. KSC011

<small>Wednesday, 25 March 2015 14:58:43 37 Kalymnos Drive, Karama NT 0812, Australia</small>
LOCATION	Karama Shopping Plaza Kalymnos Drive, Karama	
SAMPLE I.D	KSC011	
LOCATION DETAILS	Karama Medical Centre	
BUILDING MATERIAL BUILDING TYPE	Gyprock Cement Sheet above door SMP	
MATERIAL CONDITION	Good	
ASSESSOR	Tracy Allen NTWS-AA-439630

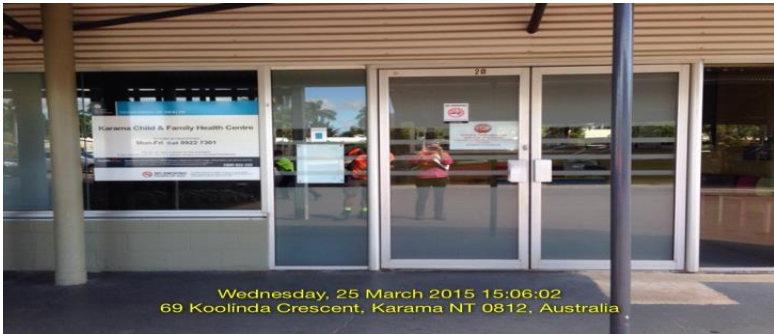
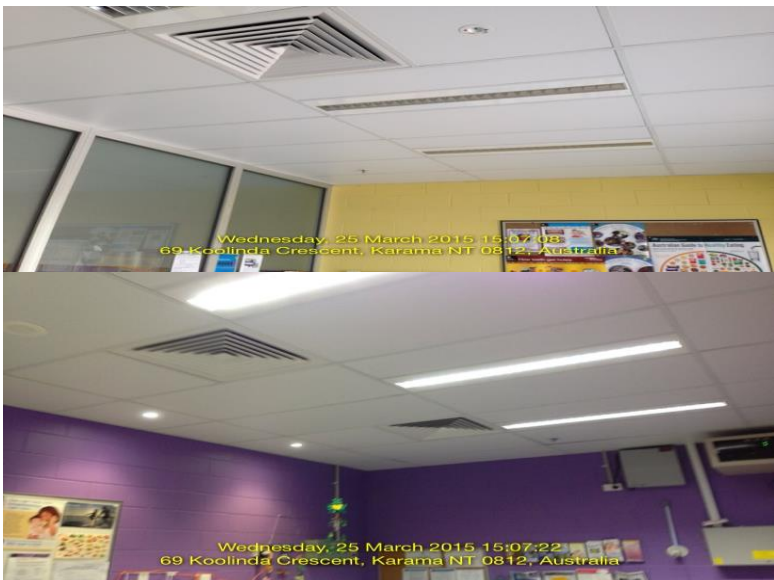
DATE OF ASSESSMENT	27.03.2015	Photo I.D. KSC012

LOCATION	Karama Shopping Plaza Kalymnos Drive, Karama	
SAMPLE I.D	NA	
LOCATION DETAILS	Karama Child and Family Health	
BUILDING MATERIAL BUILDING TYPE	Gyprock	
MATERIAL CONDITION	New	
ASSESSOR	Tracy Allen NTWS-AA-439630

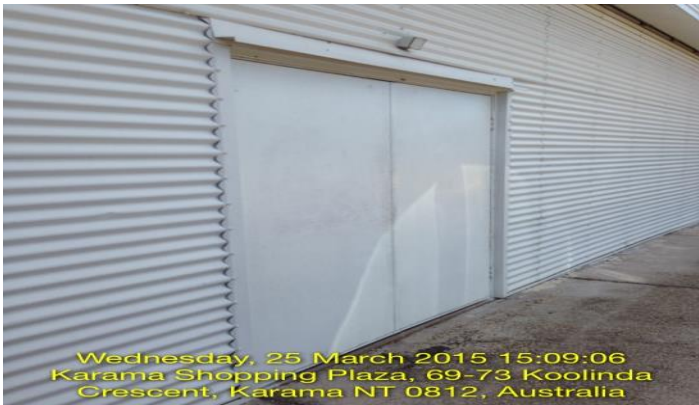
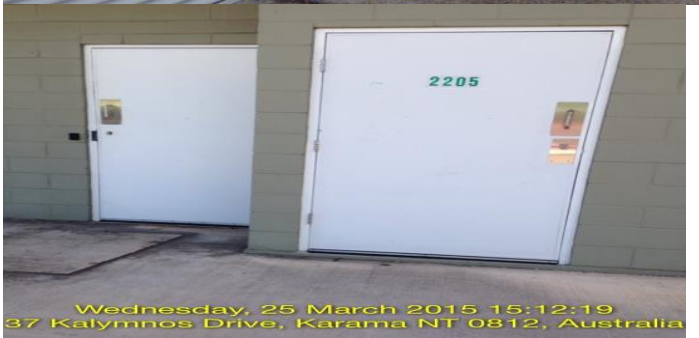
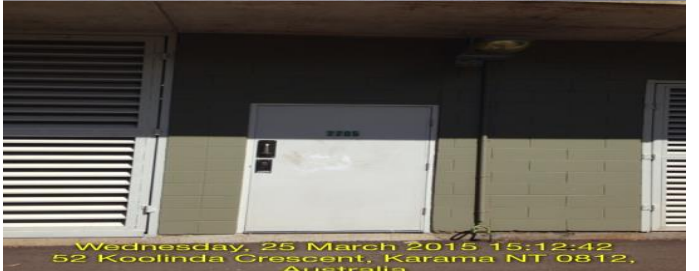
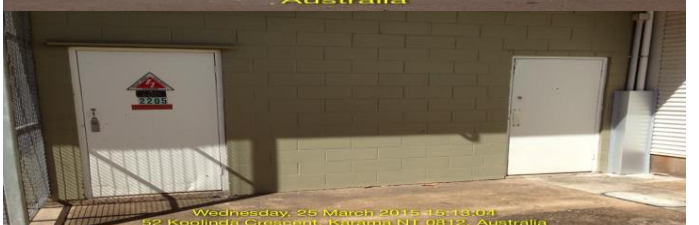
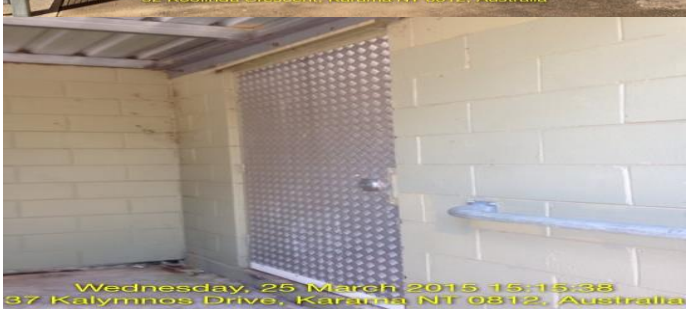
DATE OF ASSESSMENT	27.03.2015	Photo I.D. KSC013,14,15,16,18,19,20
LOCATION	Karama Shopping Plaza Kalymnos Drive, Karama

<p>Wednesday, 25 March 2015 15:15:38 37 Kalymnos Drive, Karama NT 0812, Australia</p>
SAMPLE I.D	NA	
LOCATION DETAILS	Fire Access Doors	
BUILDING MATERIAL BUILDING TYPE	Wood Interior unknown (the age of the building indicates that these doors are not ACM	
MATERIAL CONDITION	Good	
ASSESSOR	Tracy Allen NTWS-AA-439630

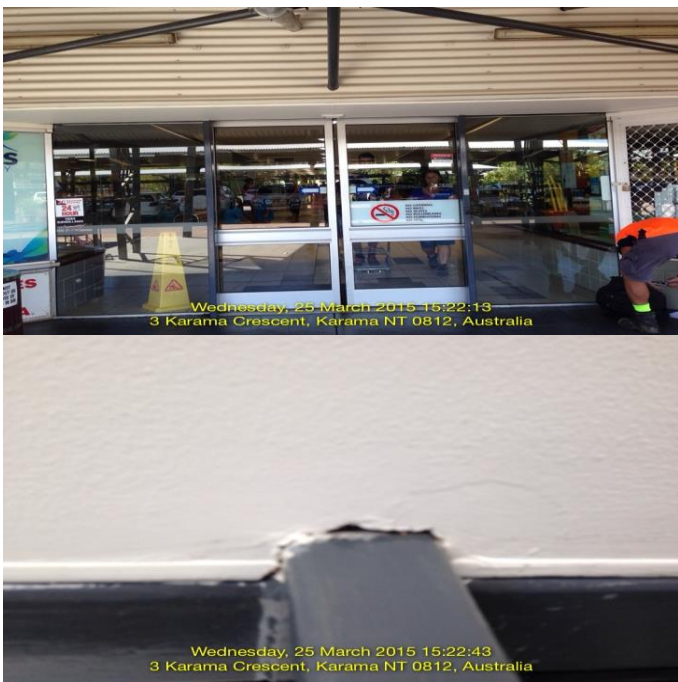
DATE OF ASSESSMENT	27.03.2015	Photo I.D. KSC022

LOCATION	Karama Shopping Plaza Kalymnos Drive, Karama	
SAMPLE I.D	KSC022	
LOCATION DETAILS	Karama Shopping Plaza western entrance Soffit between Karama Library and Celebrations	
BUILDING MATERIAL BUILDING TYPE	Cement Sheet SMF	
MATERIAL CONDITION	New	
ASSESSOR	Tracy Allen NTWS-AA-439630

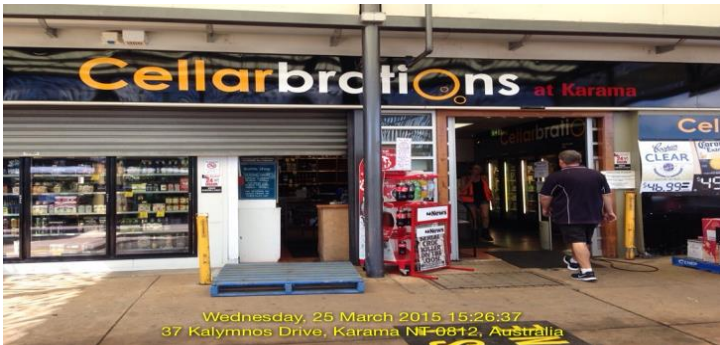
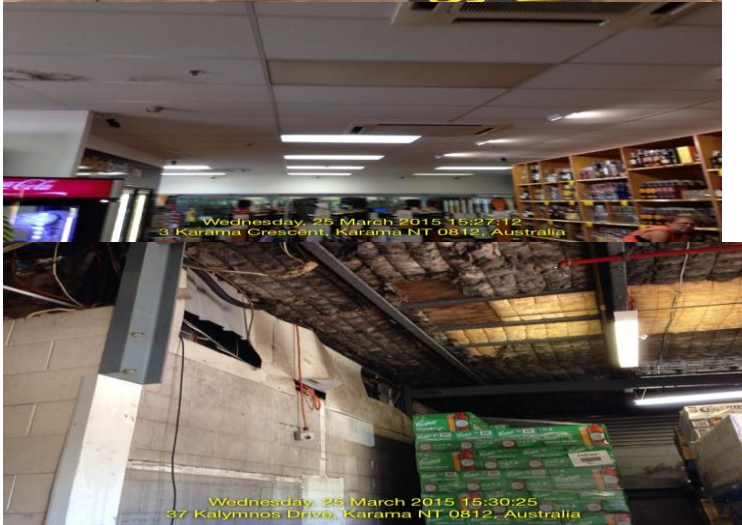
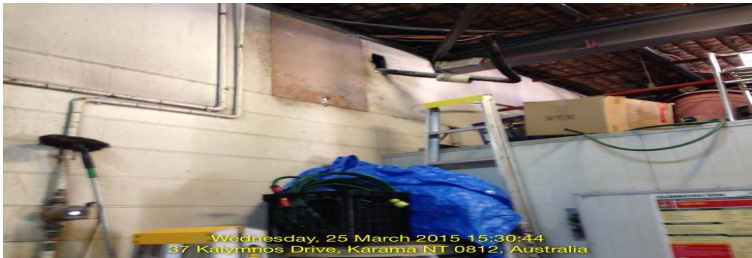
DATE OF ASSESSMENT	27.03.2015	Photo I.D. KSC023

<p>Wednesday, 25 March 2015 15:30:44 37 Kalymnos Drive, Karama NT 0812, Australia</p>
LOCATION	Karama Shopping Plaza Kalymnos Drive, Karama	
SAMPLE I.D	NA	
LOCATION DETAILS	Celebrations Bottleshop	
BUILDING MATERIAL BUILDING TYPE	Gyprock	
MATERIAL CONDITION	New	
ASSESSOR	Tracy Allen NTWS-AA-439630

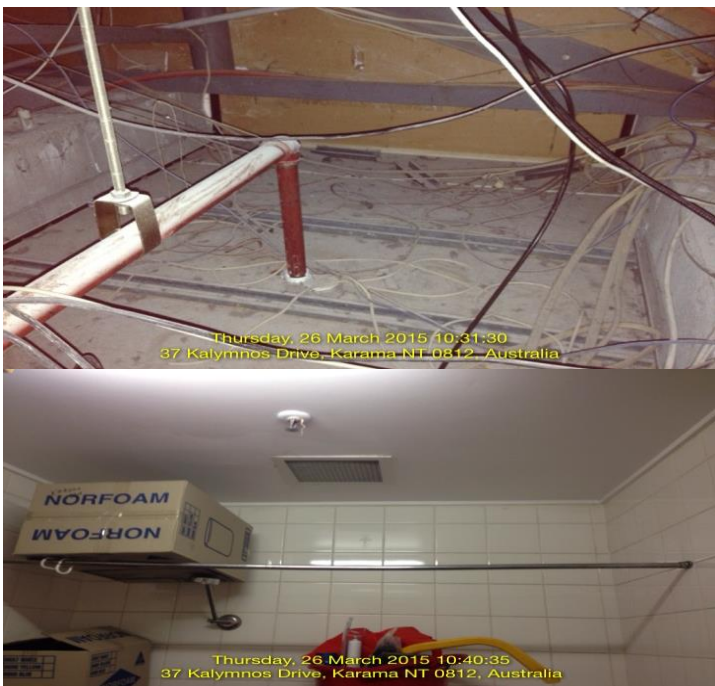
DATE OF ASSESSMENT	27.03.2015	Photo I.D. KSC031

LOCATION	Karama Shopping Plaza Kalymnos Drive, Karama	
SAMPLE I.D	KSC031	
LOCATION DETAILS	Karama Tavern staff Male & Female ablutions	
BUILDING MATERIAL BUILDING TYPE	Gyprock Cement Sheet non ACM	
MATERIAL CONDITION	Good	
ASSESSOR	Tracy Allen NTWS-AA-439630

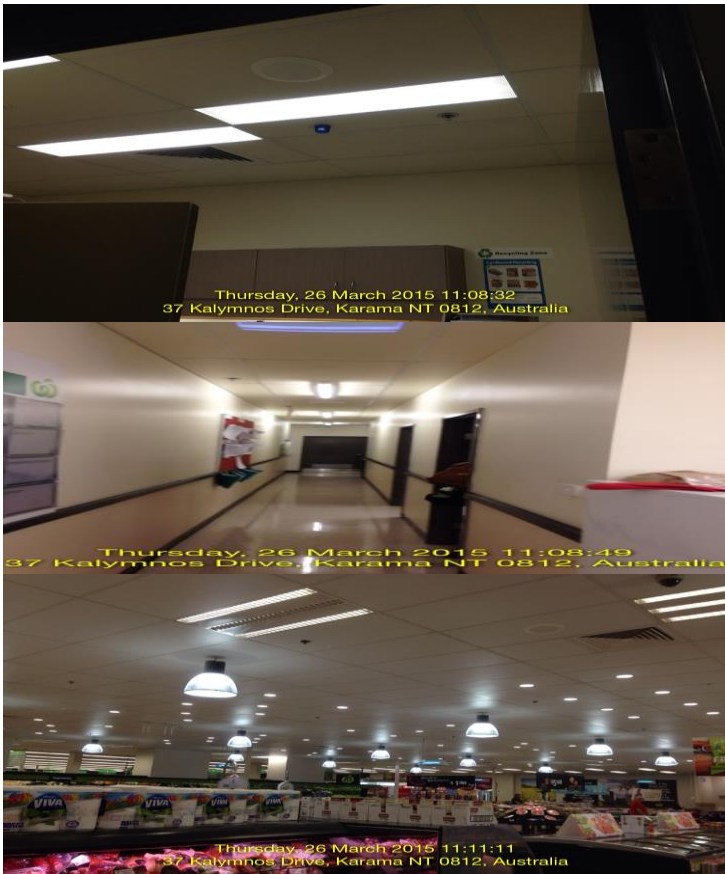
DATE OF ASSESSMENT	27.03.2015	Photo I.D. KSC033

LOCATION	Karama Shopping Plaza Kalymnos Drive, Karama	
SAMPLE I.D		
LOCATION DETAILS	Woolworths Staff	
BUILDING MATERIAL BUILDING TYPE	Gyprock	
MATERIAL CONDITION	Good	
ASSESSOR	Tracy Allen NTWS-AA-439630

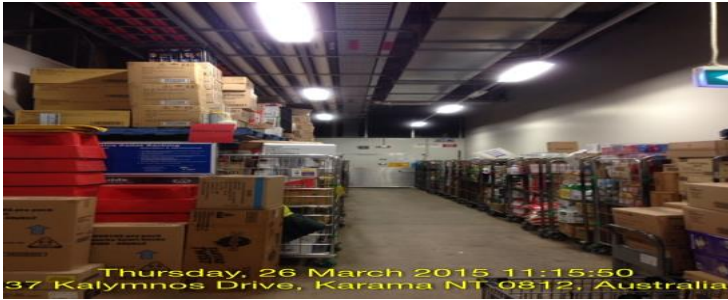
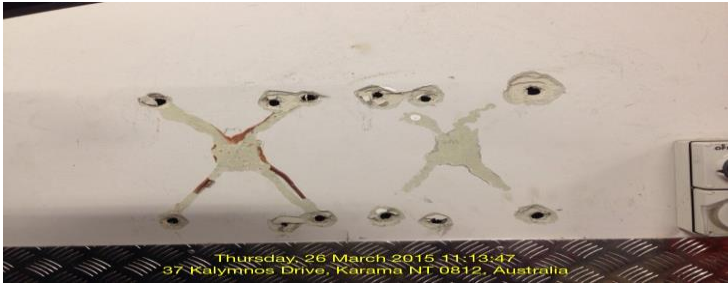
DATE OF ASSESSMENT	27.03.2015	Photo I.D. KSC035

LOCATION	Karama Shopping Plaza Kalymnos Drive, Karama	
SAMPLE I.D	KSC035	
LOCATION DETAILS	Woolworths loading dock area wall linings	
BUILDING MATERIAL BUILDING TYPE	Cement Sheeting non ACM	
MATERIAL CONDITION	Good	
ASSESSOR	Tracy Allen NTWS-AA-439630

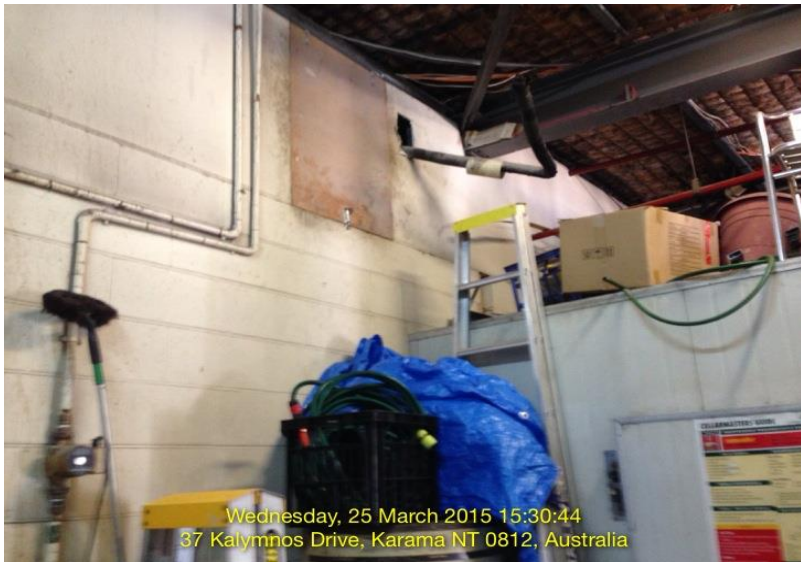
DATE OF ASSESSMENT	27.03.2015	Photo I.D. KSC036

<p>Wednesday, 25 March 2015 15:30:44 37 Kalymnos Drive, Karama NT 0812, Australia</p>
LOCATION	Karama Shopping Plaza Kalymnos Drive, Karama	
SAMPLE I.D	KSC036	
LOCATION DETAILS	Karama Tavern old Keg Lines	
BUILDING MATERIAL BUILDING TYPE	PVC	
MATERIAL CONDITION	Good	
ASSESSOR	Tracy Allen NTWS-AA-439630
