## ASBESTOS REGISTER

SITE REFERENCE:  
**NT1009**

OUR REFERENCE:  
**C122530 : J154258**

**FRAMPTONS FIRST NATIONAL  
82 TODD STREET  
82 TODD STREET, ALICE SPRINGS NT 0871**

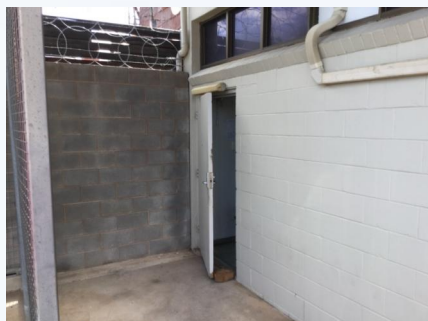
NO.: 1  
 PHOTO NO.: J154258-NT1009-PHOTO002  
 RESULT: ASBESTOS - NEGATIVE  
 BUILDING/LEVEL: GHD BUILDING - GROUND LEVEL  
 ROOM/LOCATION: LAB AREA - NORTHWEST  
 FEATURE/MATERIAL: FIRE DOOR - FIRE DOOR CORE  
 SAMPLE NO.: J154258-NT1009-002

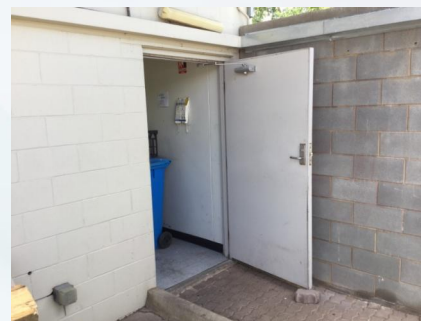
NO.: 2  
 PHOTO NO.: J154258-NT1009-PHOTO006  
 RESULT: ASBESTOS - PRESUMED NEGATIVE  
 BUILDING/LEVEL: GHD BUILDING - GROUND LEVEL  
 ROOM/LOCATION: LAB AREA - SOUTHWEST  
 FEATURE/MATERIAL: FIRE DOOR - FIRE DOOR CORE  
 SAMPLE NO.: SIMILAR TO: J154258-NT1009-002

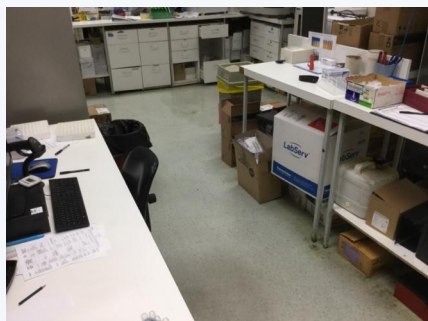
NO.: 3  
 PHOTO NO.: J154258-NT1009-PHOTO003  
 RESULT: ASBESTOS - NEGATIVE  
 BUILDING/LEVEL: GHD BUILDING - GROUND LEVEL  
 ROOM/LOCATION: LAB AREA - THROUGHOUT  
 FEATURE/MATERIAL: FLOOR COVERING - FIBROUS BACKED SHEET VINYL  
 SAMPLE NO.: J154258-NT1009-003

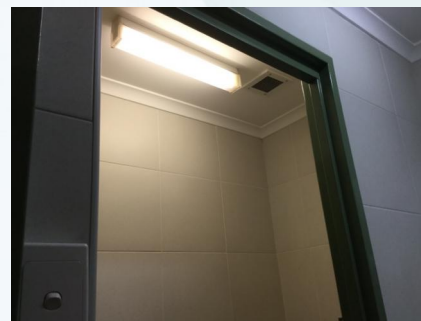
NO.: 4  
 PHOTO NO.: J154258-NT1009-PHOTO011  
 RESULT: ASBESTOS - PRESUMED NEGATIVE  
 BUILDING/LEVEL: GHD BUILDING - GROUND LEVEL  
 ROOM/LOCATION: TOILET. - THROUGHOUT  
 FEATURE/MATERIAL: CEILING LINING - FIBRE CEMENT SHEETING  
 SAMPLE NO.: SIMILAR TO: J154258-NT1009-001

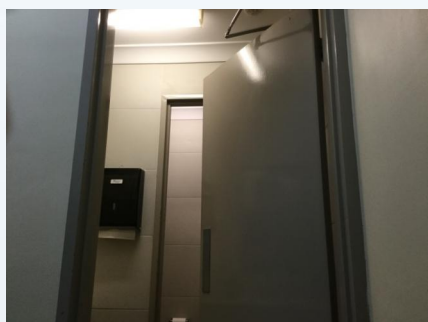
NO.: 5  
 PHOTO NO.: J154258-NT1009-PHOTO001  
 RESULT: ASBESTOS - NEGATIVE  
 BUILDING/LEVEL: GHD BUILDING - GROUND LEVEL  
 ROOM/LOCATION: TOILETS - THROUGHOUT  
 FEATURE/MATERIAL: CEILING LINING - FIBRE CEMENT SHEETING  
 SAMPLE NO.: J154258-NT1009-001

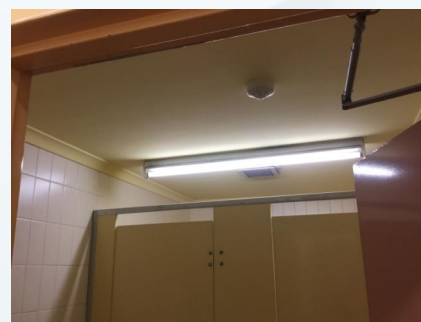
NO.: 6  
 PHOTO NO.: J154258-NT1009-PHOTO004  
 RESULT: ASBESTOS - NEGATIVE  
 BUILDING/LEVEL: GHD BUILDING - GROUND LEVEL  
 ROOM/LOCATION: TOILETS - THROUGHOUT  
 FEATURE/MATERIAL: CEILING LINING - FIBRE CEMENT SHEETING  
 SAMPLE NO.: J154258-NT1009-004

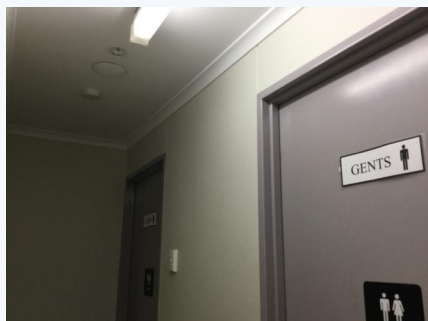
NO.: 7  
 PHOTO NO.: J154258-NT1009-PHOTO007  
 RESULT: ASBESTOS - PRESUMED NEGATIVE  
 BUILDING/LEVEL: GHD BUILDING - GROUND LEVEL  
 ROOM/LOCATION: TOILETS - THROUGHOUT  
 FEATURE/MATERIAL: CEILING LINING - FIBRE CEMENT SHEETING  
 SAMPLE NO.: SIMILAR TO: J154258-NT1009-004

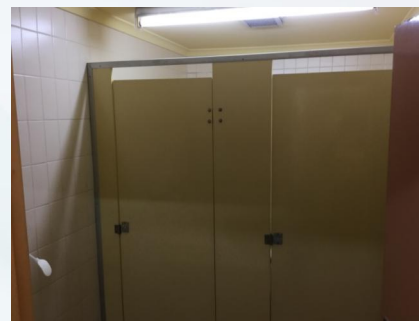
NO.: 8  
 PHOTO NO.: J154258-NT1009-PHOTO005  
 RESULT: ASBESTOS - NEGATIVE  
 BUILDING/LEVEL: GHD BUILDING - GROUND LEVEL  
 ROOM/LOCATION: TOILETS - THROUGHOUT  
 FEATURE/MATERIAL: TOILET CUBICLE - FIBRE CEMENT SHEETING  
 SAMPLE NO.: J154258-NT1009-005

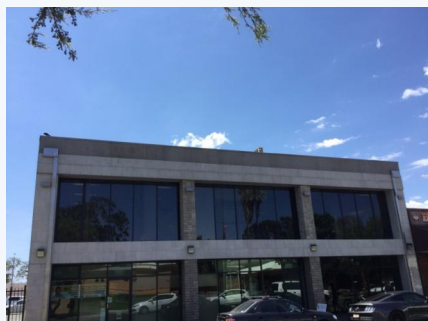
NO.: 9  
 PHOTO NO.: J154258-NT1009-PHOTO012  
 RESULT: ASBESTOS - PRESUMED NEGATIVE  
 BUILDING/LEVEL: GHD BUILDING - LEVEL ONE  
 ROOM/LOCATION: EXTERIOR - EAST  
 FEATURE/MATERIAL: INFILL PANELS - HIGH LEVEL - FIBRE CEMENT SHEETING  
 SAMPLE NO.: SIMILAR TO: J154258-NT1009-008

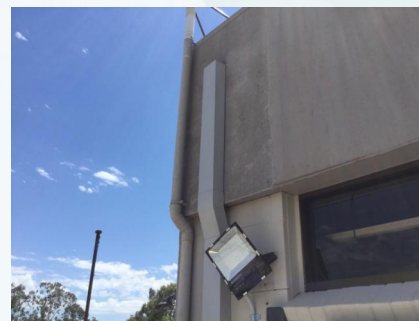
NO.: 10  
 PHOTO NO.: J154258-NT1009-PHOTO009  
 RESULT: ASBESTOS - NEGATIVE  
 BUILDING/LEVEL: GHD BUILDING - LEVEL ONE  
 ROOM/LOCATION: EXTERIOR - NORTHWEST  
 FEATURE/MATERIAL: INFILL PANELS - HIGH LEVEL - FIBRE CEMENT SHEETING  
 SAMPLE NO.: J154258-NT1009-007

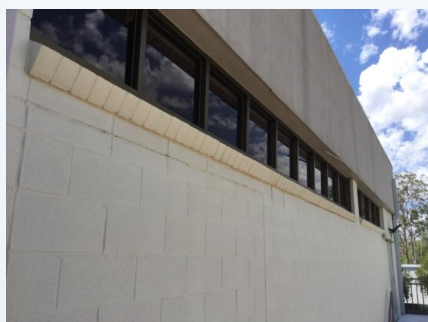
NO.: 11  
 PHOTO NO.: J154258-NT1009-PHOTO008  
 RESULT: ASBESTOS - NEGATIVE  
 BUILDING/LEVEL: GHD BUILDING - LEVEL ONE  
 ROOM/LOCATION: EXTERIOR - WEST  
 FEATURE/MATERIAL: INFILL PANELS - HIGH LEVEL - FIBRE CEMENT SHEETING  
 SAMPLE NO.: J154258-NT1009-006

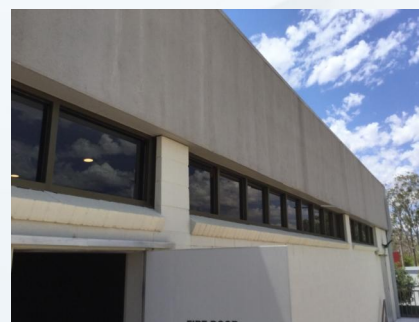
NO.: 12  
 PHOTO NO.: J154258-NT1009-PHOTO010  
 RESULT: ASBESTOS - NEGATIVE  
 BUILDING/LEVEL: GHD BUILDING - LEVEL ONE  
 ROOM/LOCATION: EXTERIOR - WEST  
 FEATURE/MATERIAL: INFILL PANELS - HIGH LEVEL - FIBRE CEMENT SHEETING  
 SAMPLE NO.: J154258-NT1009-008
