**Asbestos Audit Report for
Alice Plaza
Shopping Centre,
36 Todd Street Mall,
Alice Springs, NT**

14 June 2005

Savills (SA) Pty Ltd

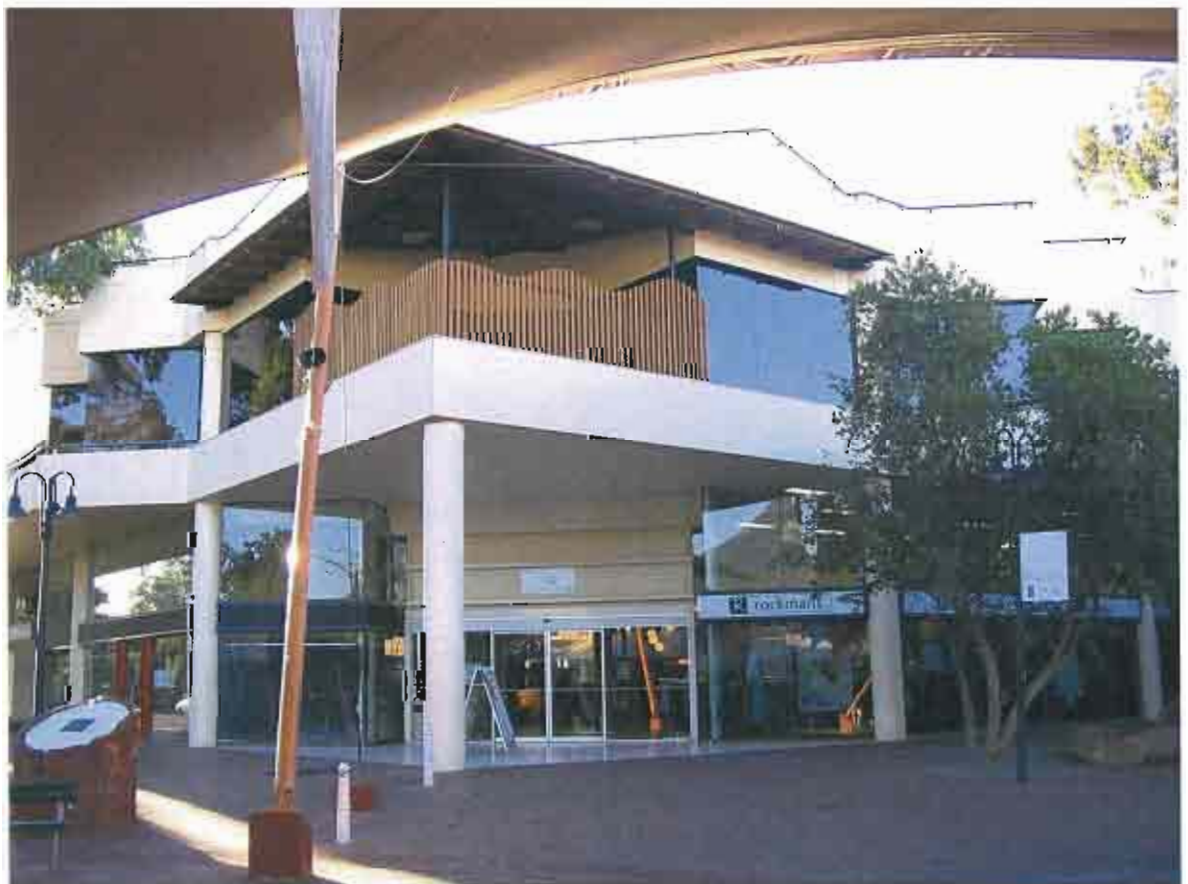
Photo No 2

Fibrous cement sheeting wall infill above windows. Painted. Good Condition. Approximately 10 m². Similar to Sample Number 4. Photo No 2. No asbestos was detected in the material sampled (refer Appendix A).

Todd Street Mall – main entrance

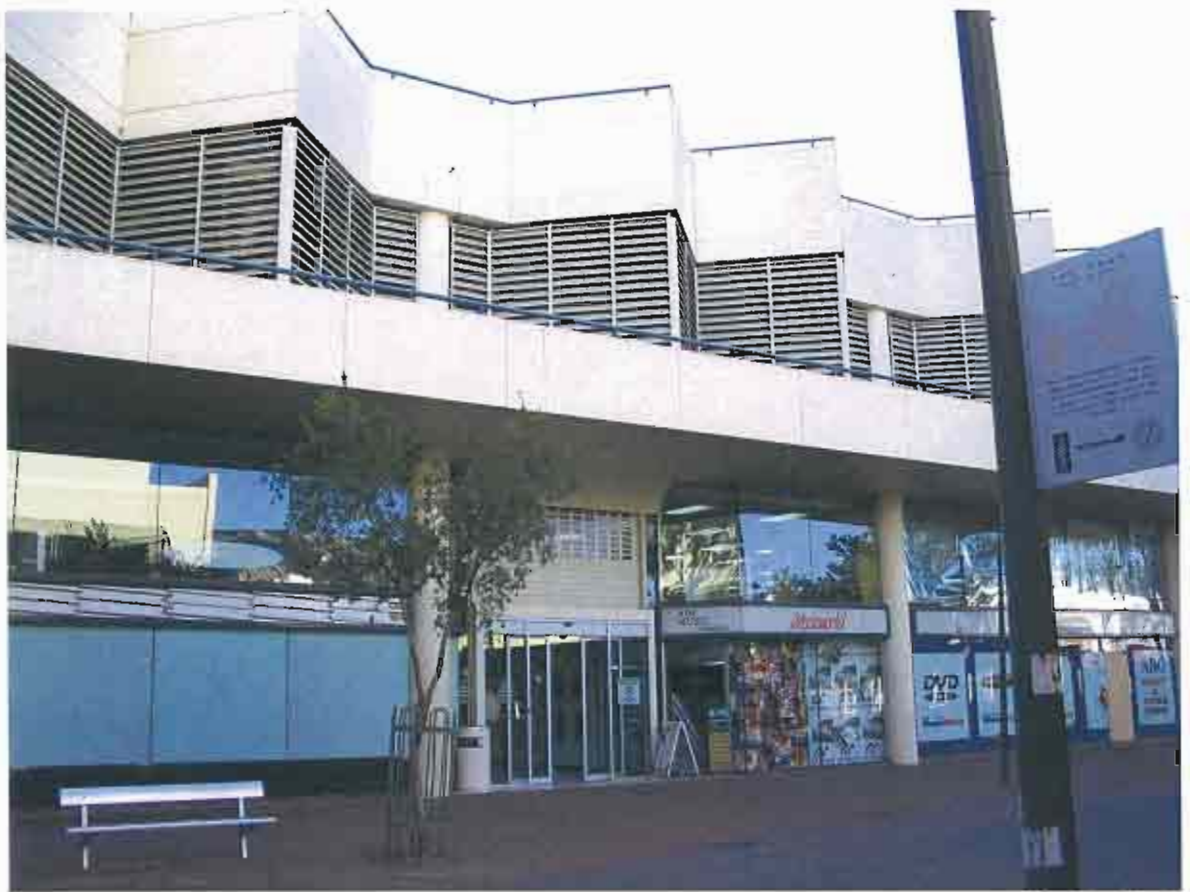
Fibrous cement sheeting external façade located on eastern and southern sides. Painted. Good Condition. Approximately 1,000 m². Similar to Sample Number 4. Photo No 3. No asbestos was detected in the material sampled (refer Appendix A).

Photo No 3
Todd Street Mall - facade

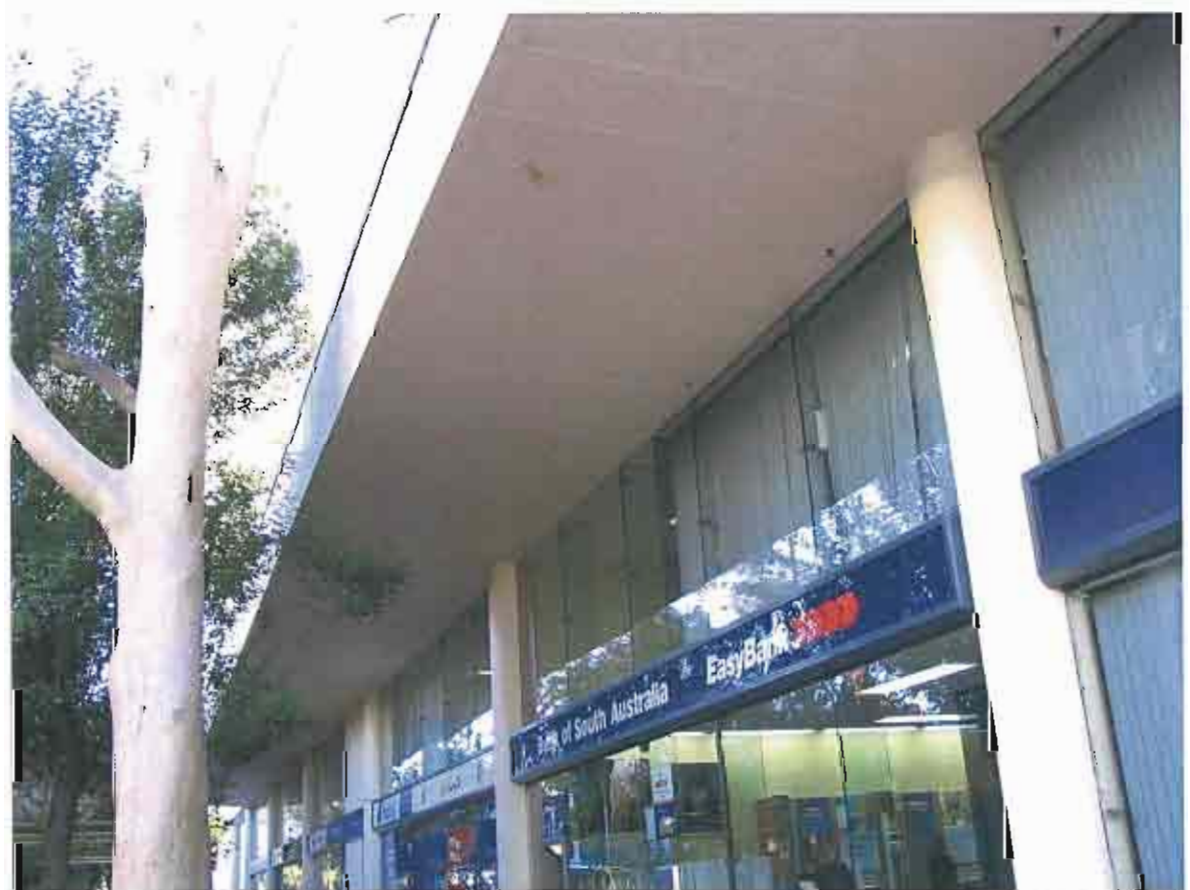
Possible fibrous cement sheeting ceiling lining located on eastern and southern sides (refer Section 7.2). Painted. Good Condition. Approximately 500 m². Photo No 4.

Fibrous cement sheeting was noted in numerous locations including but not limited to external balcony ceiling lining, Bi-Lo underside of box gutter and underside roof above butcher, deli and bakery (refer Section 5 for locations). Sample analysis of similar materials revealed no asbestos. However, additional inspections and sample collection of materials not sampled for analysis is recommended prior to refurbishment, renovation alteration, maintenance, removal or works likely to disturb those materials.

Photo No 4
Todd Street Mall – canopy ceiling lining

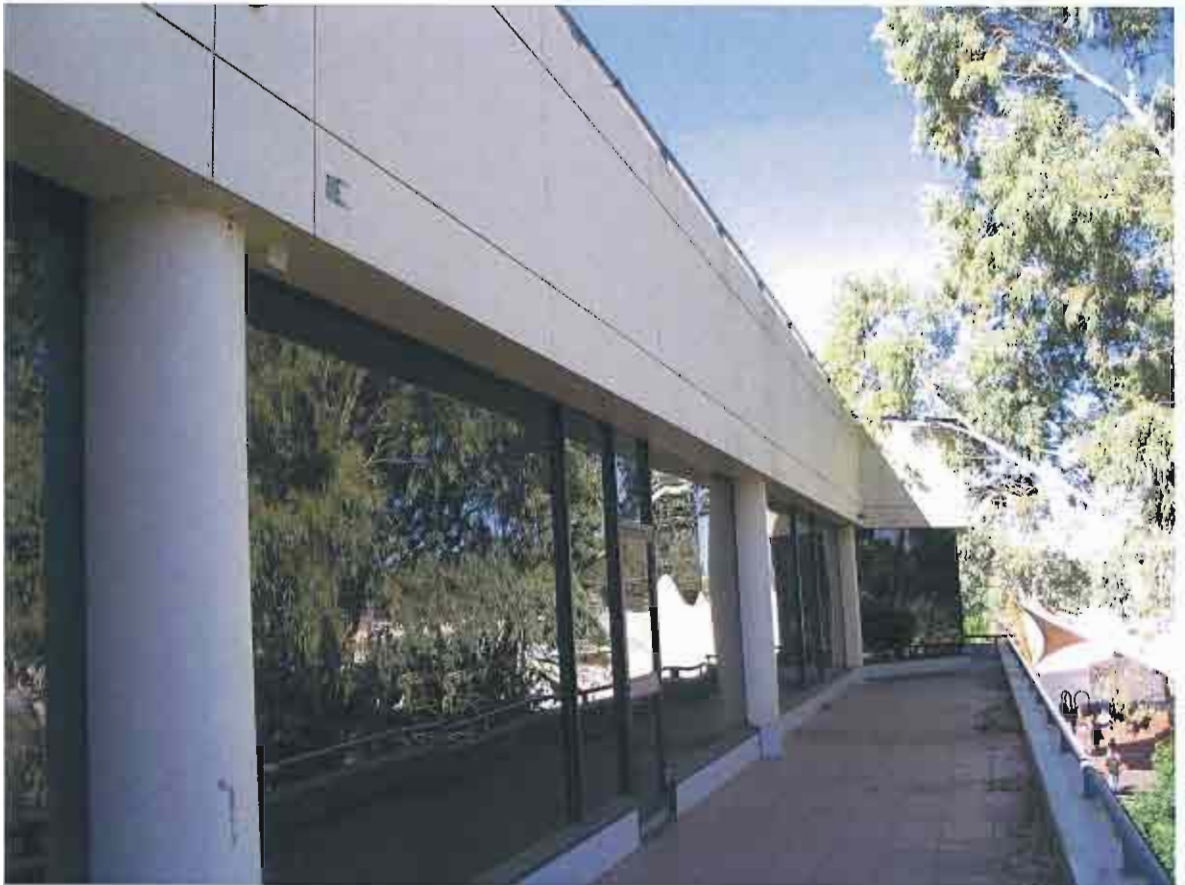
Fibrous cement sheeting external façade located on southern, western and eastern sides. Painted. Good Condition. Approximately 1,000 m². Sample Number 4. Photo Nos 3 and 5. No asbestos was detected in the material sampled (refer Appendix A).

Photo No 5
External 1st Floor – southern façade

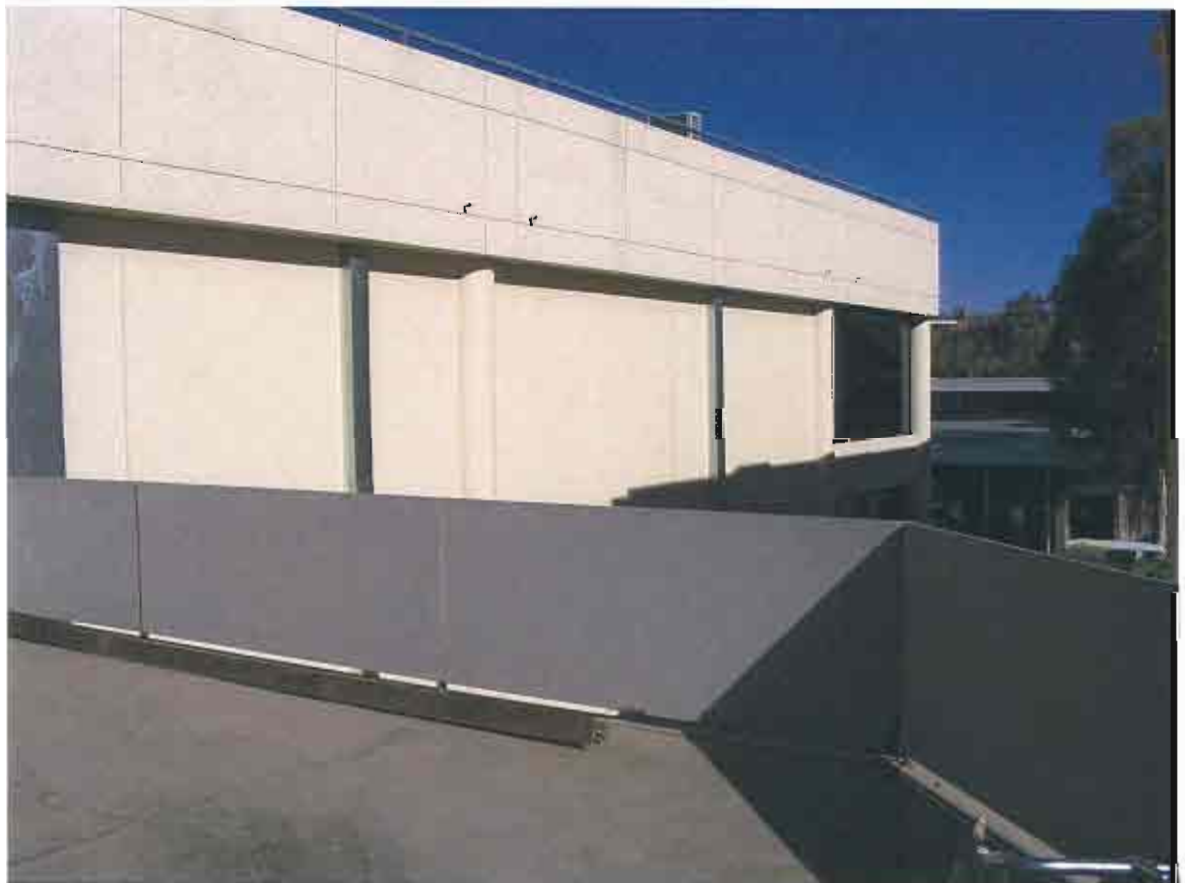
Fibrous cement sheeting balustrading. Medium Condition. Approximately 13 m². Sample Number 5. Photo No 6. No asbestos was detected in the material sampled (refer Appendix A).

Note: Minor damage visible with small quantity debris.

Photo No 6
External 1st Floor – western façade and loading dock balustrade

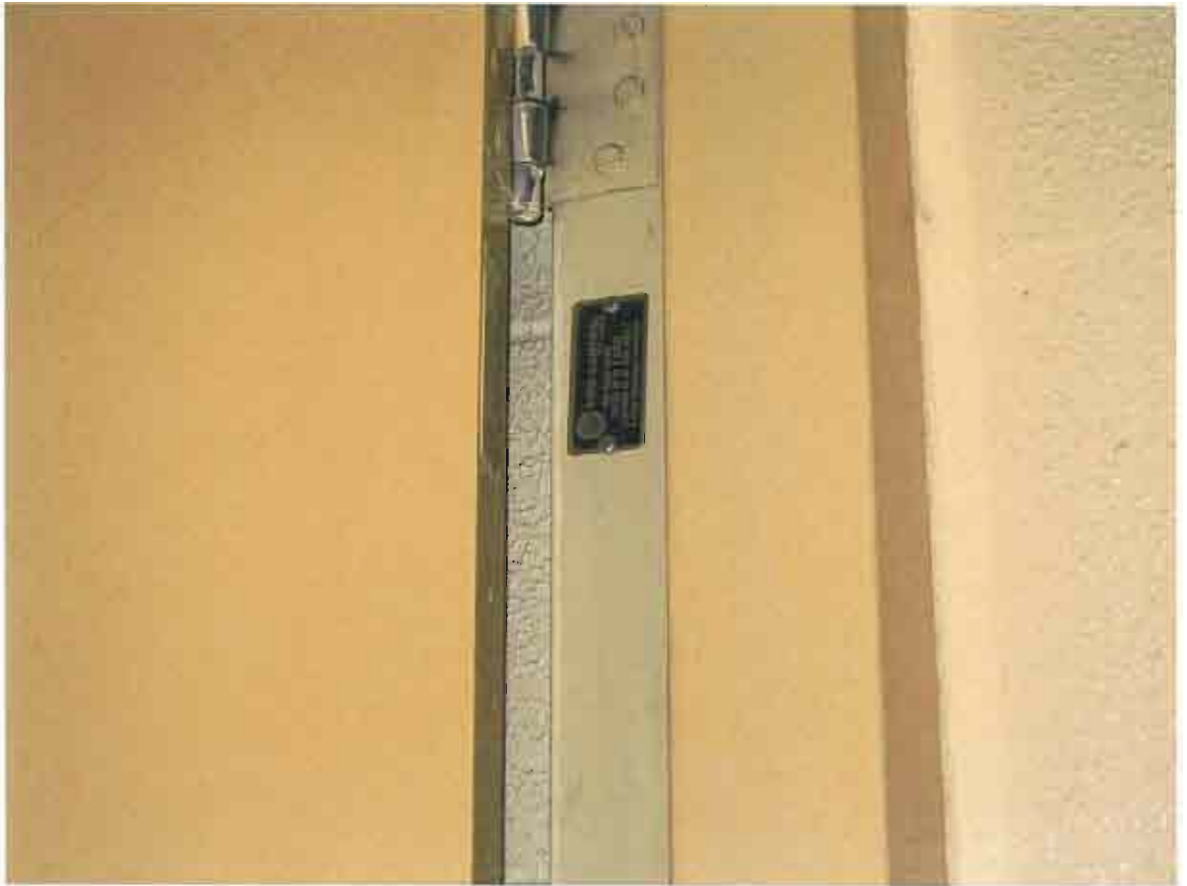
'Fire Control' fire door inner and outer cores (refer Section 7.1). Good Condition. Approximately 2 m². Sample Numbers 2 and 3. Photo No 7. No asbestos was detected in the material sampled (refer Appendix A).

Photo No 7
1st Floor Stair 'Fire Control' fire door tag

However, we recommend the building manager should contact the door manufacturers for confirmation of nil asbestos within all installed fire doors.

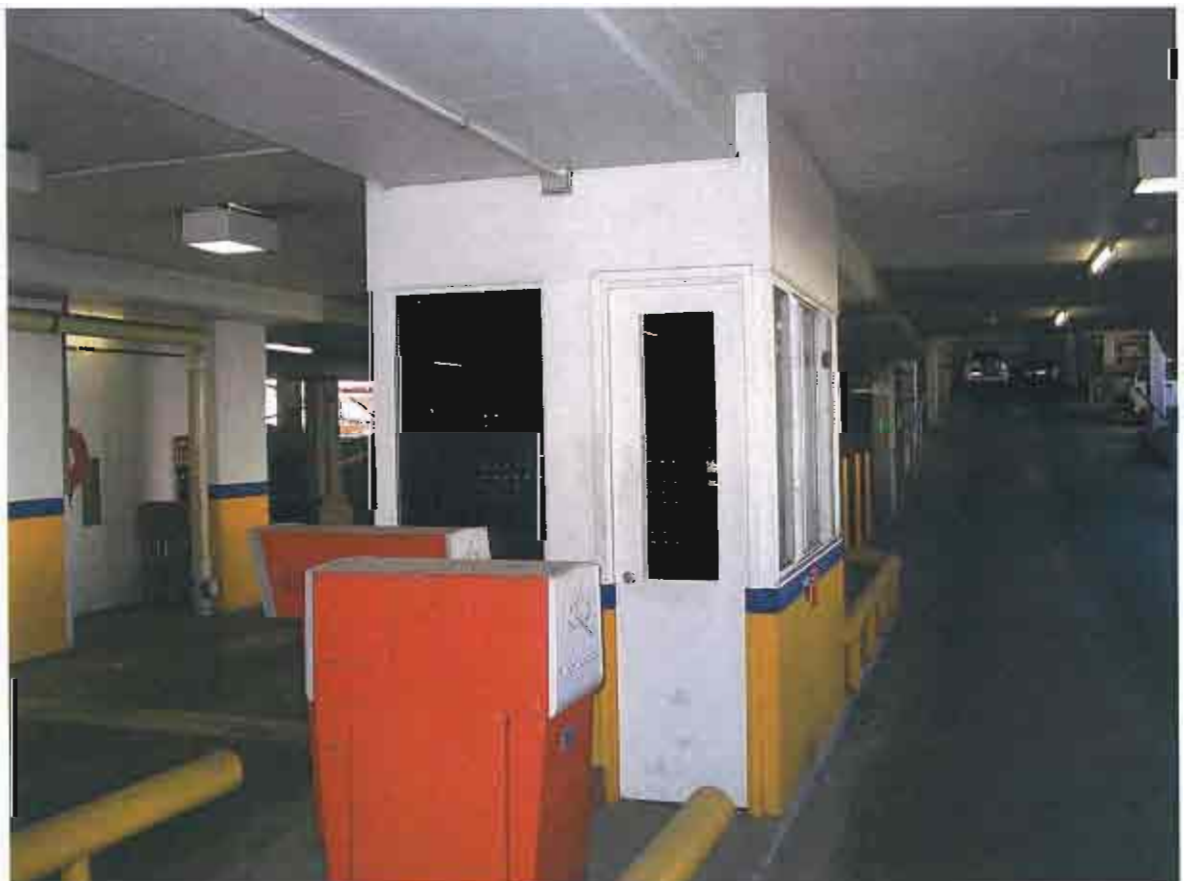
Photo No 10
Multi-Level Carpark guard box

External and internal wall cladding fibrous cement sheeting. Good Condition. Approximately 20 m². Sample Number 25. Photo No 10. No asbestos was detected in the material sampled (refer Appendix A).

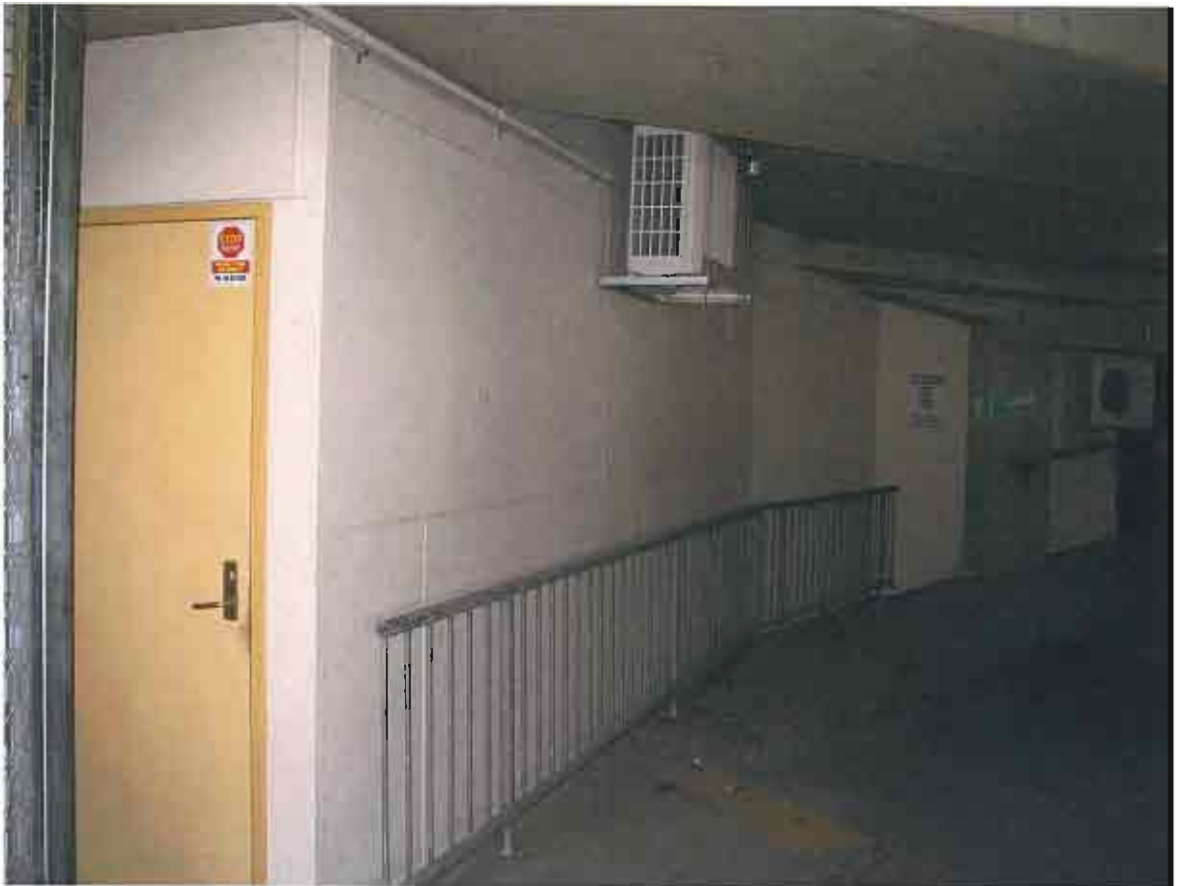
Fibrous cement sheeting wall cladding located on northern side adjacent ramp and pub. Painted. Good Condition. Approximately 30 m². Sample Number 6. Photo No 11. No asbestos was detected in the material sampled (refer Appendix A).

Photo No 11
Multi-Level Carpark northern wall (adjacent pub)

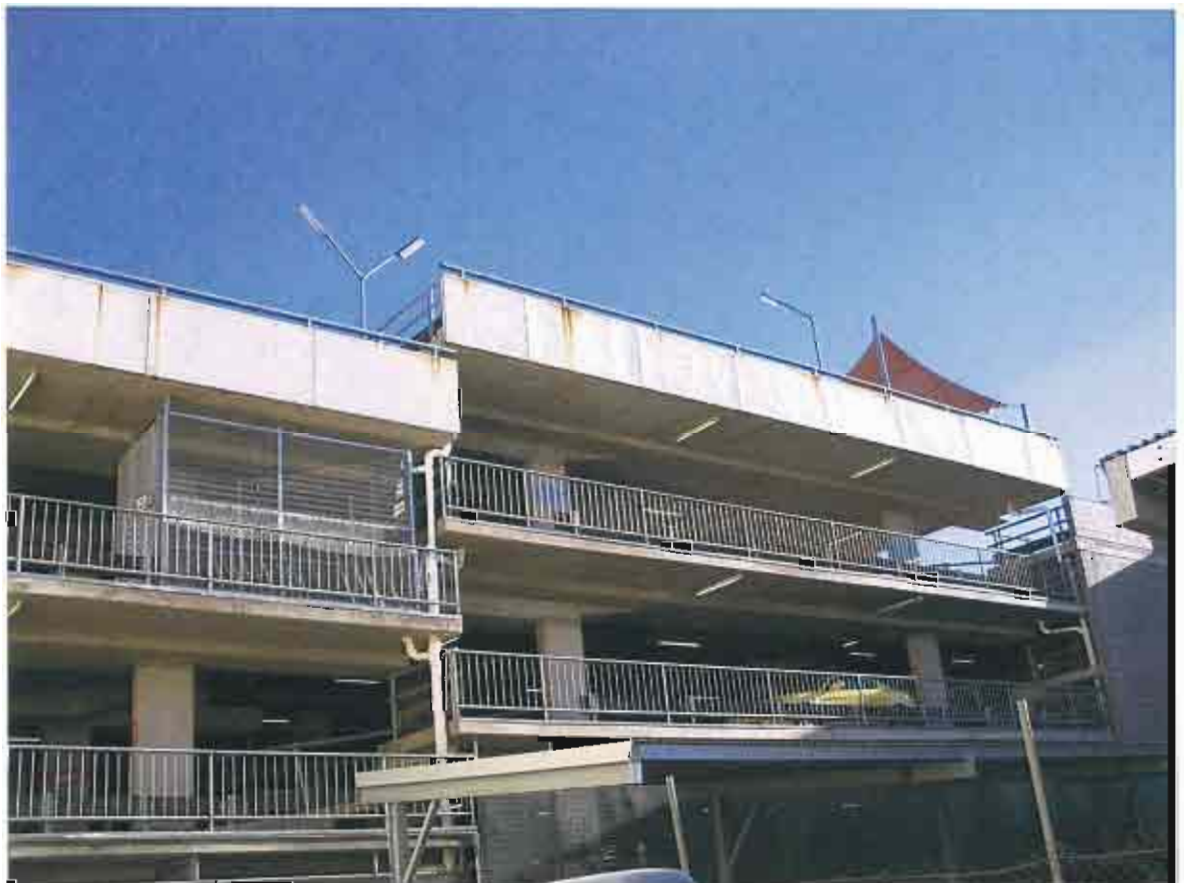
Fibrous cement sheeting covering both sides of balustrading located on northern and southern sides. Medium Condition. Approximately 80 m². Similar to Sample Number 5. Photo No 12. No asbestos was detected in the material sampled (refer Appendix A).

Note: Numerous sheets cracked.

Photo No 12
Multi-Level Carpark northern side balustrade covering

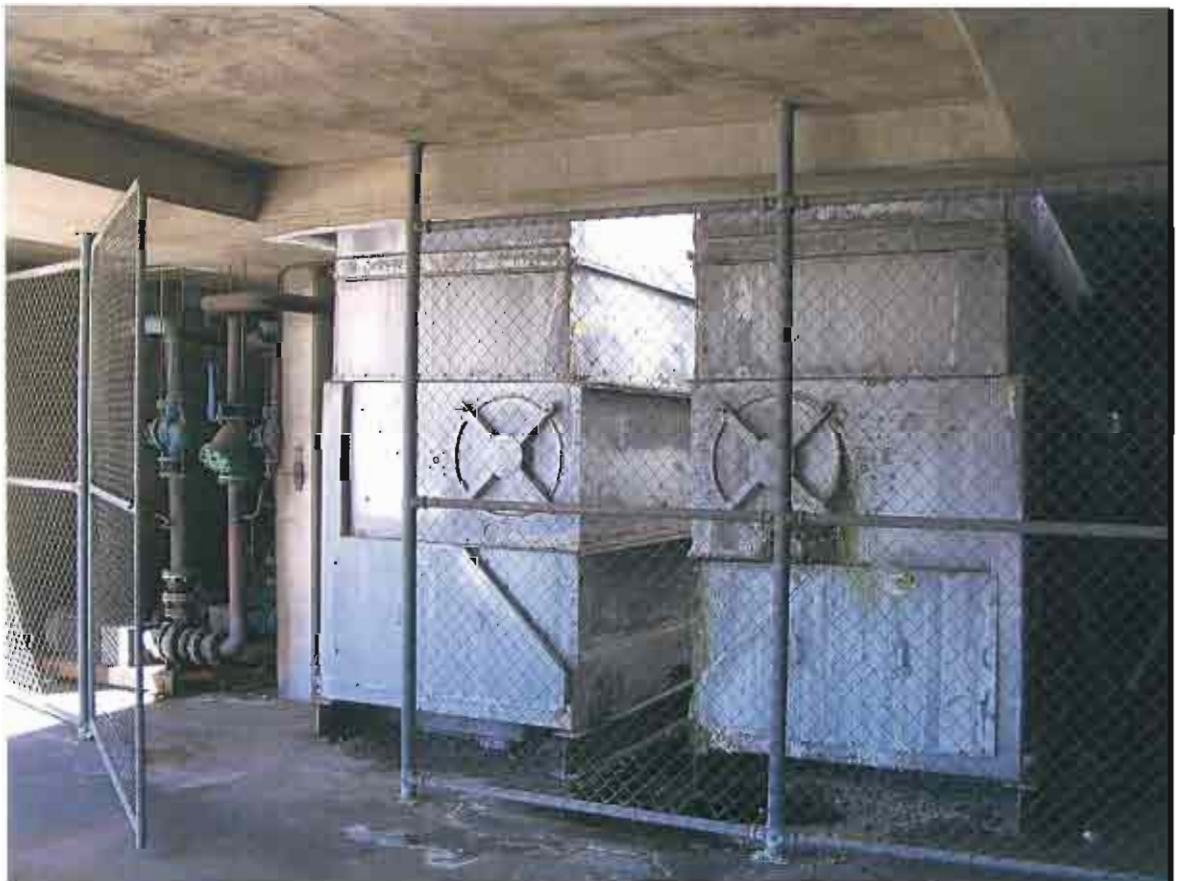
Photo No 14

Air conditioning plant joint mastic. Good Condition. Unquantifiable. Sample Number 1. Photo No 14. No asbestos was detected in the material sampled (refer Appendix A).

Multi-Level Carpark, Level 3, air conditioning plant

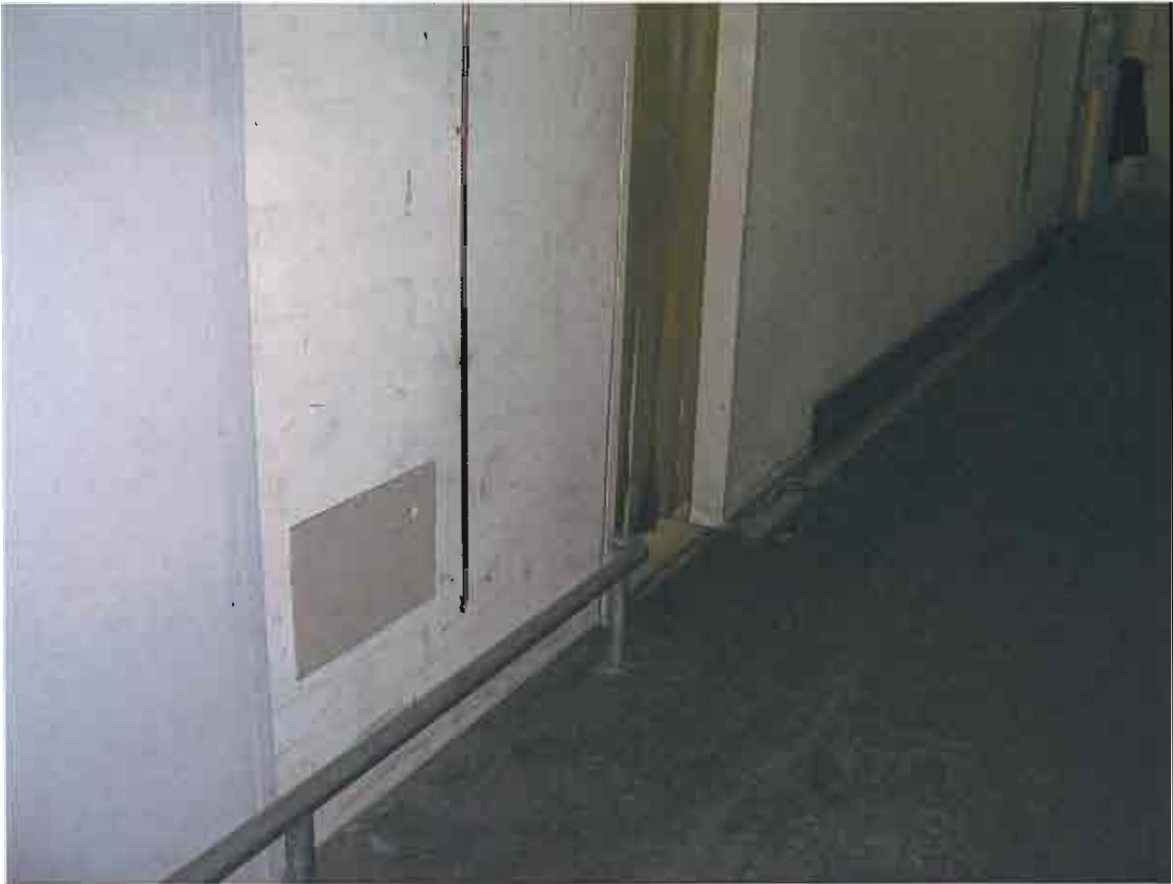
Photo No 15

Fibrous cement sheeting patching wall in two locations. Not Painted. Medium Condition. Approximately 2.25 m². Sample Number 11. Photo No 15. No asbestos was detected in the material sampled (refer Appendix A).

White vinyl floor tiles. Good Condition. Approximately 5 m². Sample Number 12. Photo No 15. No asbestos was detected in the material sampled (refer Appendix A).

Bi-Lo Corridor (adjacent rear butcher) – fibrous cement sheeting and vinyl floor tiles adjacent wall

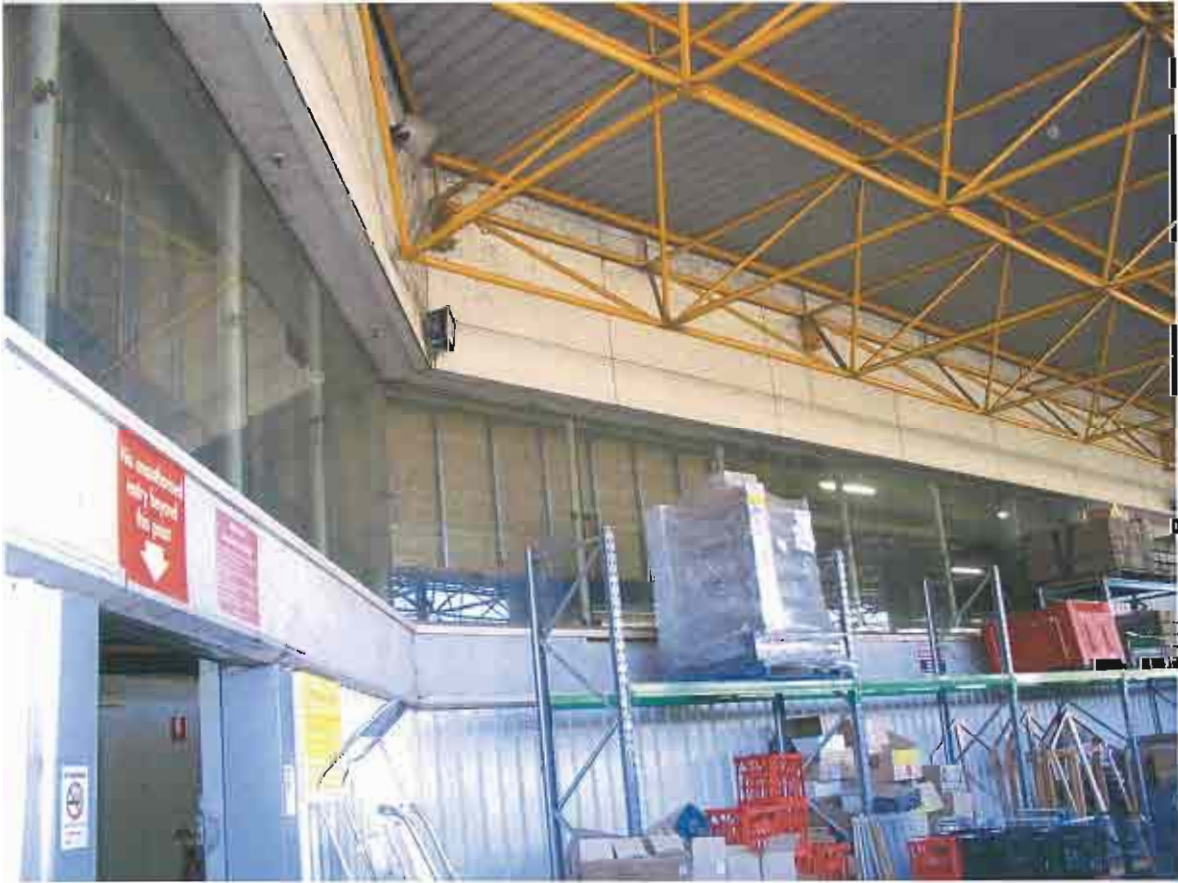
Photo No 16

Fibrous cement sheeting located on the external façade above the windows (refer Section 7.2). Painted. Good Condition. Approximately 30 m². Similar to Sample Number 4. Photo No 16. No asbestos was detected in the material sampled (refer Appendix A).

Fibrous cement sheeting infill on wall at mid section between lower iron wall and glass above. Not Painted. Medium Condition. Approximately 15 m². Sample Number 13. Photo No 16. No asbestos was detected in the material sampled (refer Appendix A).

Note: Damage visible.

Bi-Lo Receiving Bay façade above windows and mid wall infill below windows

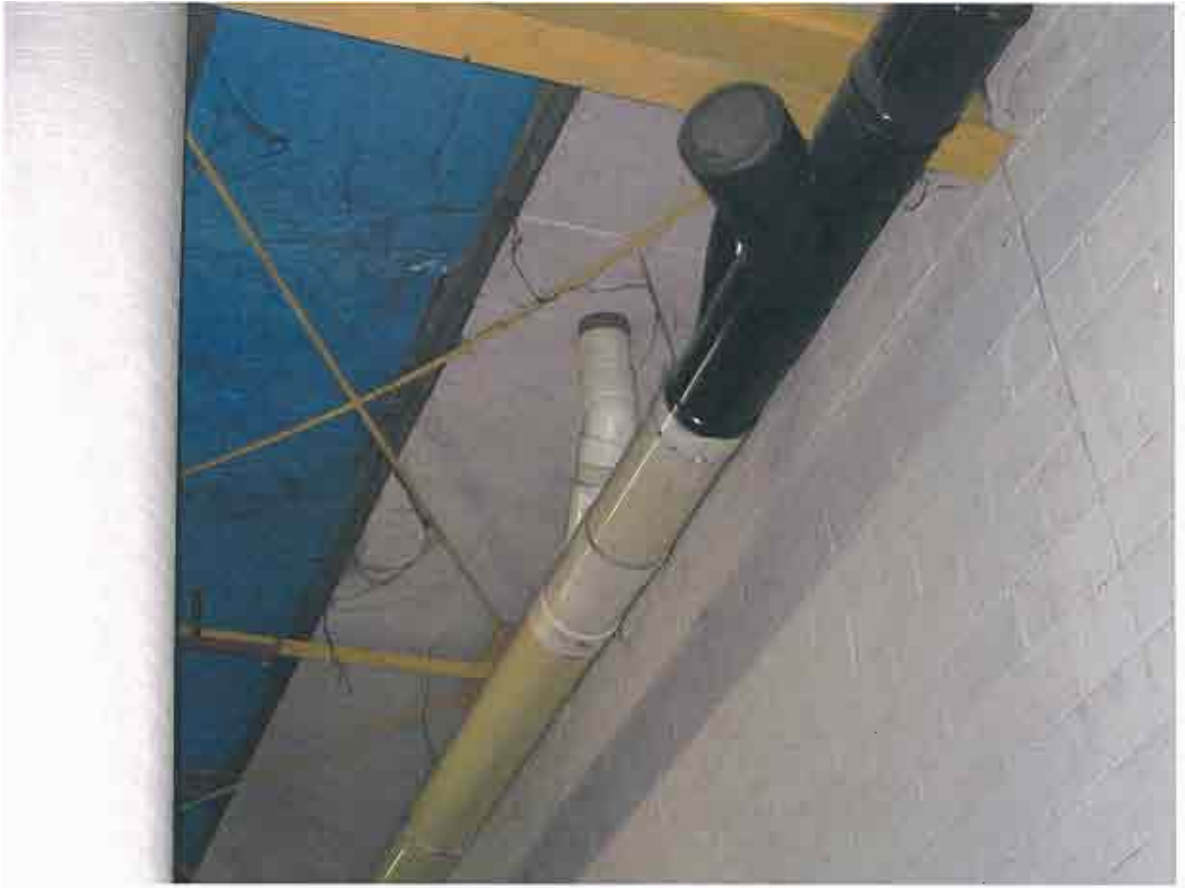
Photo No 17

Fibrous cement sheeting located on the underside of the box gutter on the eastern and western ends (refer Section 7.2). Not Painted. Good Condition. Approximately 25 m². Photo No 17.

Bi-Lo Store (north west side) underside box gutter

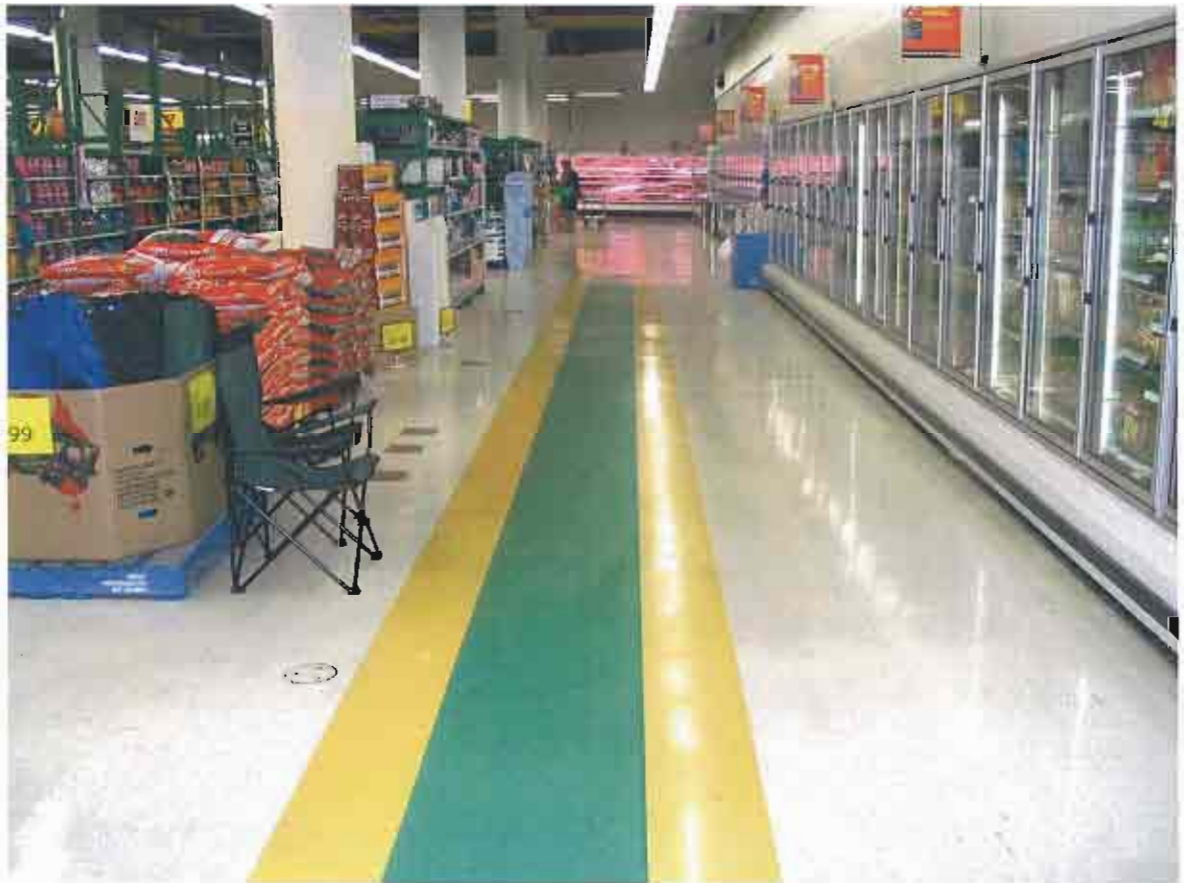
Photo No 18

Green vinyl floor tiles. Good Condition. Approximately 150 m². Sample Number 15. Photo No 18. No asbestos was detected in the material sampled (refer Appendix A).

Yellow vinyl floor tiles. Good Condition. Approximately 150 m². Sample Number 14. Photo No 18. No asbestos was detected in the material sampled (refer Appendix A).

White vinyl floor tiles. Good Condition. Approximately 1,000 m². Similar to Sample Number 12. Photo No 18. No asbestos was detected in the material sampled (refer Appendix A).

Note: Colour variations of tiles are evident where repairs have been carried out (refer Section 7.3).

Colour variations of the white vinyl floor tiles within the Bi-Lo retail areas are evident. Replacement tiles have been installed to repair and/or replace existing floor tiles.

Bi-Lo Retail, typical white, green and yellow vinyl floor tiles

Additional sample collection and analysis should be carried out on all colour variations prior to renovating, demolition, repairs and other works likely to disturb this material to determine possible asbestos content.

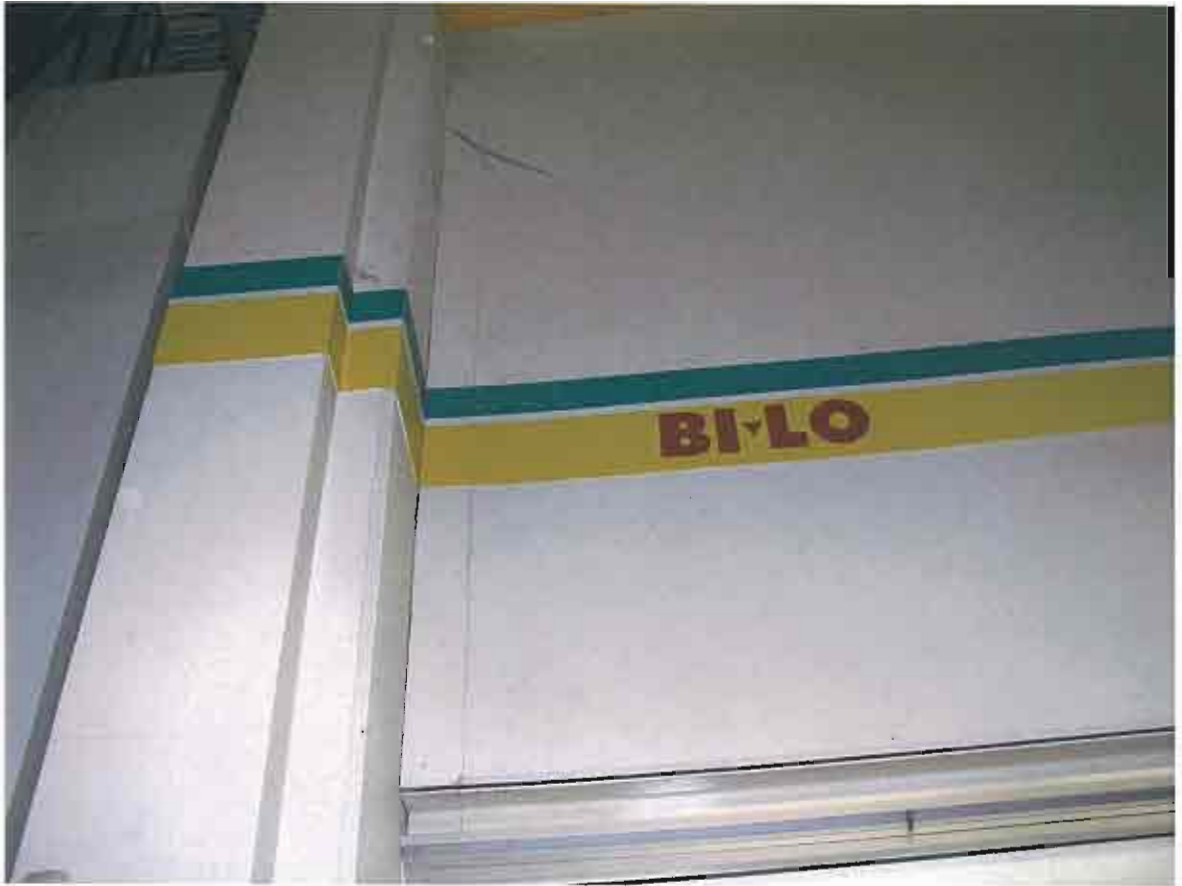
Photo No 19

Fibrous cement sheeting infill strip on upper wall adjacent column. Painted. Good Condition. Approximately 1 m². Sample Number 16. Photo No 19. No asbestos was detected in the material sampled (refer Appendix A).

Bi-Lo Magazine Store, upper wall infill strip adjacent column

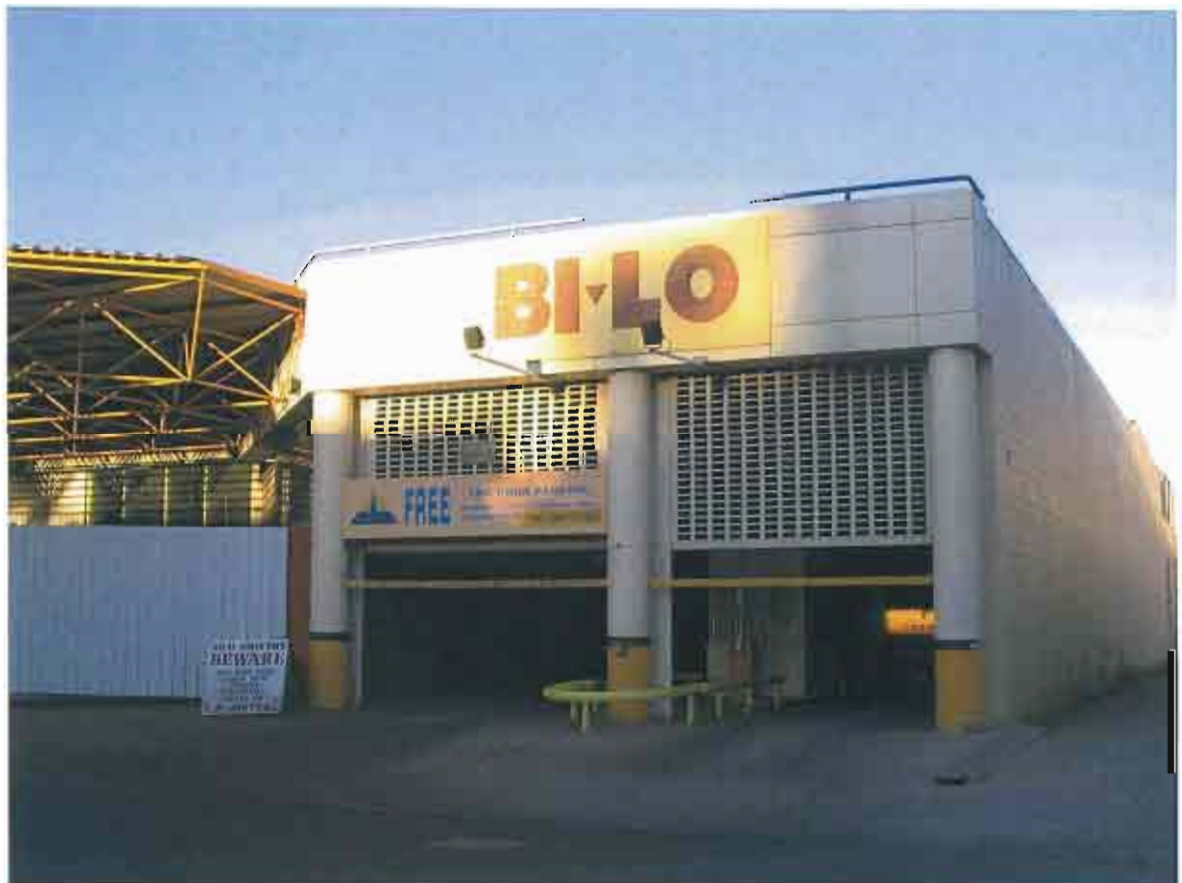
Photo No 20

Fibrous cement sheeting located on the external western facade. Painted. Good Condition. Approximately 10 m². Similar to Sample Number 4. Photo No 20. No asbestos was detected in the material sampled (refer Appendix A).

Bi-Lo Carpark external western facade

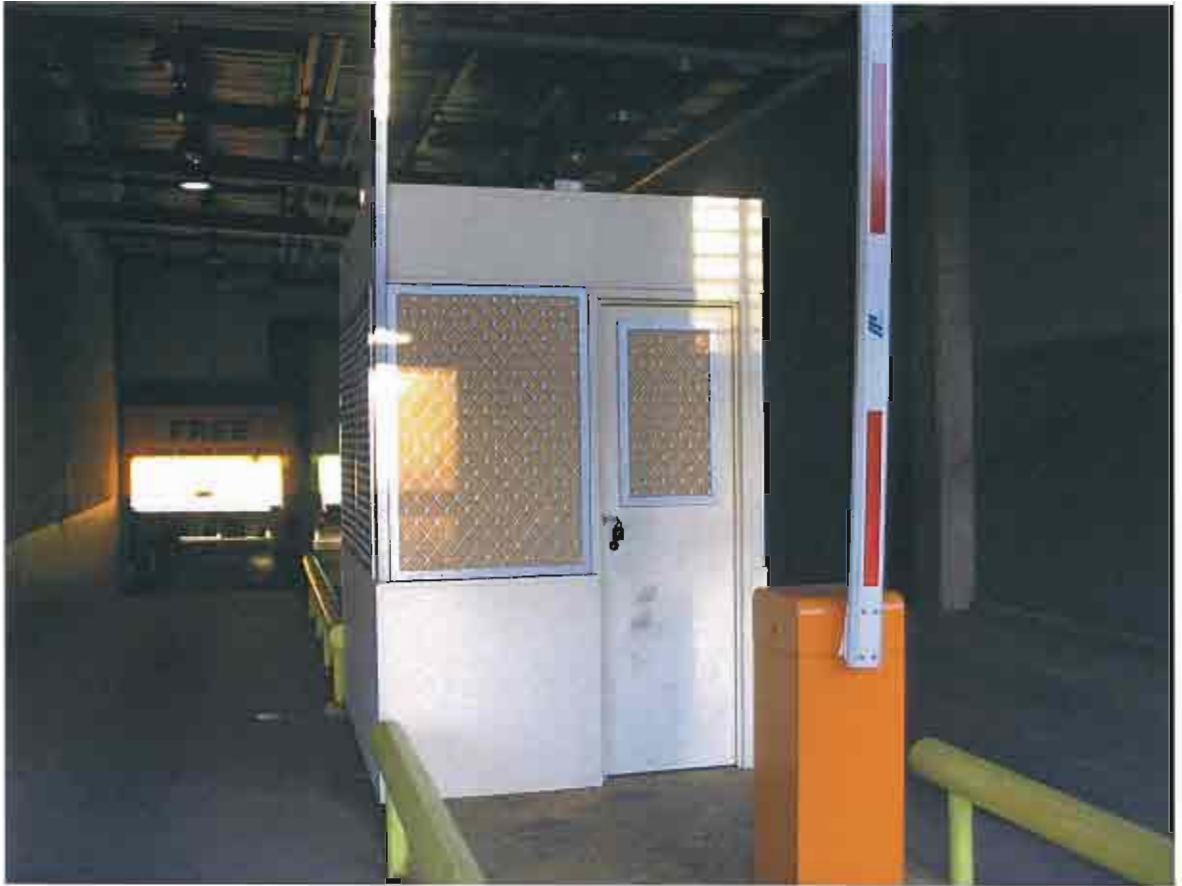
Fibrous cement sheet external wall cladding. Painted. Good Condition. Approximately 10 m². Sample Number 8. Photo No 21. No asbestos was detected in the material sampled (refer Appendix A).

Photo No 21
Bi-Lo Carpark guard box

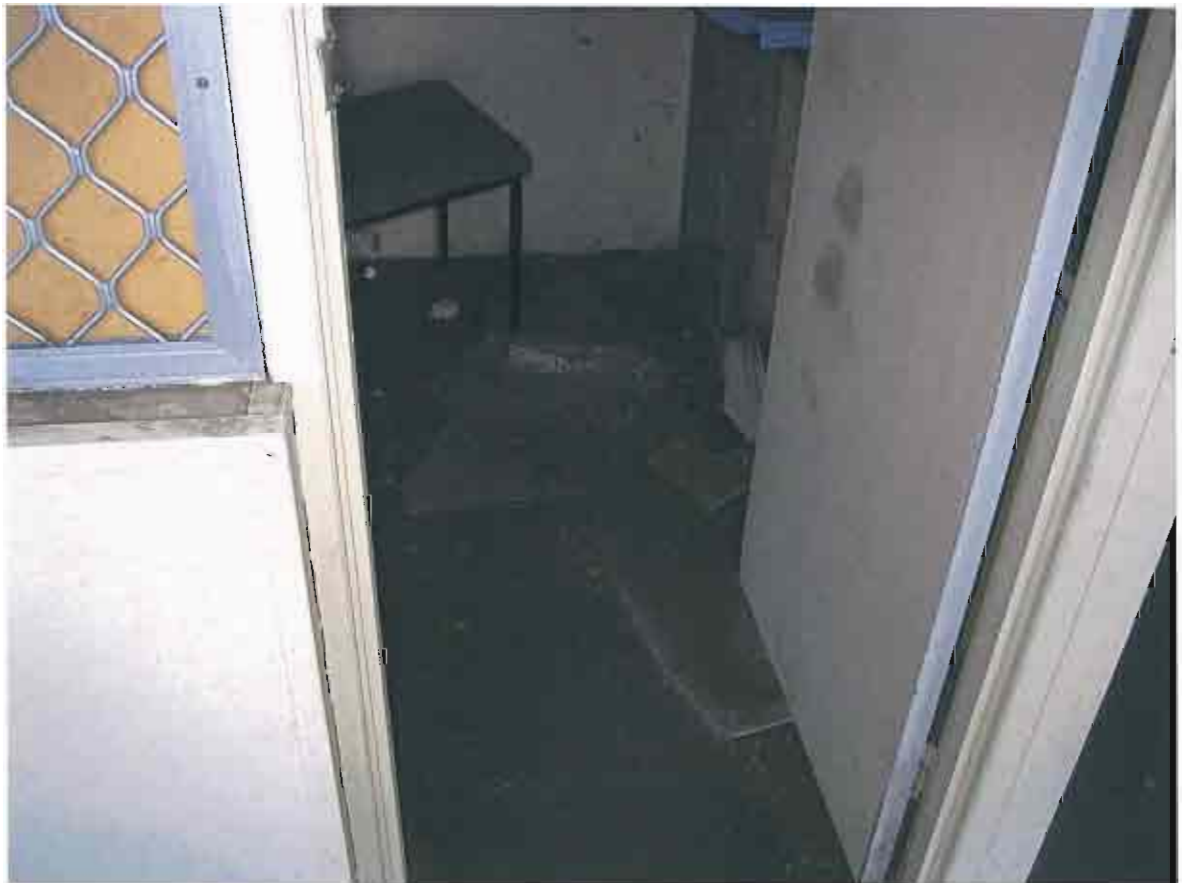
Fibrous cement sheeting ceiling, lower walls and wall above windows. Poor Condition. Approximately 12 m². Similar to Sample Number 8. Photo No 22. No asbestos was detected in the material sampled (refer Appendix A).

Note: Walls badly damaged with debris on ground.

Photo No 22
Bi-Lo Carpark internal guard box – fibrous cement debris

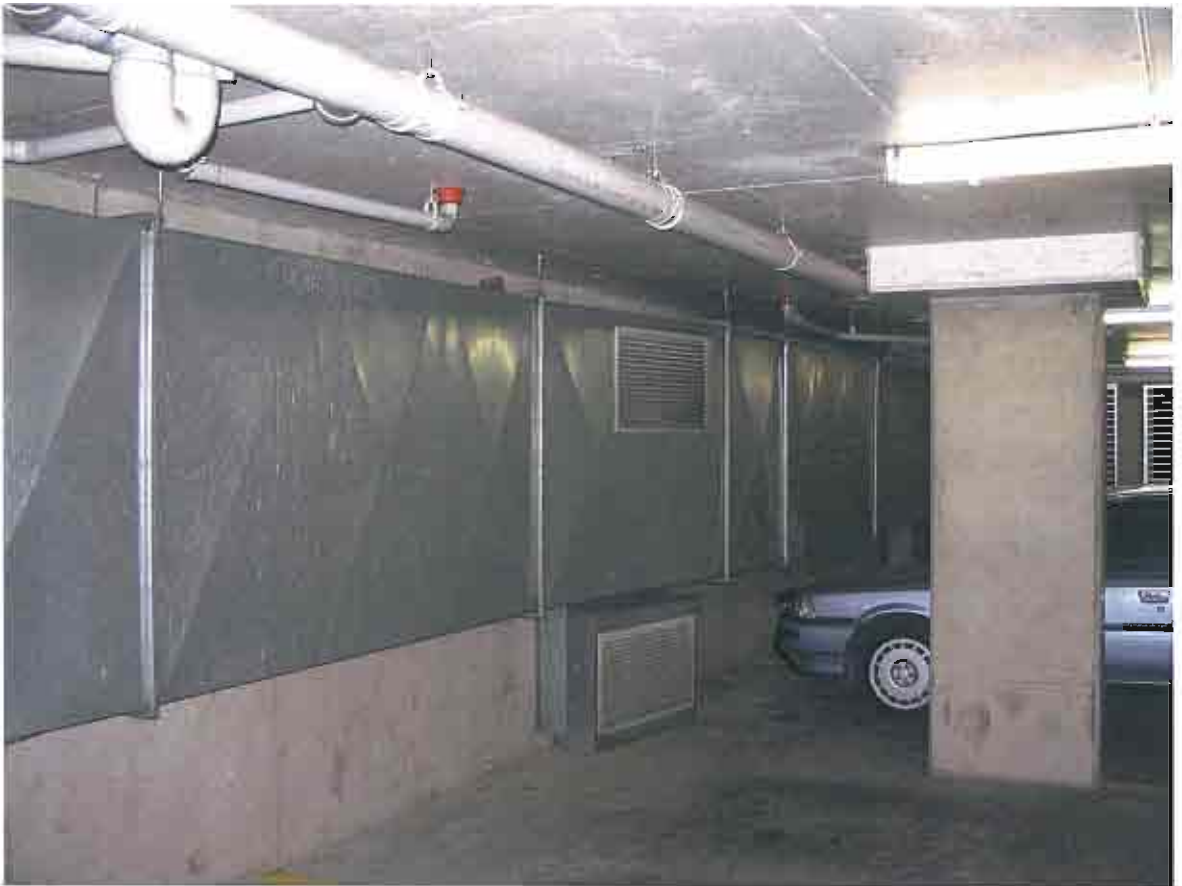
Air conditioning ducts joint mastic. Good Condition. Unquantifiable. Sample Number 7. Photo No 23. No asbestos was detected in the material sampled (refer Appendix A).

Photo No 23
Bi-Lo Carpark, air conditioning ducts

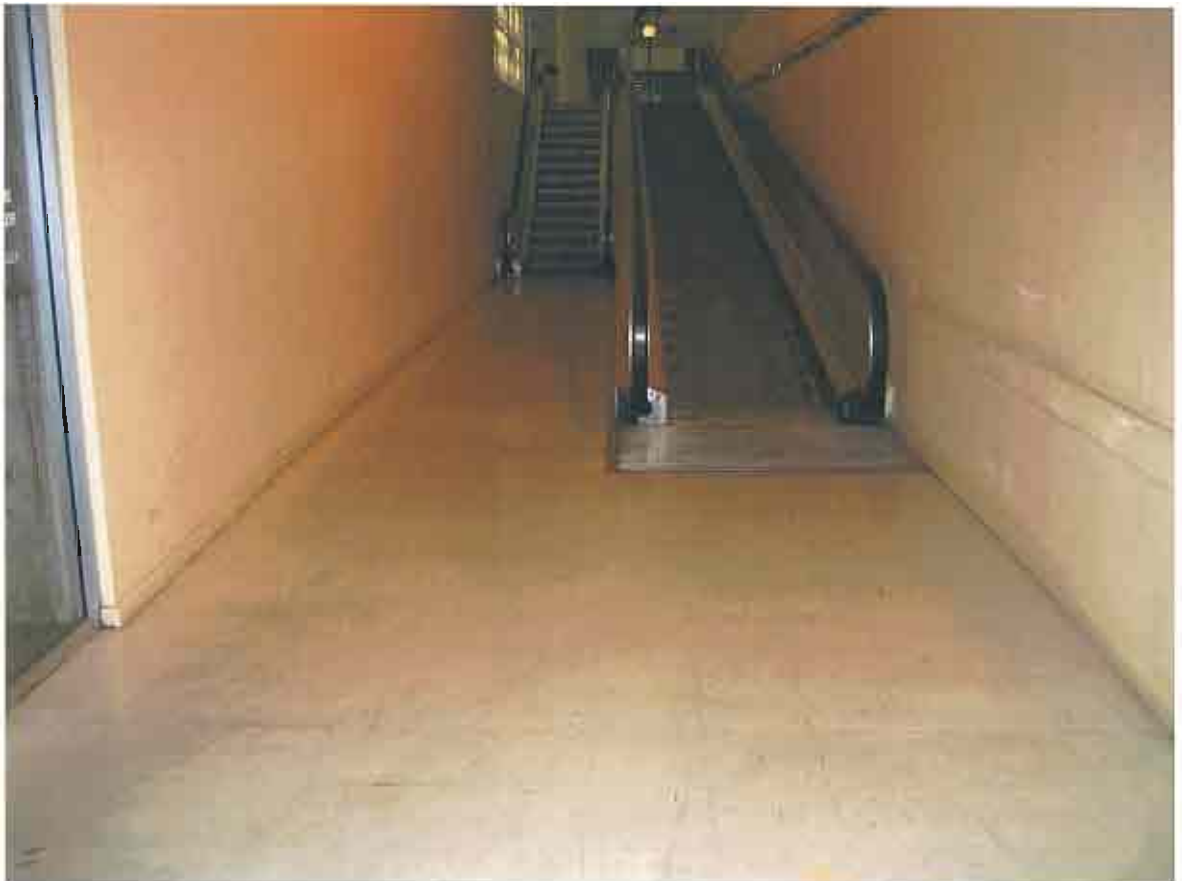
White vinyl floor tiles. Good Condition. Approximately 29 m². Sample Number 9. Photo No 24. No asbestos was detected in the material sampled (refer Appendix A).

Photo No 24
Bi-Lo Carpark escalator foyer white vinyl floor tiles
