## COMPLIANCE ASBESTOS RE-INSPECTION AND RISK ASSESSMENT

NOVEMBER 2023

J053743

Nightcliff Library - 10 Pavonia Place  
Nightcliff NT  
0812

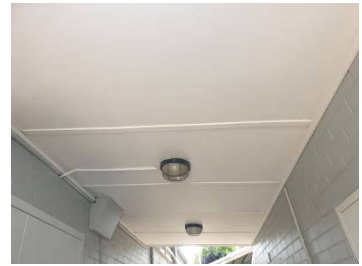
Location		Nightcliff Library - Ground Floor - Breezeway - Throughout - Exterior - Ceiling Lining - Fibre Cement Sheeting - Between Main Building And Toilets			
Hazard Type	Asbestos	Material Assessment		Disturbance Assessment	
Friability	Non-friable	Product Type	1	Occupancy	1
Sample No.	NT0557 - 4 (GJ)*	Extent of damage	0	Disturbance	1
Result	Positive Chrysotile	Surface Treatment	1	Exposure	2
		Asbestos Type	1	Maintenance	1
Item Number	2	Material Score	3	Disturbance Score	5
		Priority Score	8	Very Low

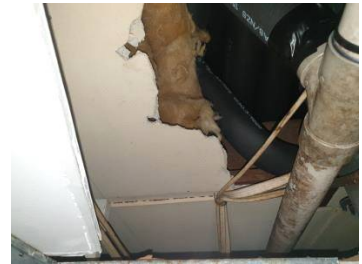
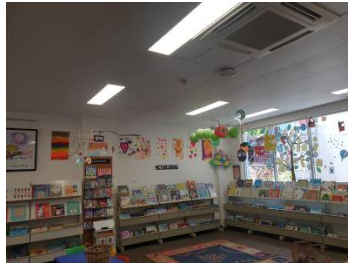
Item No.	Hazard Type	Item Location and Description	Recommendations
Item 3	Asbestos	Nightcliff Library, Ground Floor, Library, Northeast area, Interior - Ceiling Lining - Fibre Cement Sheeting - Item Is Above Existing Suspended Ceiling - Minor damage to sections adjacent air conditioners	Encapsulate / Repair & Manage In Situ

Location		Nightcliff Library - Ground Floor - Library - Northeast area - Interior - Ceiling Lining - Fibre Cement Sheeting - Item Is Above Existing Suspended Ceiling - Minor damage to sections adjacent air conditioners			
Hazard Type	Asbestos	Material Assessment		Disturbance Assessment	
Friability	Non-friable	Product Type	1	Occupancy	1
Sample No.	NT0557 - 1 (GJ)*	Extent of damage	1	Disturbance	2
Result	Positive Chrysotile	Surface Treatment	1	Exposure	2
		Asbestos Type	1	Maintenance	1
Item Number	3	Material Score	4	Disturbance Score	6
		Priority Score	10	Low

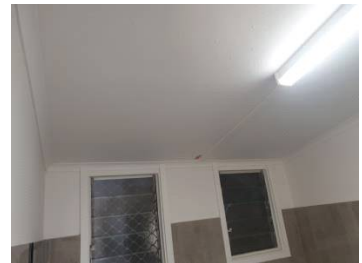
Location		Nightcliff Library - Ground Floor - Public Toilet - Throughout - Interior - Ceiling Lining - Fibre Cement Sheeting			
Hazard Type	Asbestos	Material Assessment		Disturbance Assessment	
Friability	Non-friable	Product Type	1	Occupancy	1
Sample No.	As NT0557 - 2 (GJ)*	Extent of damage	0	Disturbance	2
Result	Strongly Assumed Positive Chrysotile	Surface Treatment	1	Exposure	2
		Asbestos Type	1	Maintenance	1
Item Number	4	Material Score	3	Disturbance Score	6
		Priority Score	9	Low

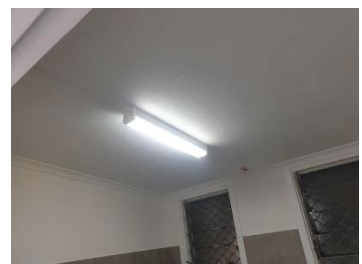
Location		Nightcliff Library - Ground Floor - Staff Toilet - Throughout - Interior - Ceiling Lining - Fibre Cement Sheeting			
Hazard Type	Asbestos	Material Assessment		Disturbance Assessment	
Friability	Non-friable	Product Type	1	Occupancy	1
Sample No.	NT0557 - 2 (GJ)*	Extent of damage	0	Disturbance	2
Result	Positive Chrysotile	Surface Treatment	1	Exposure	2
		Asbestos Type	1	Maintenance	1
Item Number	5	Material Score	3	Disturbance Score	6
		Priority Score	9	Low
