**Lot 6, Chesterfield Circuit
Nhulunbuy, Northern Territory**

Asbestos Materials Report

Prepared for
NT Developments Pty Ltd
PO Box 2125
ASCOT QLD 4007

September 2014
File Ref: 0880061926 / J20605.001

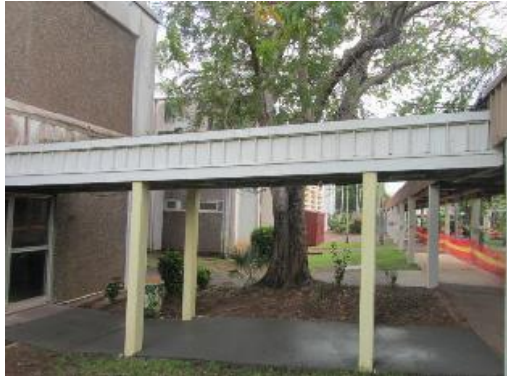
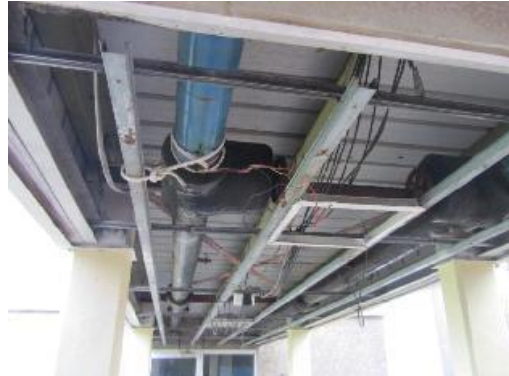
1. Asbestos cement linings to the soffit of the walkway at the east end of the main building.

Napier & Blakeley Findings: At the time of this inspection, all asbestos cement linings had been removed and the soffit structure was exposed. See Photo 1.

All asbestos cement soffit sheeting has been removed from the walkway to the east of the main building

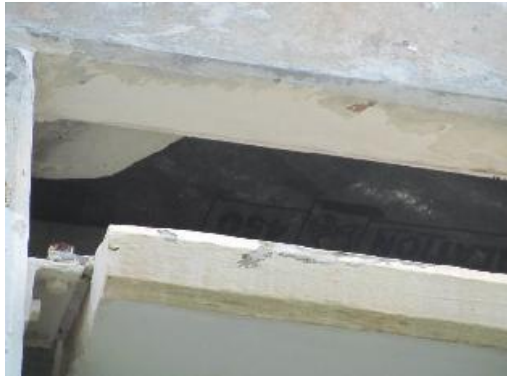
3. Asbestos cement linings to the roof eaves on both the north and south facades of the Main Building.

Napier & Blakeley Findings: At the time of this inspection, all asbestos cement roof eave linings had been removed and no replacement linings were in place. See Photos.

All asbestos cement roof eaves have been removed from the south facade of the main building

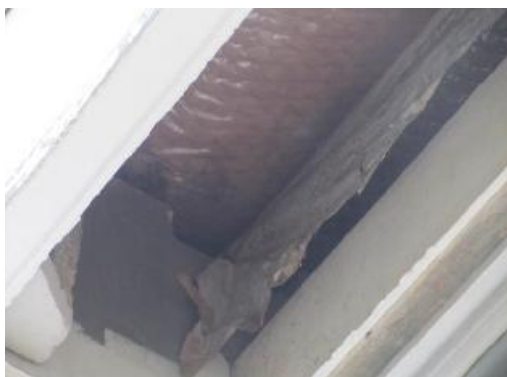
All asbestos cement roof eaves have been removed from the north facade of the main building.

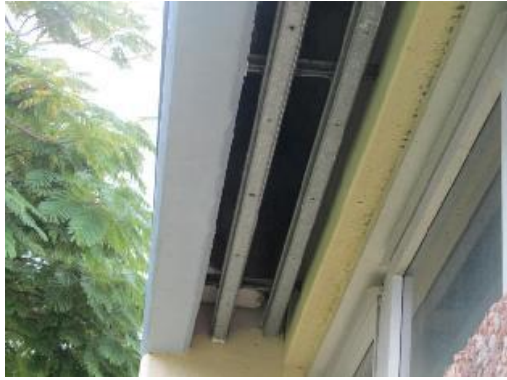
12. Asbestos cement roof eaves to the north and south facades of the Annex Building.

Napier & Blakeley Findings: At the time of this inspection, all asbestos cement linings had been removed and no replacement linings were in place.

All asbestos cement roof eaves have been removed from the north facade of the annex building

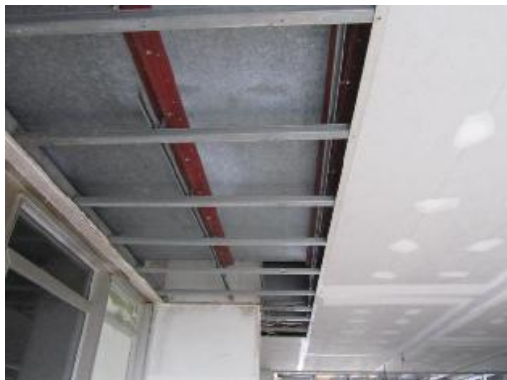
All asbestos cement roof eaves have been removed from the south facade of the annex building

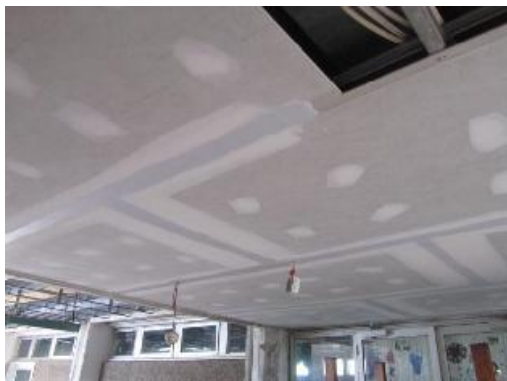
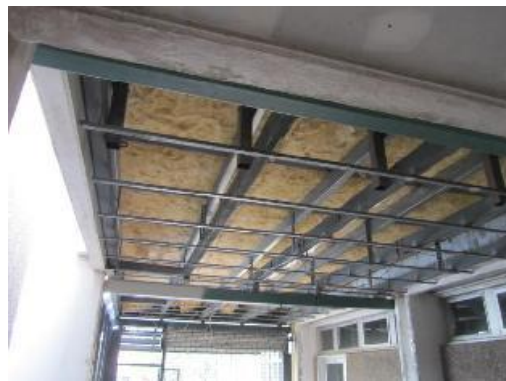
2. Asbestos cement linings to the soffit of the walkway between the Main Building and the Annex.

Napier & Blakeley Findings: At the time of this inspection, all asbestos cement linings had been removed. Fragments of material were still present adhered to the metal channels to the underside of the walkway. It is not known whether these are asbestos cement fragments or fibre cement.

Sections of the soffit structure were exposed while new fibre cement linings were in place at the eastern end. See Photos.

All asbestos cement soffit linings have been removed from the walkway between the main building and the annex building. Metal channels left in place and recorded as possibly having asbestos cement debris attached have been removed.

As of 8 Sept 2014, all channels and attached pieces of fibre cement had been removed from site.

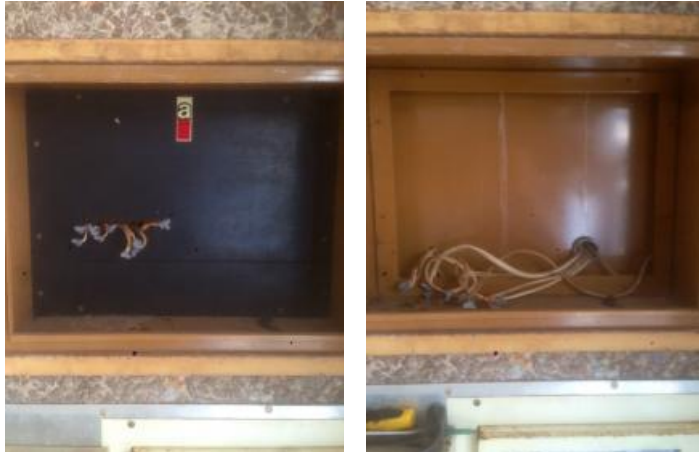
11. An asbestos based electrical backing board was identified within the metal electrical cabinet on the south façade of the Annex Building at the east end.

Napier & Blakeley Findings: At the time of this inspection, the backing board was still present.

The asbestos containing electrical backing board located on the south façade of the Annex building has been removed.

As of 8 Sept 2014, the backing board had been removed. See photos.

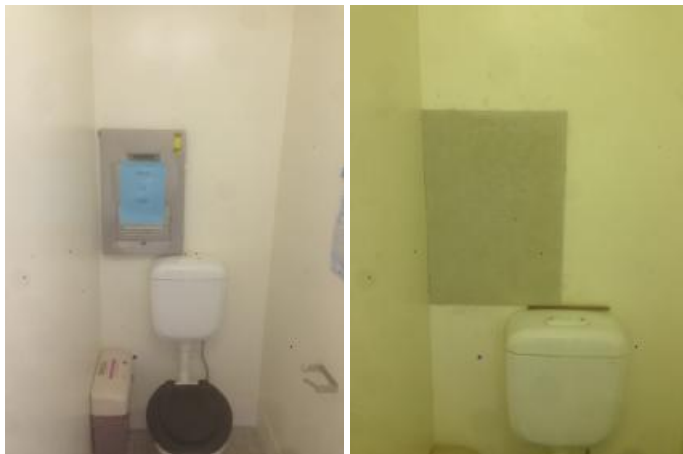
8. Presumed asbestos based insulation and gaskets within Sanitary Disposal Units found in Female Toilets on both levels of Main Building.

Napier & Blakeley Findings: At the time of this inspection, Disposal Units had been removed from the building.

Sanitary disposal devices located in female toilets in the main building have all been removed.

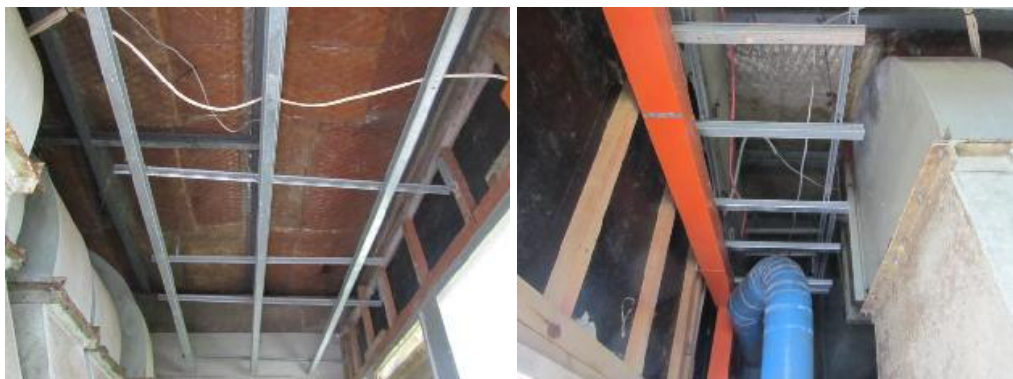
14. Asbestos cement wall linings to north, south and east walls of the Plant Room in the Annex Building.

Napier & Blakeley Findings: At the time of this inspection, all asbestos cement wall linings had been removed.

15. Asbestos cement linings to air conditioning ductwork in the Plant Room.

Napier & Blakeley Findings: At the time of this inspection, all asbestos cement duct linings had been removed.

Asbestos cement linings to walls, ceilings and ducts in the plant room have all been removed.

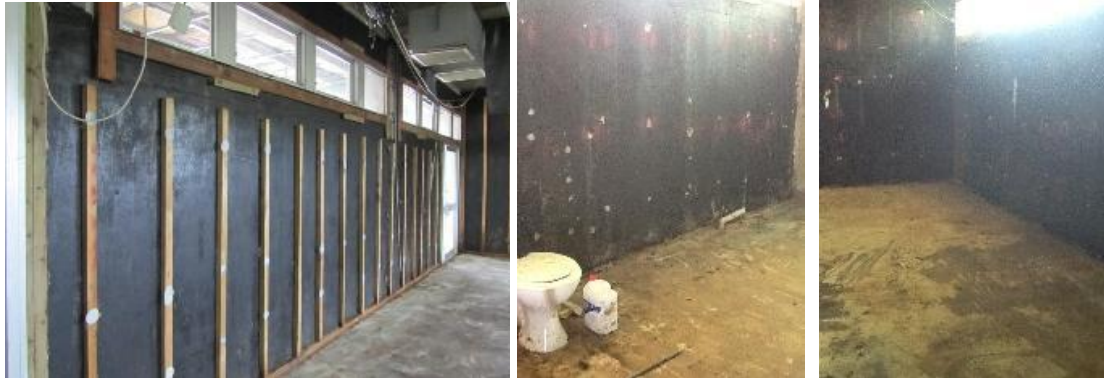
13. Asbestos cement wall linings to the eastern tenancy in the Annex Building.

Napier & Blakeley Findings: At the time of this inspection, all asbestos cement wall linings had been removed. Remnants of asbestos cement were still present on timber wall battens.

At the east end of the Annex building, battens containing asbestos cement fragments have now all been removed.

As of 8 September 2014, all wall battens had been removed. See photos.

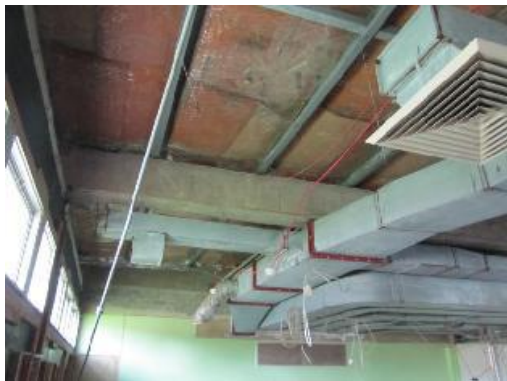
In the same space, all asbestos cement linings associated with the ceiling or ducting has now been removed.

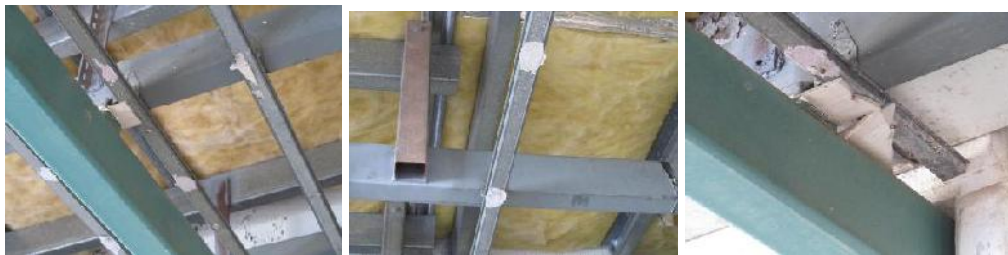
The walkway between the Main Building and the Annex had what appeared to be asbestos cement remnants adhered to soffit channels. These have all been removed. See next photos.

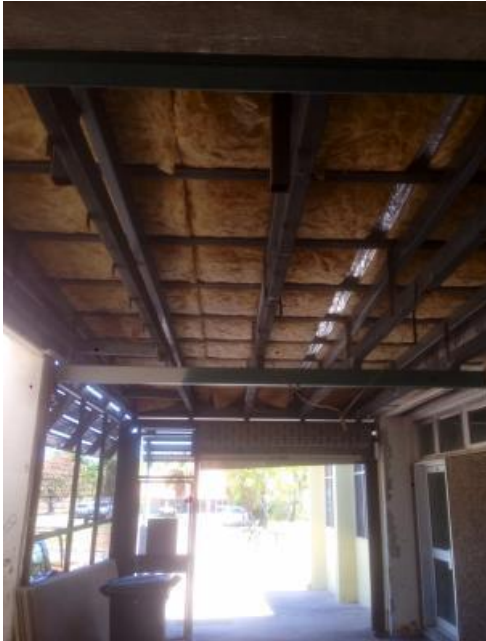
Photo shows furring channels to walkway removed.

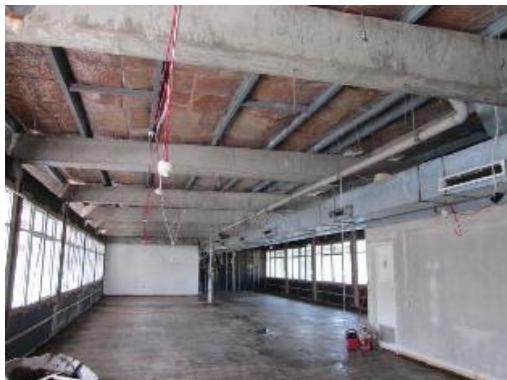
9. Asbestos cement ceiling tiles throughout the first floor of the Main Building.

Napier & Blakeley Findings: At the time of this inspection, all asbestos cement ceiling tiles had been removed and no new ceilings had been installed.

Asbestos cement ceiling tiles to the main building have been removed

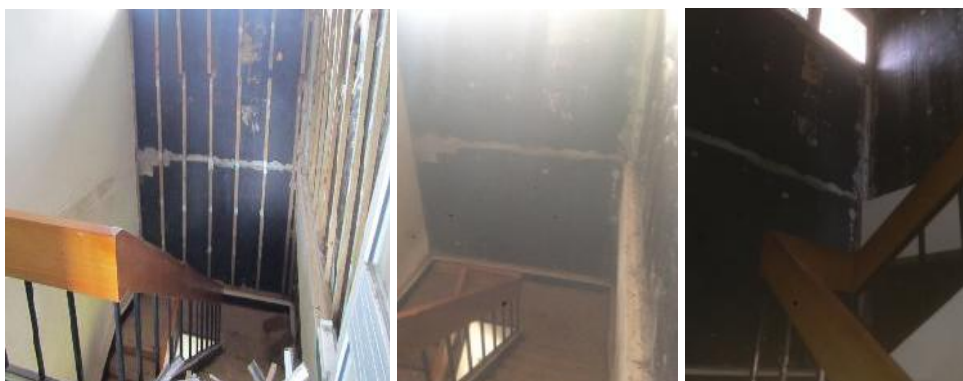
10. Asbestos cement wall linings throughout the first floor of the Main Building and including the stairwells at both the east and south ends.

Napier & Blakeley Findings: At the time of this inspection, all asbestos cement wall linings had been removed. Remnants of asbestos cement were still present on timber wall battens.

Battens containing asbestos cement fragments in stairwells have been removed.

As of 8 Sept 2014 all wall battens had been removed. See photos.

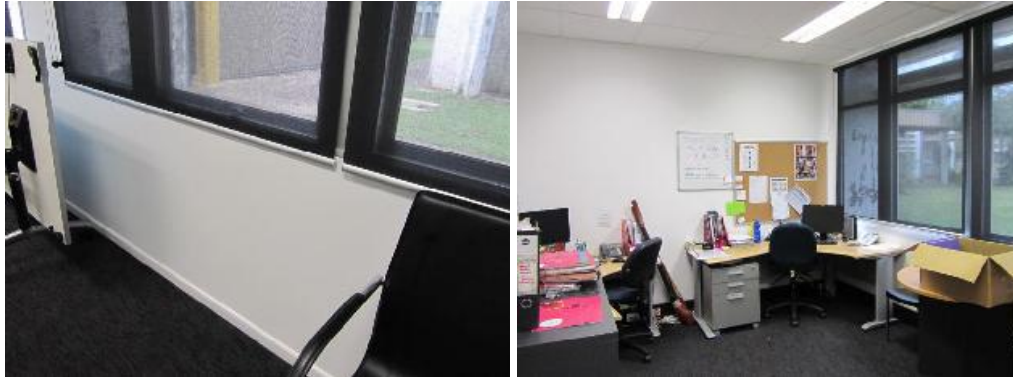
The ground floor of the Main Building has already been renovated. There are no “before” or “after” photos recording the asbestos removal.

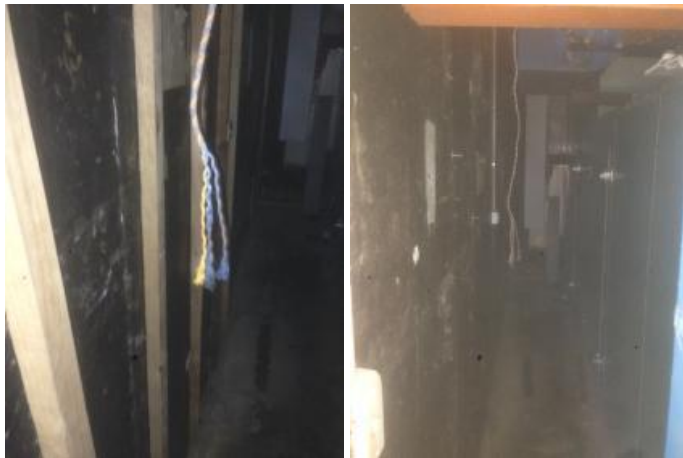
All wall battens in the plant room removed

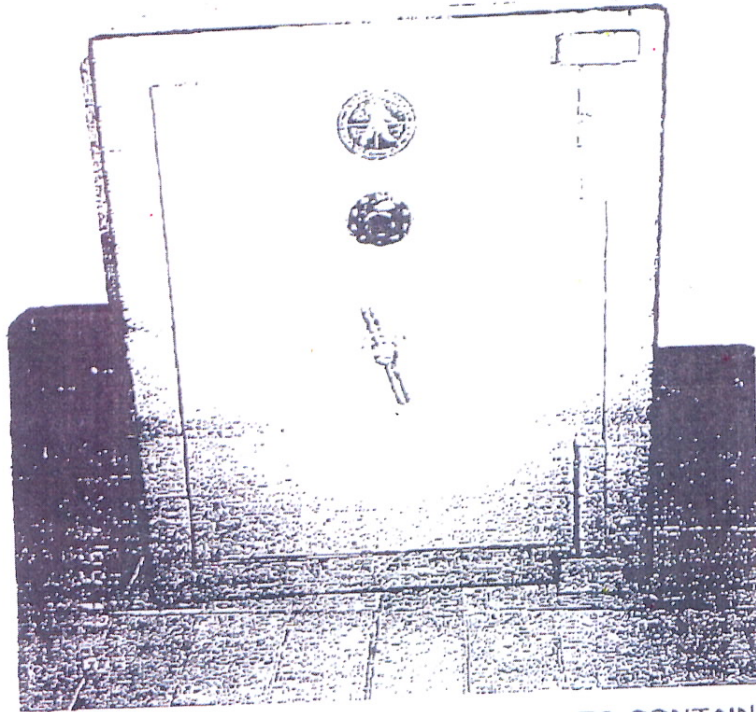
- 1.6 Asbestos insulation is expected to be used as lining to the door walls and back of the Victoria safe located at the base of the eastern stairwell, approximate area totals 2m².

Insulation is expected to be friable generally inaccessible and unpainted. The door cladding is in good condition.

SAFE WALLS, BACK AND DOOR LIKELY TO CONTAIN ASBESTOS INSULATION

RECOMMENDED ACTION : AFFIX CAUTION LABELS. USE CARE WHEN ACCESSING, REMOVE DURING NEXT MAINTENANCE LIKELY TO DISTURB.

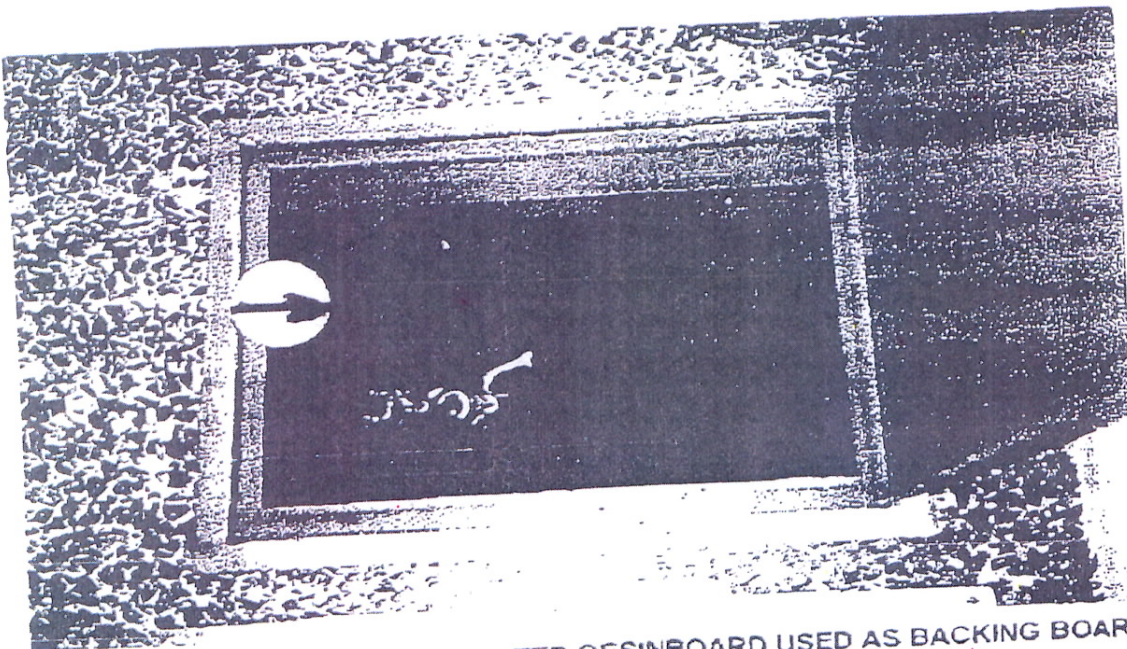
- 2.1 An asbestos impregnated resin board used as a backing board was located on the eastern end of the southern wall. Approximate area is 0.5m².

Material is non friable, in good condition, with limited access and unpainted.

ASBESTOS IMPREGNATED RESINBOARD USED AS BACKING BOARD ON SOUTHERN WALL OF ANNEXE

RECOMMENDED ACTION : AFFIX CAUTION LABELS. CHECK CONDITION ANNUALLY. AVOID DAMAGE. REMOVE IF REFURBISHMENT, STRUCTURAL ALTERATIONS, ELECTRICAL UPGRADE, OR DEMOLITION IS TO BE CARRIED OUT IN THIS AREA.

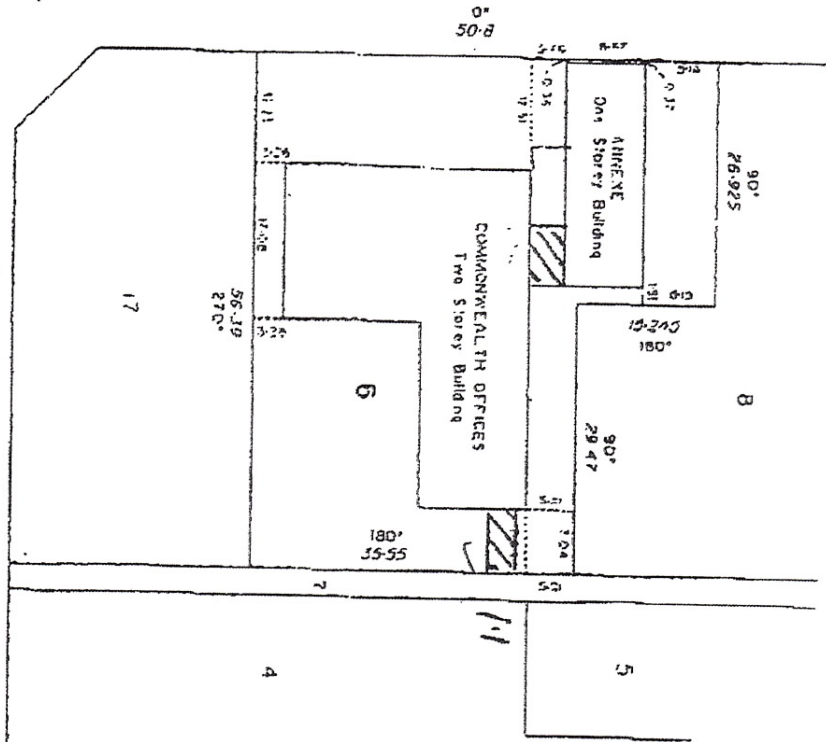
Asbestos cement sheeting used as ceiling lining to walkways
