# ASBESTOS REGISTER UPDATE

NO. 84097

Harbour View Plaza, 8 McMinn Street,  
Darwin

September 2015  
J132870

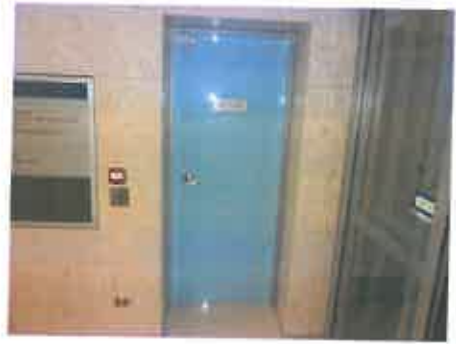
GROUND LEVEL, INTERNAL			
Location	Type of Material		
3. Fire door to "Fire Stairwells A & B" core material (2m <sup>2</sup> /door)	Area accessed but not sampled. Based on findings in similar areas, it is highly likely the core material contain asbestos.

Recommendation and Action			
Refer to Section 7.0: Policies & Management Procedures			
Situational Asbestos Risk Assessment:			
Friability	Condition	Signage	Risk Rating
Friable when exposed	Stable	Warning signs in place	Medium

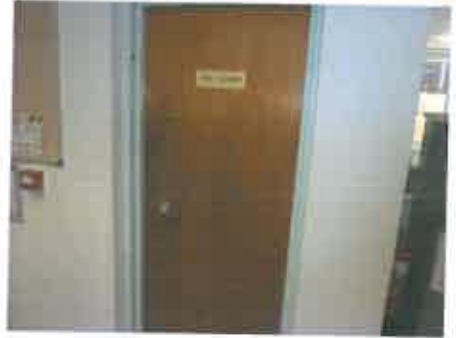
LEVEL 1, INTERNAL			
Location	Type of Material		
4. Fire door to "Fire Stairwells A & B" core material (2m <sup>2</sup> /door)	Area accessed but not sampled. Based on findings in similar areas, it is highly likely the core material contain asbestos.

Recommendation and Action			
Refer to Section 7.0: Policies & Management Procedures			
Situational Asbestos Risk Assessment:			
Friability	Condition	Signage	Risk Rating
Friable when exposed	Stable	Warning signs in place	Medium

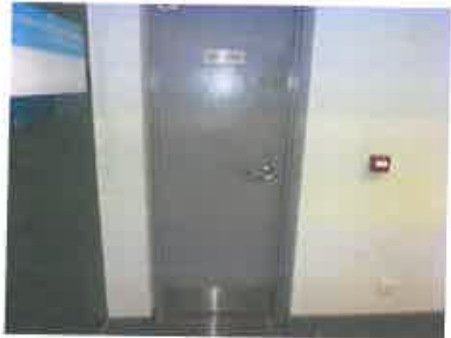
LEVEL 2, INTERNAL			
Location	Type of Material		
5. Fire door to "Fire Stairwell A & B" core material (2m <sup>2</sup> /door)	Area accessed but not sampled. Based on findings in similar areas, it is highly likely the core material contain asbestos.		
<b>Recommendation and Action</b>			
Refer to Section 7.0: Policies & Management Procedures			
<b>Situational Asbestos Risk Assessment:</b>			
Friability	Condition	Signage	Risk Rating
Friable when exposed	Stable	Warning signs in place	Medium

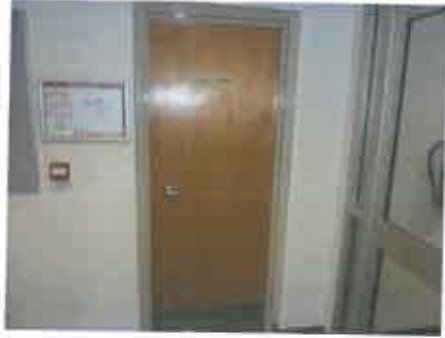
LEVEL 3, INTERNAL			
Location	Type of Material		
6. Fire door to "Fire Stairwell A & B" core material (2m <sup>2</sup> /door)	Area accessed but not sampled. Based on findings in similar areas, it is highly likely the core material contain asbestos.		
<b>Recommendation and Action</b>			
Refer to Section 7.0: Policies & Management Procedures			
<b>Situational Asbestos Risk Assessment:</b>			
Friability	Condition	Signage	Risk Rating
Friable when exposed	Stable	Warning signs in place	Medium

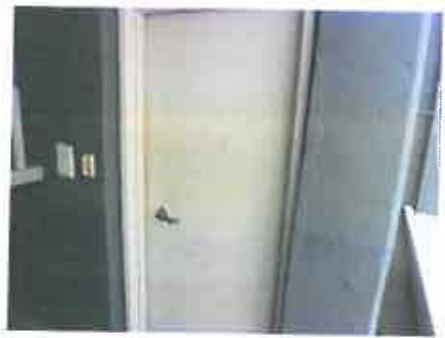
LEVEL 6, INTERNAL			
Location	Type of Material		
9. Fire door to roof access of Fire Stairwell A & B core material (2m <sup>2</sup> /door)	Area accessed but not sampled. Based on findings in similar areas, it is highly likely the core material contain asbestos.

Recommendation and Action			
Refer to Section 7.0: Policies & Management Procedures			
Situational Asbestos Risk Assessment:			
Friability	Condition	Signage	Risk Rating
Friable when exposed	Stable	Warning signs in place	Medium

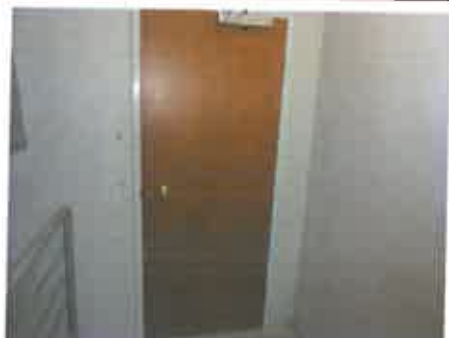
Location	Type of Material		
10. Fire door to water tank room of fire stairwell B core material (2m <sup>2</sup> )	Area accessed but not sampled. Based on findings in similar areas, it is highly likely the core material contain asbestos.

Recommendation and Action			
Refer to Section 7.0: Policies & Management Procedures			
Situational Asbestos Risk Assessment:			
Friability	Condition	Signage	Risk Rating
Friable when exposed	Stable	Warning signs in place	Medium

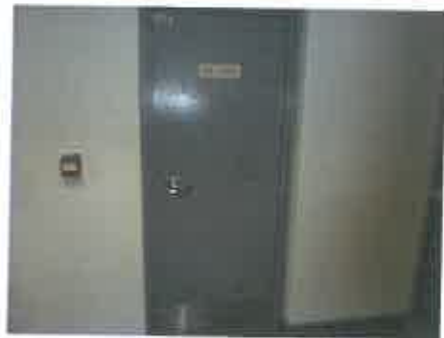
LIFT MOTOR ROOM, INTERNAL			
Location	Type of Material		
11. Fire door core material (2m <sup>2</sup> )	Area accessed but not sampled. Based on findings in similar areas, it is highly likely the core material contain asbestos.

Recommendation and Action			
Refer to Section 7.0: Policies & Management Procedures			
Situational Asbestos Risk Assessment:			
Friability	Condition	Signage	Risk Rating
Friable when exposed	Stable	Install 1 small warning sign	Medium
