Finke River Mission
51 A Gap Road
Alice Springs

Asbestos Report & Register

Date: 10 April 2015
Consultant: Anthony Lillicrap

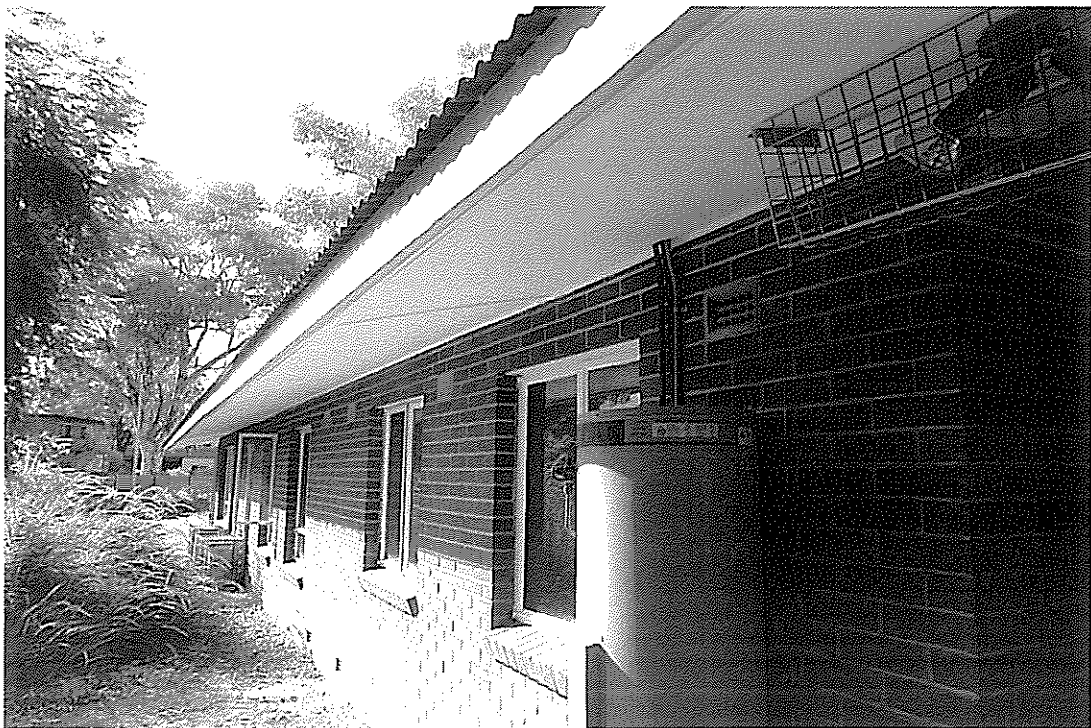
Building A- Eave lining

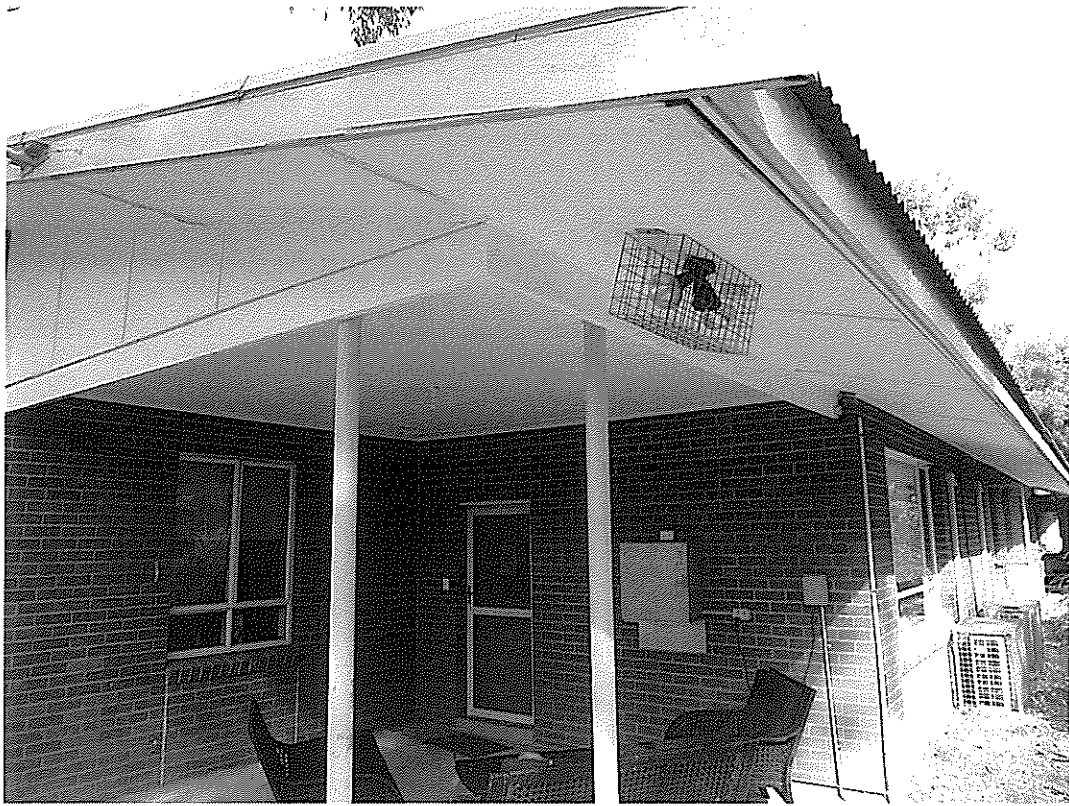
Building A- Eave lining and gable end.

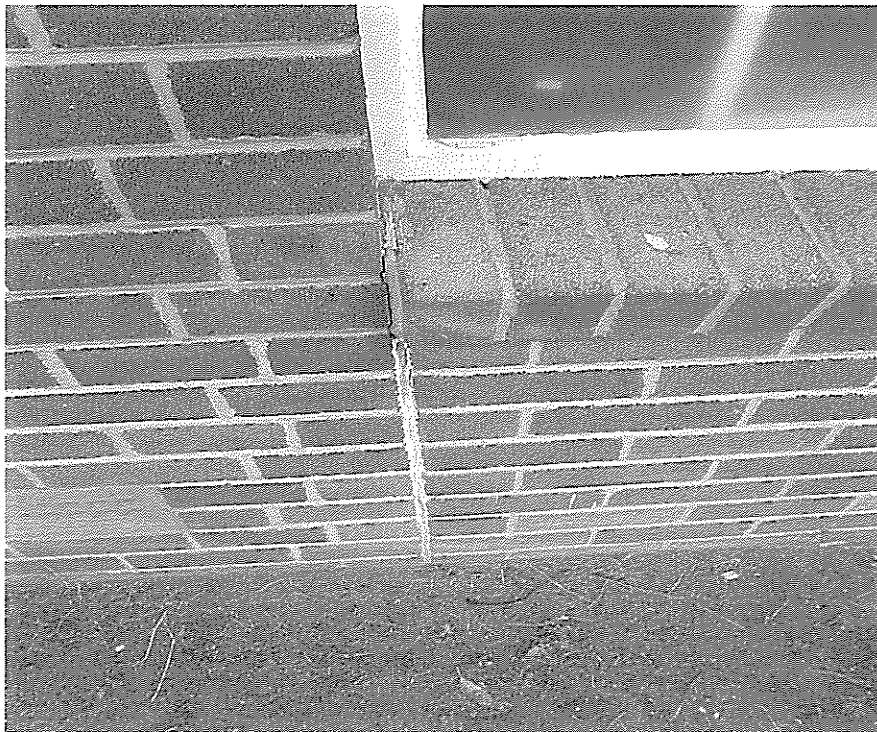
Building A- Joint sealant

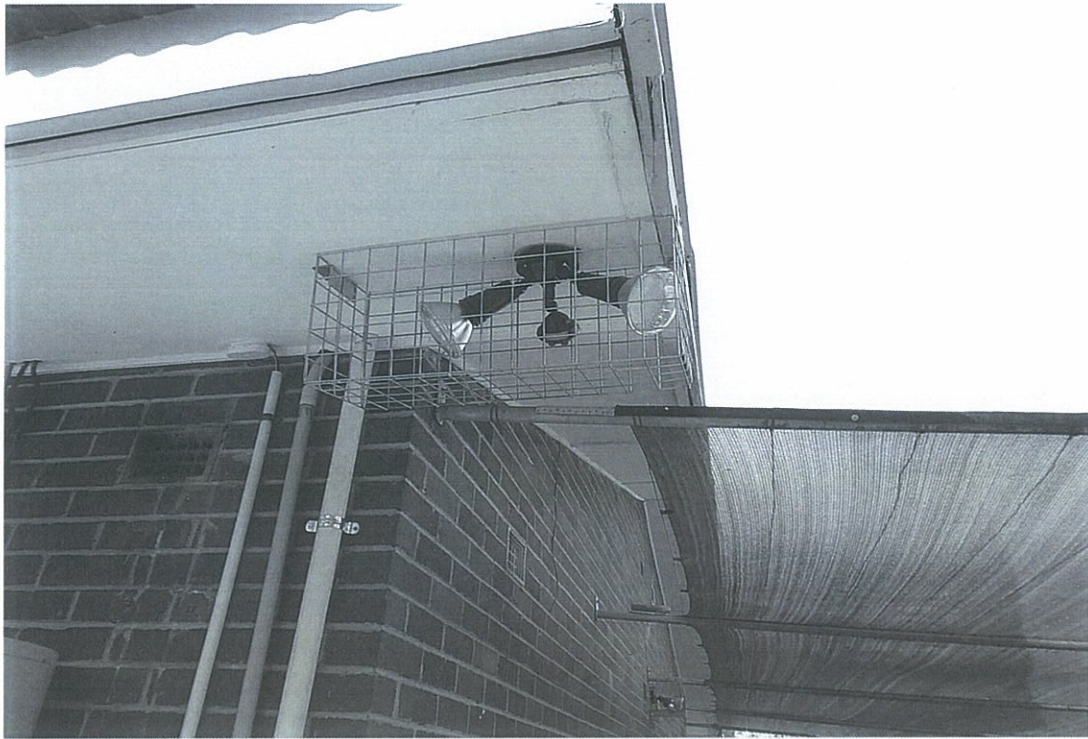
Building B- Eave lining

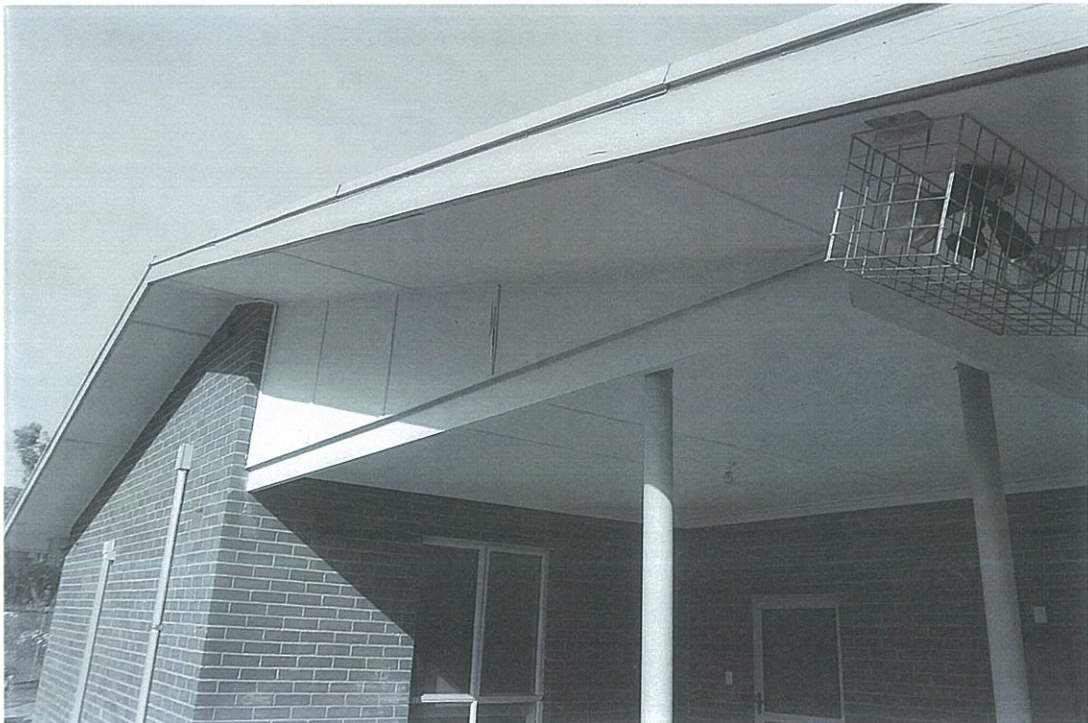
Building B- Eave lining and gable end.

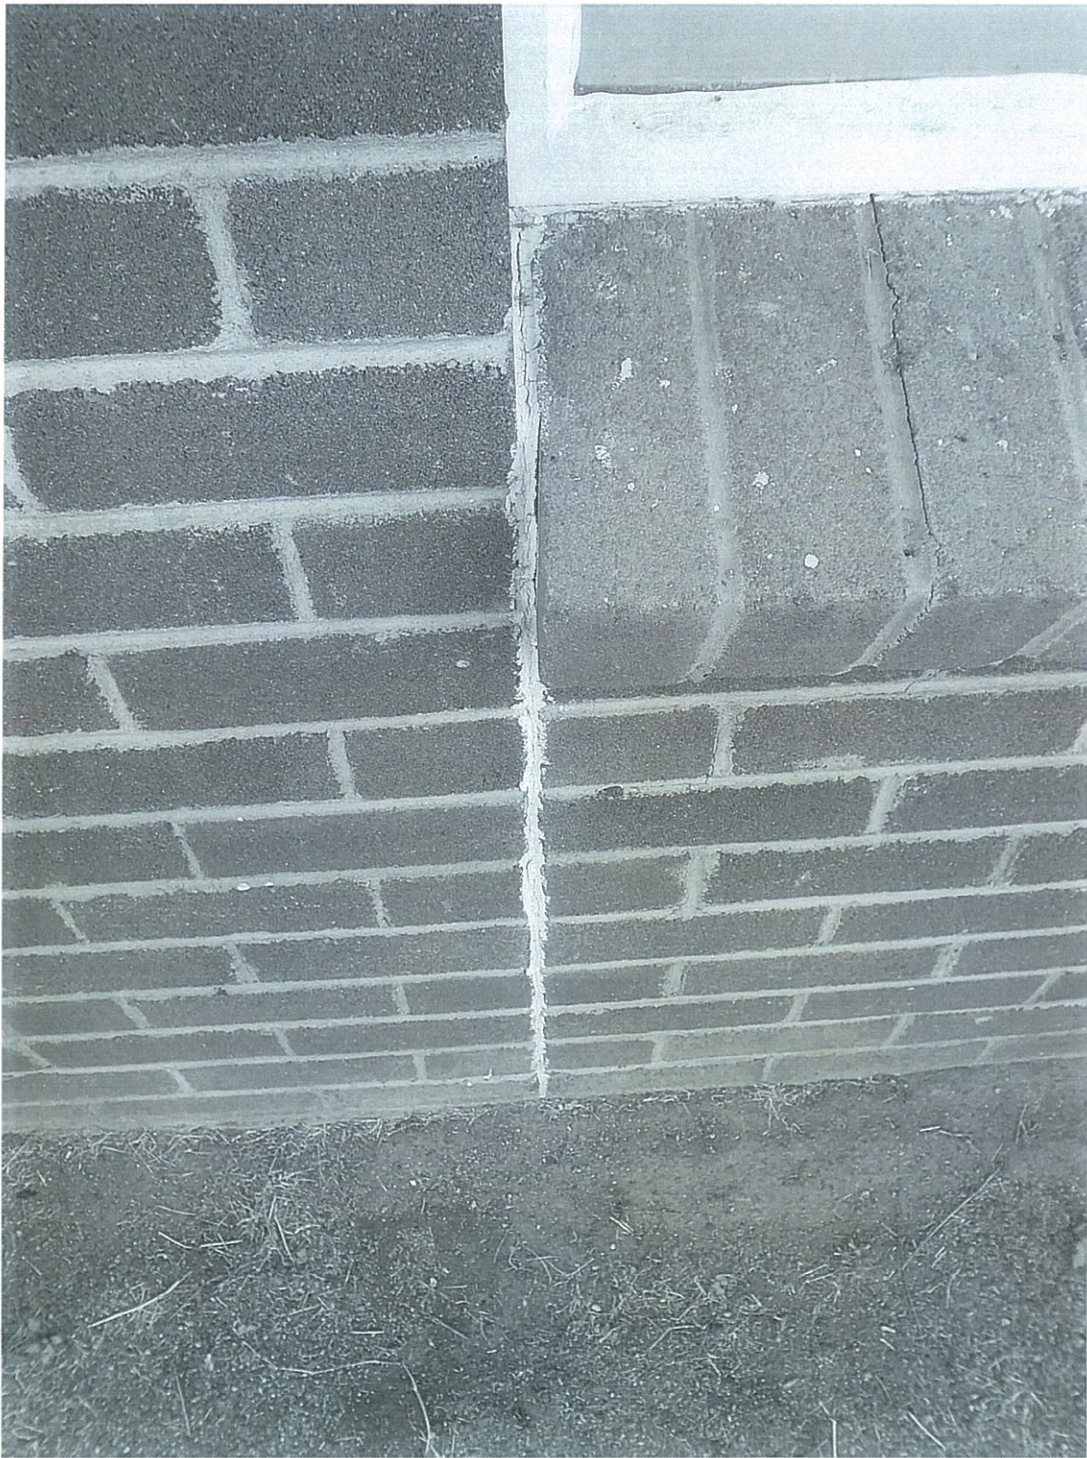
Sample ID	Location	Description	Condition	Recommended Action
AA-126	Building A- Expansion joint located at various points around the building.	Asbestos containing jointing compound	Poor	Recommend removal or spray seal/encapsulate loose fibres and cover using polyurethane sealant.
AA-131	Building B- Expansion joint located at various points around the building.	Asbestos containing jointing compound	Poor	Recommend removal or spray seal/encapsulate loose fibres and cover using polyurethane sealant.

Building B- Expansion joint
