ASBESTOS CONTAINING BUILDING MATERIALS SURVEY REPORT

68 McMinn Street

Darwin, NT 0800

Report Number 680.10041.00000.01 ASR R0 20130724

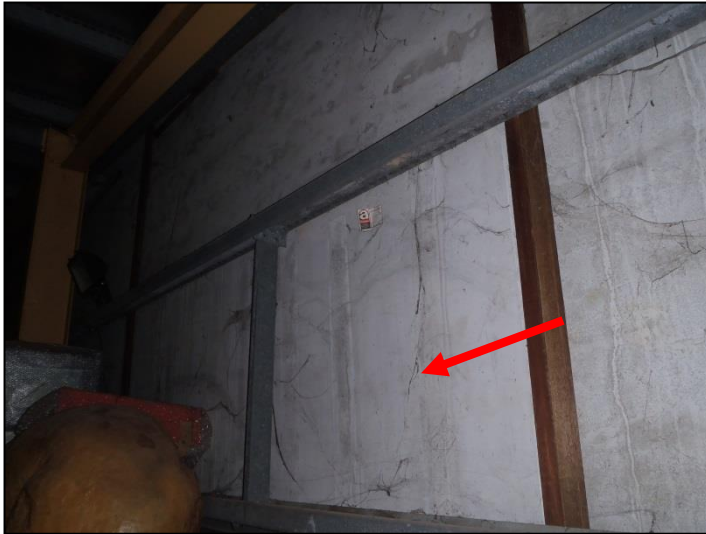
Photograph 1

Asbestos Sample Number	Sample Type	Sample Location	Analysis Result
680.10041.00000/11	FCS	Mezzanine Level, painted FCS infill panels to north elevation	NAD (organic fibres detected)
680.10041.00000/12	FCS	Mezzanine Level, Unpainted FCS infill panels to north elevation	Chrysotile asbestos detected

FCS infill panels to north elevation, mezzanine level (**asbestos containing**).

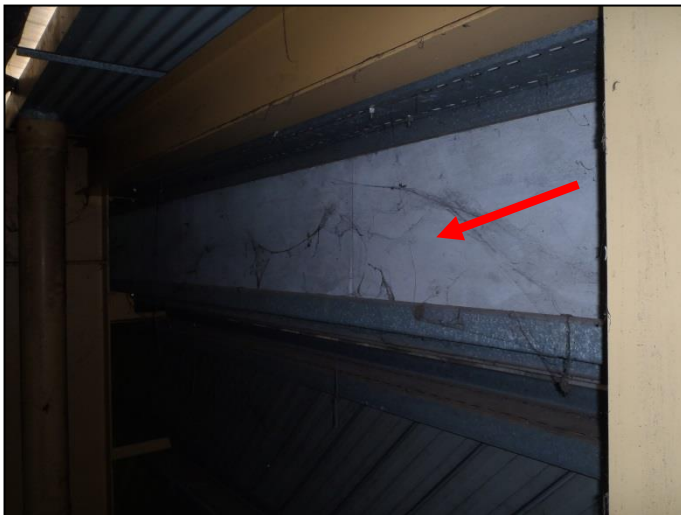
Photograph 2

FCS infill panels to top section of west elevation, mezzanine level (**assumed asbestos containing**).

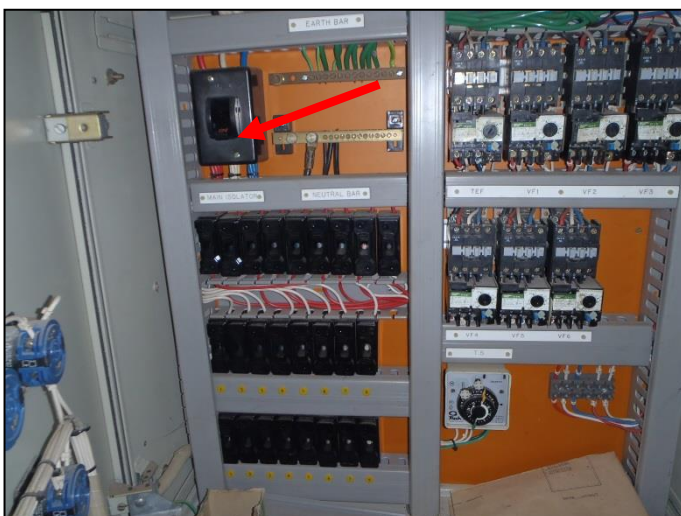
Photograph 3

Ground Floor, Assumed 'Bakelite' switches to electrical switchboard to north elevation of brick office compound to south of building (**assumed asbestos containing**).

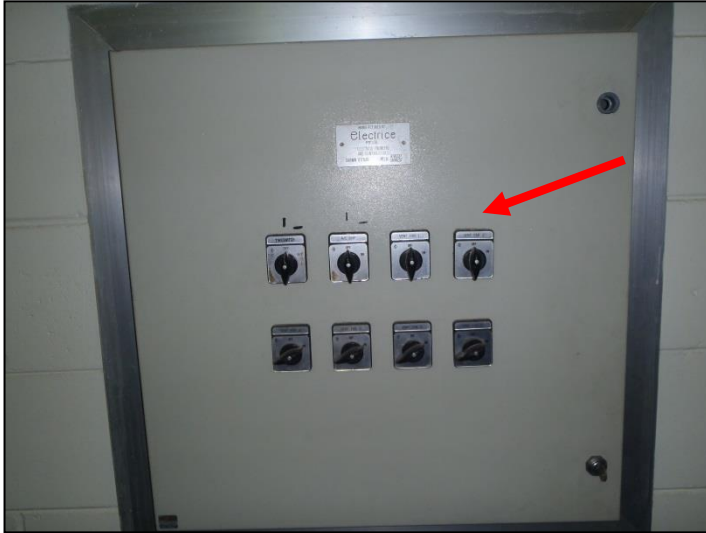
Photograph 4

Ground Floor, Assumed backing board inside un-accessed electrical switchboard to north elevation of brick office compound to south of building	Assumed asbestos containing	4	1 m ²	Non-friable	1	0	0	3	4-Very Low	C1, C2, C3, C4, C5, C12	Material requires labelling
Ground Floor, Assumed asbestos insulation to spin-lock, safe-type filing cabinet to brick office compound to south of building, 3x	Assumed asbestos containing	5	2m ²	Non-friable	2	0	0	3	5- Low	C1, C2, C3, C4, C5, C12	Material requires labelling

Ground Floor, Assumed backing board inside un-accessed, electrical switchboard to north elevation of brick office compound to south of building (**assumed asbestos containing**).

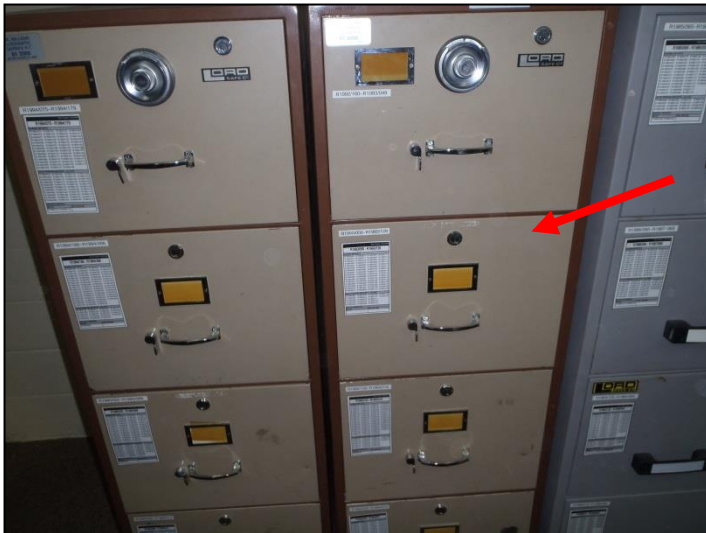
Photograph 5

Ground Floor, Assumed asbestos insulation to spin-lock, safe-type filing cabinet to brick office compound to south of building, 3x (**assumed asbestos containing**).
