Asbestos Register (Certificate of Inspection)

Bristow Hangar, Lancaster Road

Darwin International Airport

Site Inspection Completed 18th October 2023

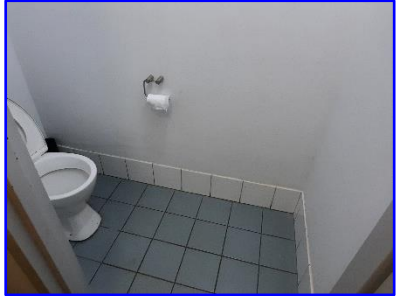
Sample Location	Description	Material Type	Photo
Offices / Admin Building – Male Toilet Wall WSP Report No Dar-PS200272-0006-169745 dated 20 October 2023 Sample 1	Wall Lining	Fibre Cement Sheet No Asbestos Detected

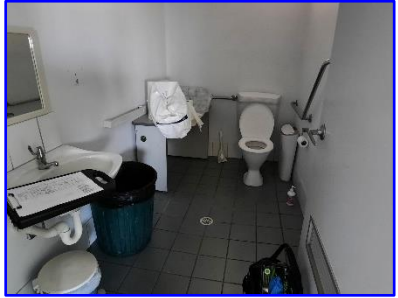
Offices / Admin Building – Disabled Toilet Wall WSP Report No Dar-PS200272-0006-169745 dated 20 October 2023 Sample 2	Wall Lining	Fibre Cement Sheet No Asbestos Detected

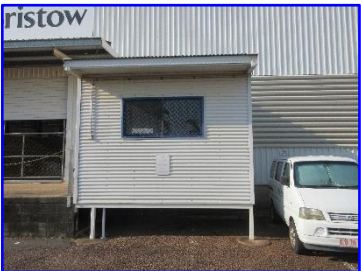
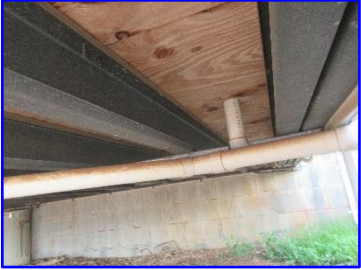
Demountable on Northern Side of Hanger	Building Fabric	Pressed Metal Clad on Structural Steel with a plywood floor

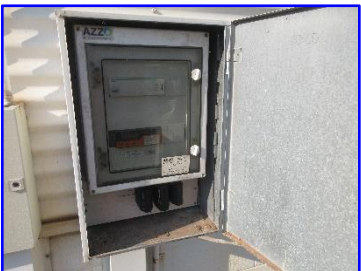
External on Northern Side of Building	Electrical Cabinet	No Asbestos Containing Materials

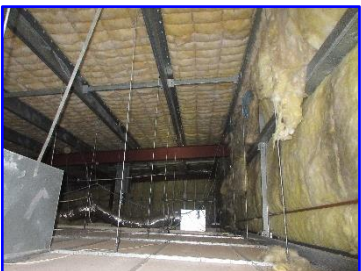
Ceiling Void	Ceiling Void	Underside of Roof, Top Side of Ceiling Lining, Structural Steel, Insulation, HVAC and Cables

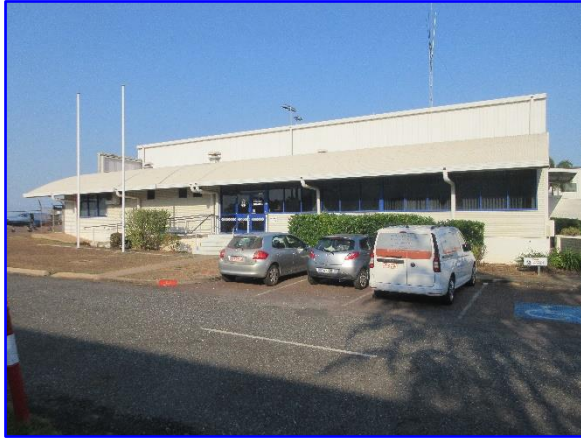
Photo 1 – Bristow Hangar, Lancaster Road, Eaton Looking West From Lancaster Road – Pressed Metal Clad and Blockwork to External of the Building

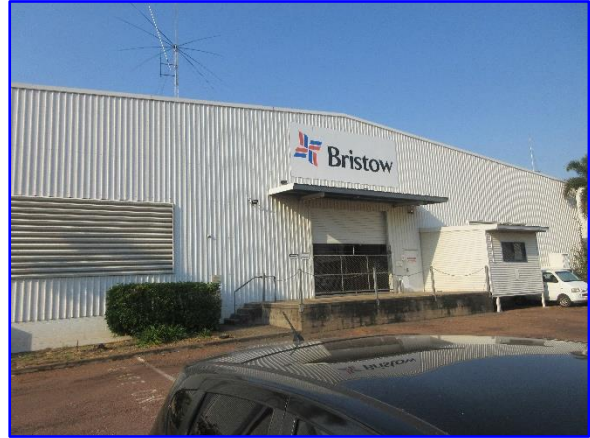
Photo 2 – Bristow Hangar, Lancaster Road, Eaton Looking From North to South - Pressed Metal Clad and Blockwork to External of the Building

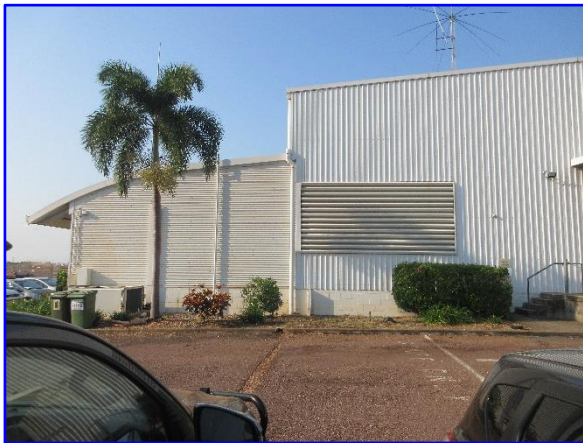
Photo 3 – Bristow Hangar, Lancaster Road, Eaton Looking From North to South, Administration Building on Left - Pressed Metal Clad and Blockwork to External of the Building

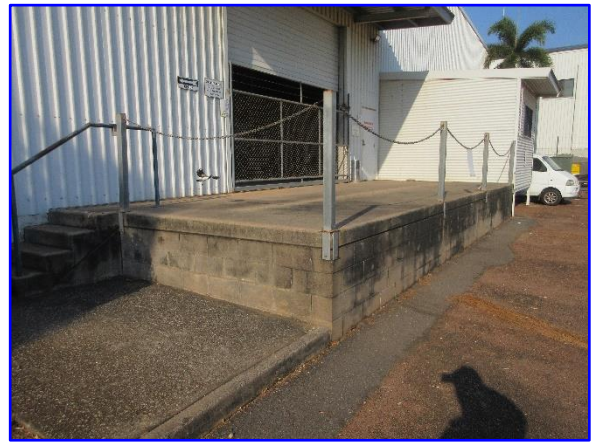
Photo 4 – Loading Dock and Add-On Building From Carpark - Pressed Metal Clad and Blockwork to External of the Building

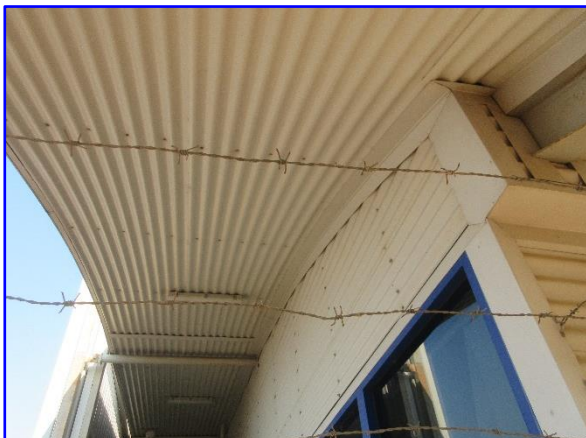
Photo 5 – External Eaves and Gables - Pressed Metal Clad to External of the Building

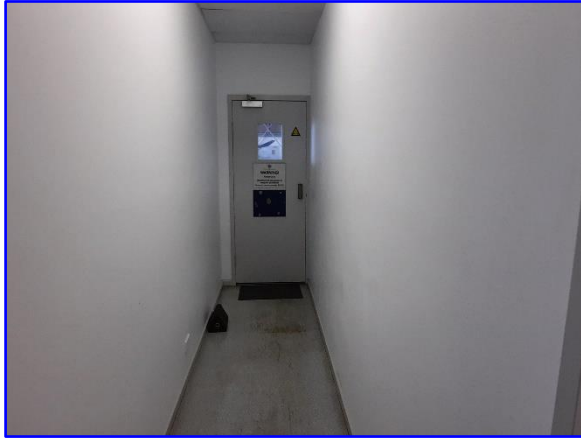
Photo 13 – Hallway in North-East Corner of Building
(Identified in Appendix D as being in the Operations Room) –
Wall to be Removed

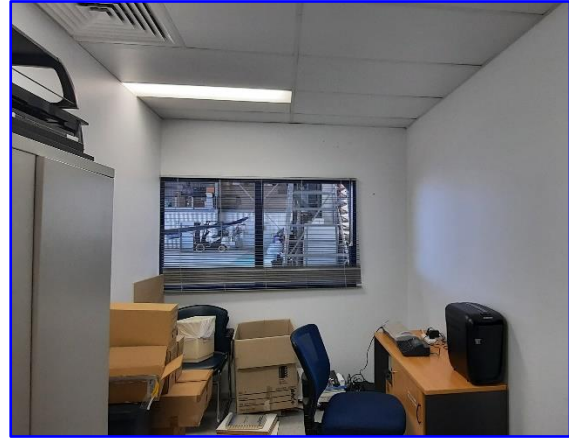
Photo 14 – Hallway in North-East Corner of Building
(Identified in Appendix D as being in the Operations Room)
– Wall to be Removed
