Job #: J15014

ASBESTOS CLEARANCE CERTIFICATE

Project Reference: J15014
Site Address: Randazzo Centre 16 Katherine Terrace, Katherine NT 0851
Specific Area/s Eaves, Corridor and Library

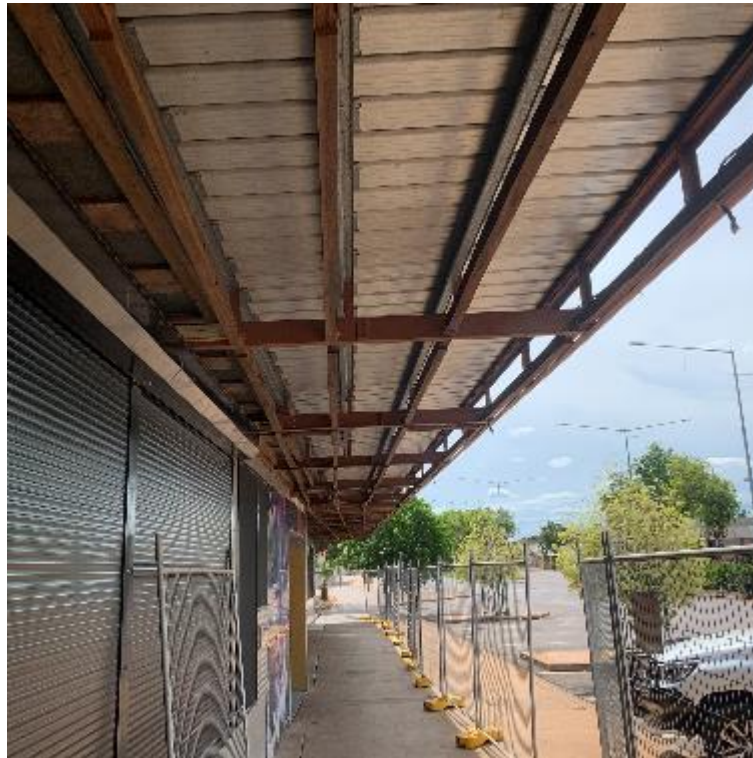
Image 1. View to the eaves and façade of the northeast elevation following the removal of asbestos cement sheeting.

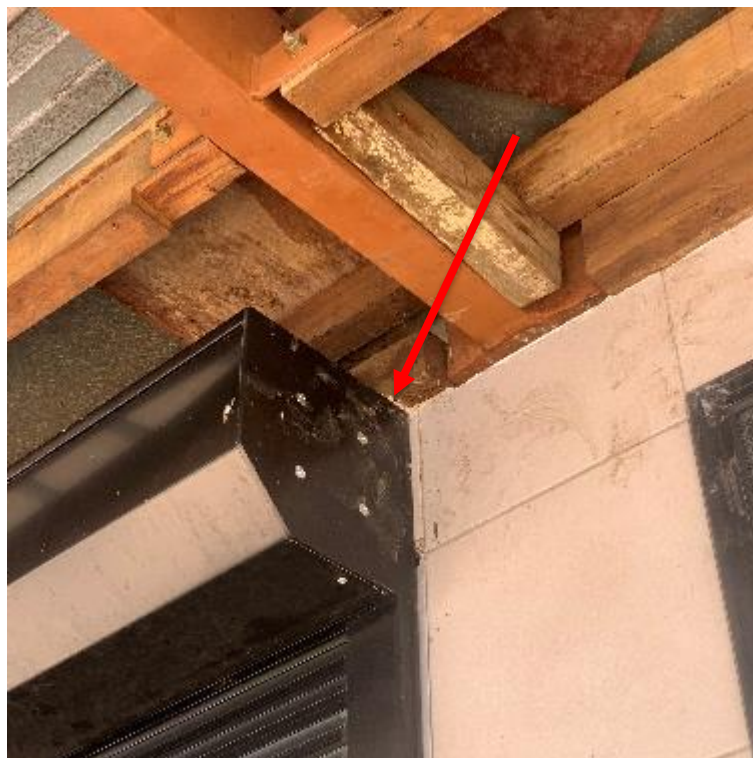
Image 2. Detail view of the asbestos cement sheet trapped between the metal roller shutters and timber framework. This ACM should be removed as demolition works progress.

- Asbestos cement sheet remains to the northeast eaves trapped between the metal roller shutter housing and timber beams; this material should be removed as demolition works progress and allow safe removal;
- Presumed asbestos cement sheet as packing material to air conditioning duct work within the Main Entry Corridor; this material should be removed as works progress and allow safe removal;

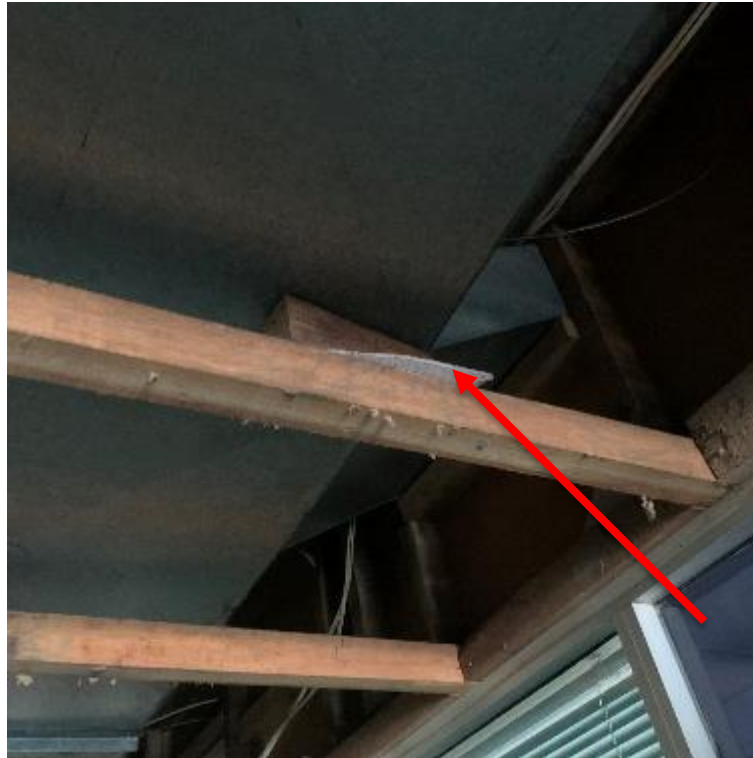
Image 3. Detail view of presumed asbestos cement sheet as packing material to air conditioning duct work within the Main Entry Corridor. This material should be removed as demolition works progress.

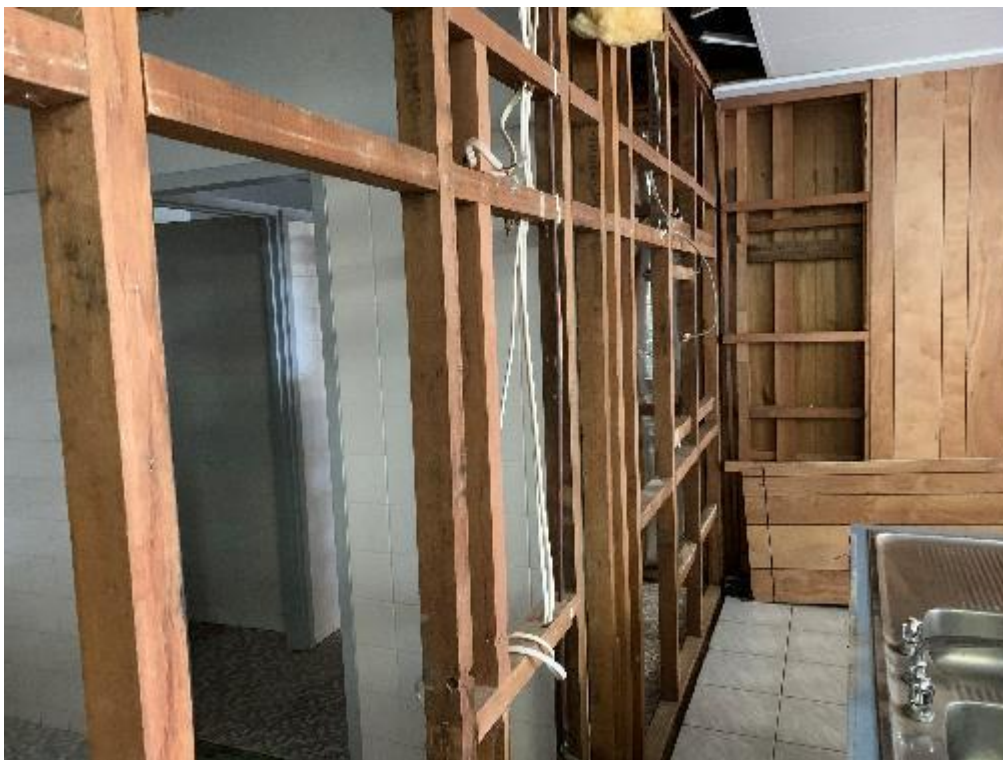
Image 4. View to the northeast wall of the Conference & Staff Room following the removal of asbestos cement sheeting.

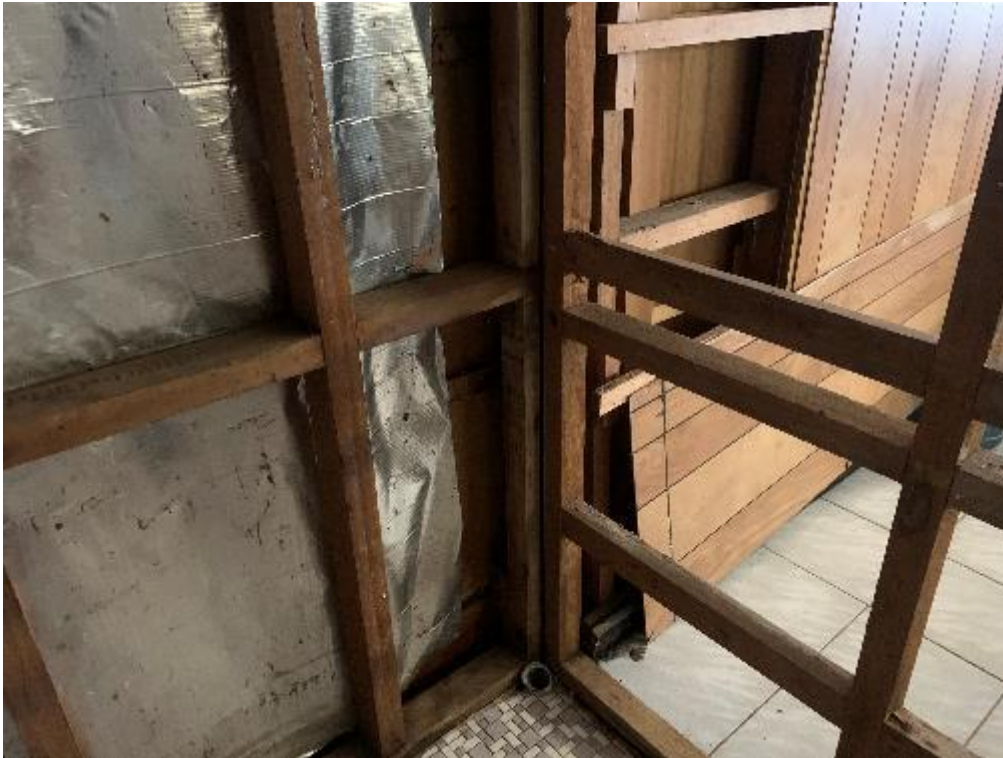
Image 5. View to the eastern and northeastern walls of the Male Toilet following the removal of asbestos cement sheet.

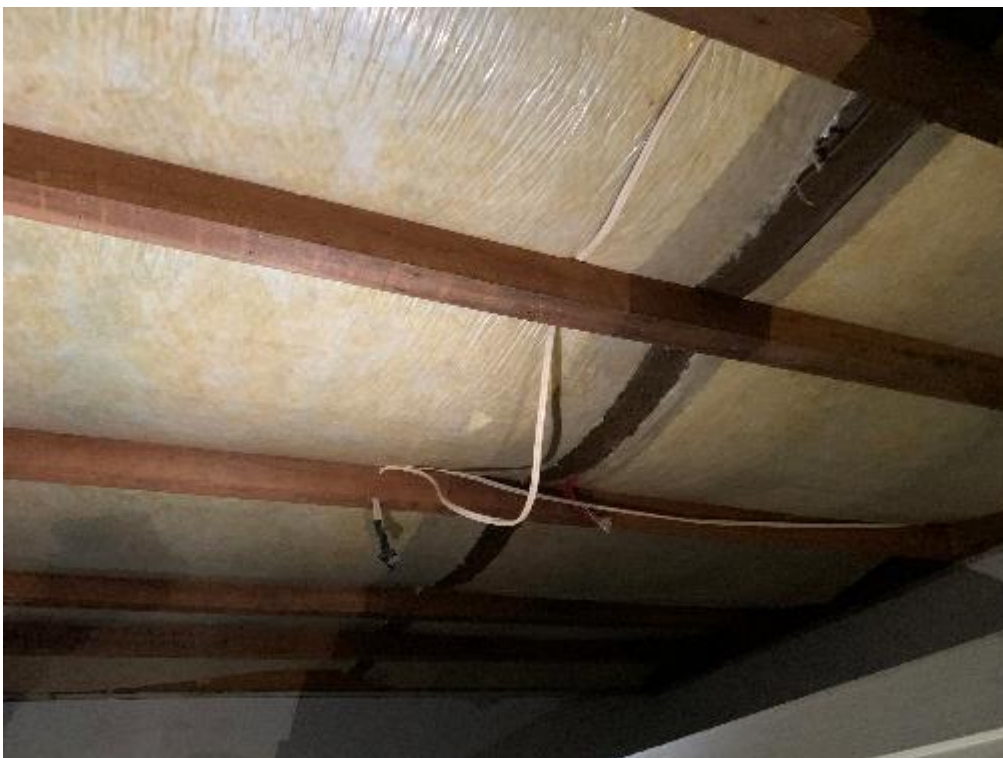
Image 6. View to the ceiling of the Female Toilet following the removal of asbestos cement sheet.
