Asbestos Register

No. ASP0001011

Prepared for:
Youth Outreach and Re-engagement Centre

2 Railway Tce
Alice Springs, NT 0870

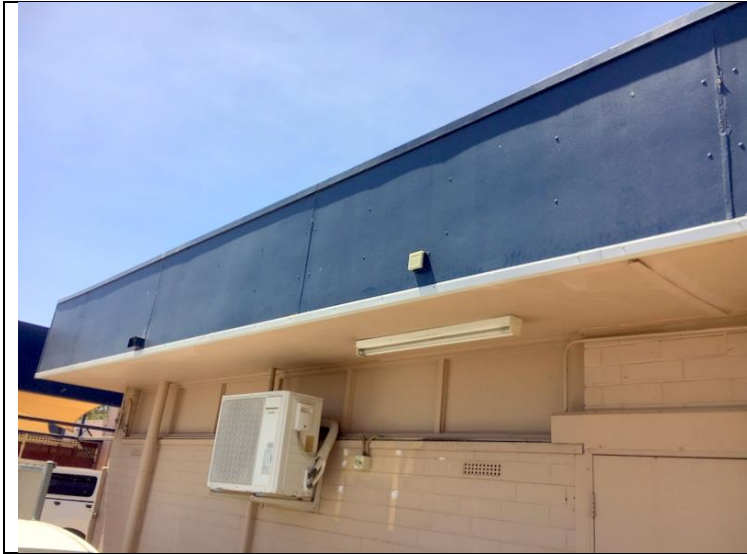
RESULT: No Asbestos Detected

BUILDING/LEVEL: Ground Level

FEATURE/MATERIAL: Fascia

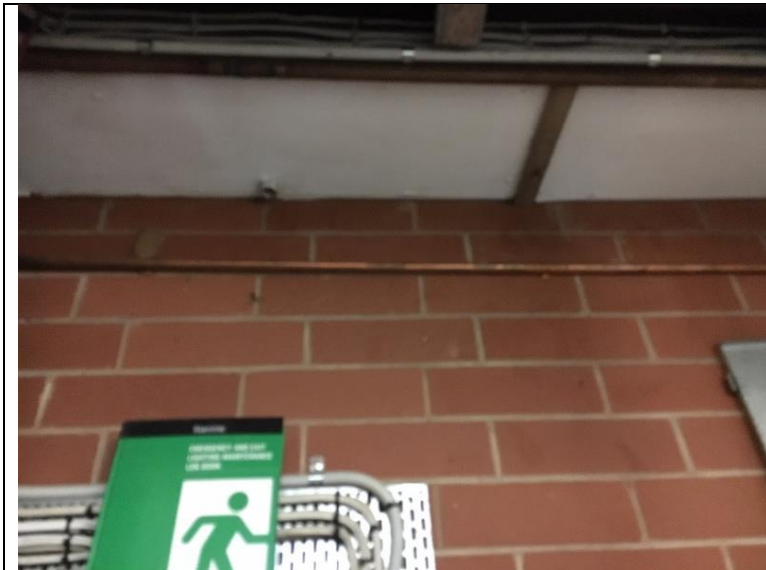
RESULT: Asbestos

BUILDING/LEVEL: Ground Level

FEATURE/MATERIAL: Eaves –
Cement Sheeting

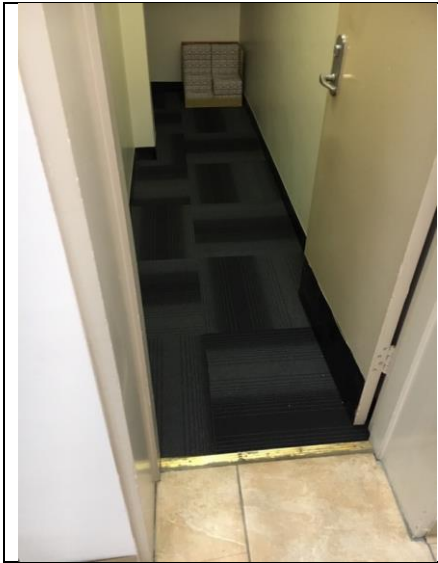
RESULT: Asbestos

BUILDING/LEVEL: Ground Level

FEATURE/MATERIAL: Storage 1 – Floor Tiles

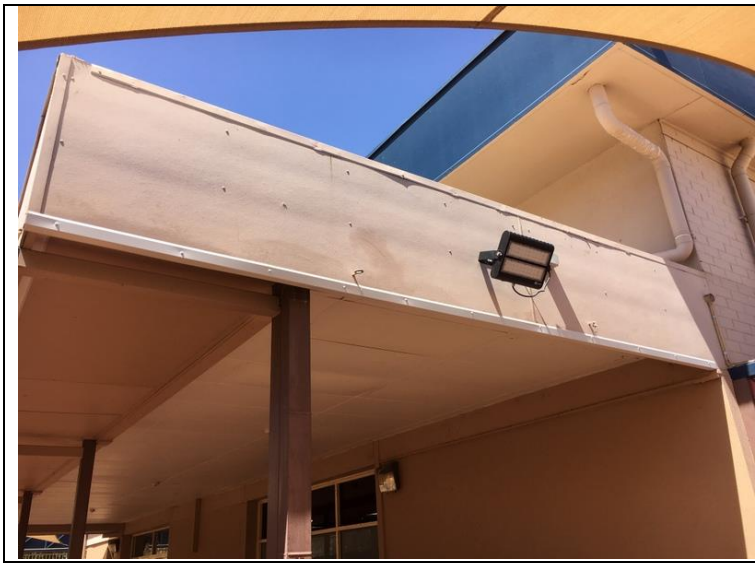
RESULT: Asbestos

BUILDING/LEVEL: Ground Level

FEATURE/MATERIAL: Eaves –
Cement Sheeting
