ASBESTOS REGISTER No. NT0495

UNITS 1 – 10, 266 TROWER ROAD
CASUARINA
NORTHERN TERRITORY

Date: August 2012

Register No: NT0495

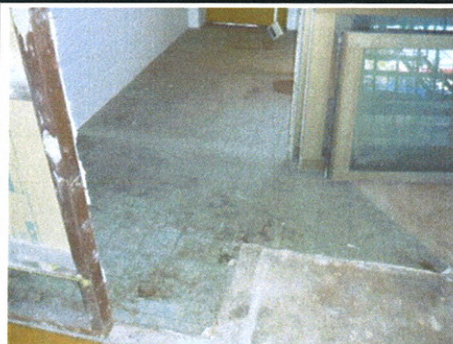
Location	Type of Material	Condition
1. Floor covering to North-East corner of tenancy, adjacent to rear door (5m ²)	Bluish vinyl sheeting containing white (Chrysotile) asbestos (Sample No. 3)	Unstable
Recommendation and Action		
Encapsulate or Remove Refer Section 6.0: Management Procedures.
