ASBESTOS REGISTER UPDATE

NO. NT0538

Energy House, 18-20 Cavenagh Street,
Darwin

December 2015

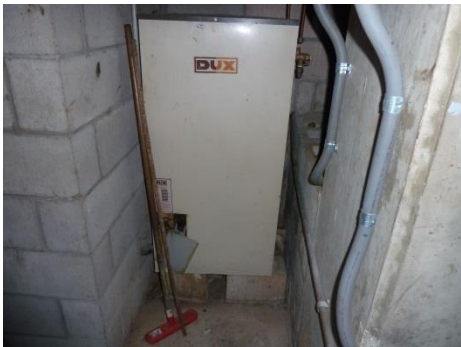
PLANT ROOM, GROUND FLOOR, INTERNAL

| Location | Type of Material | | |
|--|--|--|---|
| 1. Insulation in "Dux" HWS dated 1986 (extent unknown) | Not accessed or sampled. Based on past experience in similar areas, asbestos in some form may exist. It is recommended that if work is contemplated in this area, due care & diligence should be exercised. | | |
| Friable when exposed | Stable | Install 1 small warning sign | Medium |

| Location | Type of Material | | |
|--|--|--|---|
| Refer to Section 7.0: Policies & Management Procedures | | | |

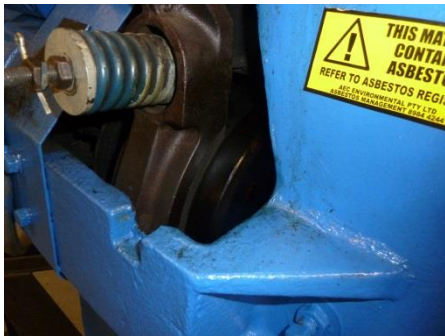
LIFT MOTOR ROOM, LEVEL 6, INTERNAL

| Location | Type of Material | | |
|--|--|---|---|
| 2. Lift motor brake shoes | Area not accessed and not sampled. Based on findings in similar areas, it is highly likely the friction material contain asbestos. | | |
| Friable when exposed | Stable | Warning signs in place | Medium |

| Location | Type of Material | | |
|--|--|---|---|
| Refer to Section 7.0: Policies & Management Procedures | | | |

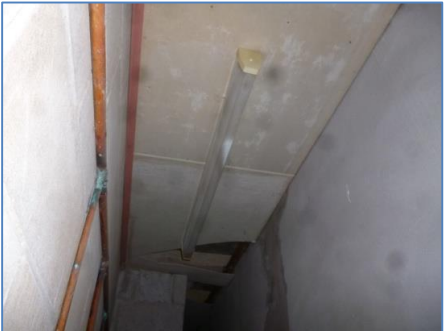
| Location | Type of Material | | |
|---|--|--|---|
| 4. Void in ceiling lining in Female toilets (3m ²) <i>*encapsulated behind new bathroom, no access this inspection</i> | Not accessed or sampled. Based on past experience in similar areas, asbestos in some form may exist. It is recommended that if work is contemplated in this area, due care & diligence should be exercised. | | |
| Unknown | Unknown | Not applicable | Unknown |

| Location | Type of Material | | |
|---|--|--|---|
| Refer to Section 7.0: Policies & Management Procedures | | | |

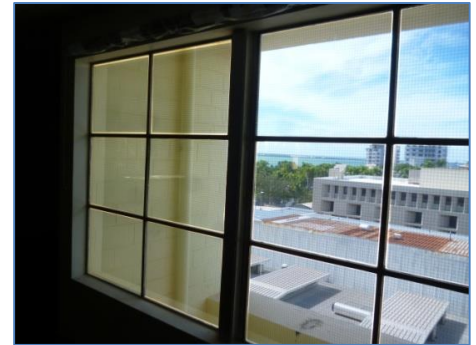
| ENERGY HOUSE, INTERNAL/EXTERNAL | | | |

| ENERGY HOUSE, INTERNAL/EXTERNAL | | | |
|--|--|---|---|
| 5. Sealant around window frames (original frames) – Western & Eastern elevation (extent unknown) | Not accessed or sampled. Based on past experience in similar areas, asbestos in some form may exist. It is recommended that if work is contemplated in this area, due care & diligence should be exercised. | | |
| Non Friable | Stable | Install 1 general awareness warning signs | Low |

| ENERGY HOUSE, INTERNAL/EXTERNAL | | | |
|--|--|---|---|
| Refer to Section 7.0: Policies & Management Procedures | | | |
