**ASBESTOS REGISTER
No. NT0664**

**HEALTH HOUSE
87 MITCHELL STREET
DARWIN NT**

Date: October 2014
Register No: NT0664

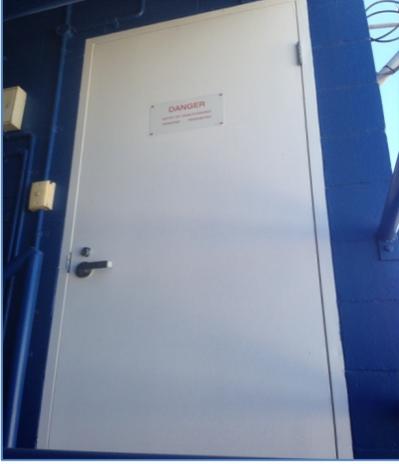
1. Fire door to Lift Motor room and Emergency Exit throughout all levels	Not accessed or sampled. Based on past experiences in similar areas, asbestos in some form may exist. It is recommended that if work is contemplated in this area due care & diligence should be exercised.		
Recommendation and Action			
Refer to Asbestos Management Plan & Section 7.0: Policies and Recommendations			
Situational Asbestos Risk Assessment			
Friability	Condition	Signage	Risk Rating
Friable when exposed	Stable	In place	Medium

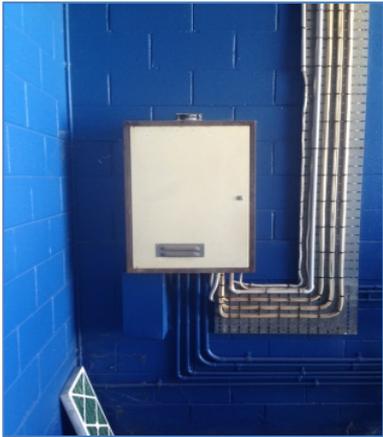
EXTERNAL (cont'd)					
Location		Type of Material			
2. Electrical board to lift Motor room		Not accessed or sampled. Based on past experiences in similar areas, asbestos in some form may exist. It is recommended that if work is contemplated in this area due care & diligence should be exercised.

Recommendation and Action	
				Refer to Asbestos Management Plan & Section 7.0: Policies and Recommendations	
Situational Asbestos Risk Assessment					
Friability	Condition	Signage	Risk Rating		
Non friable	Stable	In place	Low

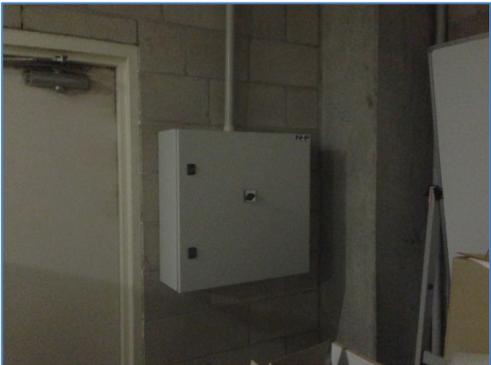
INTERNAL					
Location		Type of Material			
3. Backing board in Plant Room throughout all levels		Not accessed or sampled. Based on past experiences in similar areas, asbestos in some form may exist. It is recommended that if work is contemplated in this area due care & diligence should be exercised.

Recommendation and Action	
				Refer to Asbestos Management plan & Section 7.0: Policies and Recommendations	
Situational Asbestos Risk Assessment					
Friability	Condition	Signage	Risk Rating		
Non friable	Unknown	In place	Low

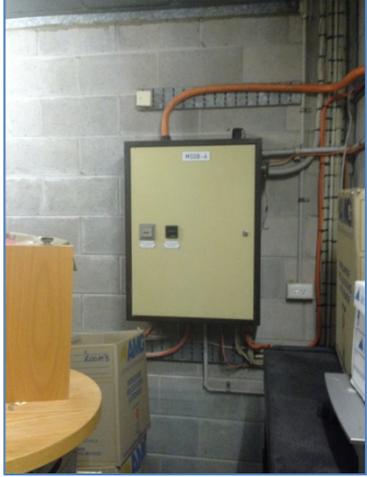
Location		Type of Material		
4. Backing board in Plant Room throughout all levels		Not accessed or sampled. Based on past experiences in similar areas, asbestos in some form may exist. It is recommended that if work is contemplated in this area due care & diligence should be exercised.

Recommendation and Action				
Refer to Asbestos Management plan & Section 7.0: Policies and Recommendations				
Situational Asbestos Risk Assessment				
<i>Friability</i>	<i>Condition</i>	<i>Signage</i>	Risk Rating	
Non friable	Unknown	In place	Low

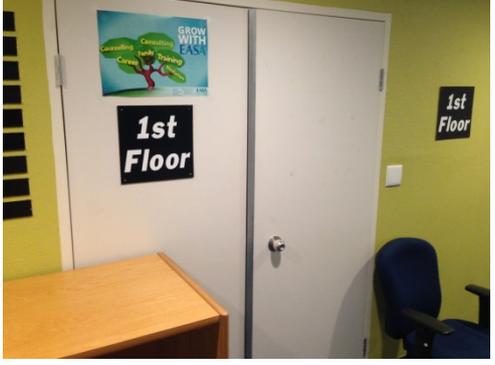
Location		Type of Material		
5. Electrical Cupboard – all levels		Not accessed or sampled. Based on past experiences in similar areas, asbestos in some form may exist. It is recommended that if work is contemplated in this area due care & diligence should be exercised.

Recommendation and Action				
Refer to Asbestos Management plan & Section 7.0: Policies and Recommendations				
Situational Asbestos Risk Assessment				
<i>Friability</i>	<i>Condition</i>	<i>Signage</i>	Risk Rating	
Non friable	Stable	In place	Low

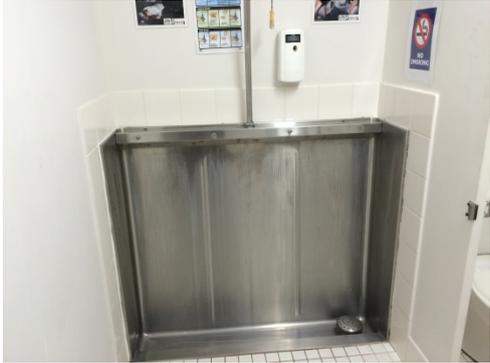
6. Male Toilets – Urinal sound deadener		Not accessed or sampled. Based on past experiences in similar areas, asbestos in some form may exist. It is recommended that if work is contemplated in this area due care & diligence should be exercised.	
Recommendation and Action			
Refer to Asbestos Management plan & Section 7.0: Policies and Recommendations			
Situational Asbestos Risk Assessment			
<i>Friability</i>	<i>Condition</i>	<i>Signage</i>	Risk Rating
Non friable	Unknown	Recommend 1 per urinal
