ASBESTOS CONTAINING BUILDING MATERIALS SURVEY REPORT

Highway House
Chung Wah Terrace
Palmerston NT 0801

Report Number 680.10035.00000.04 ASR RO 20130717

17 July 2013

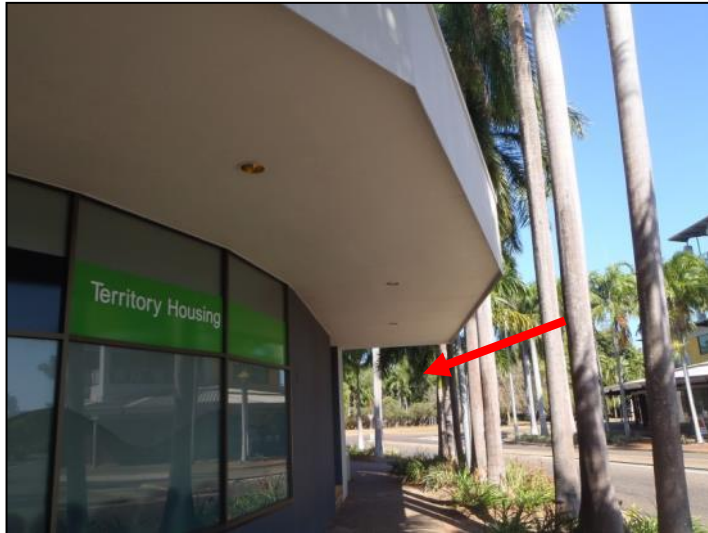
Photograph 1

FCS soffit lining to Territory Housing entrance

(asbestos containing).

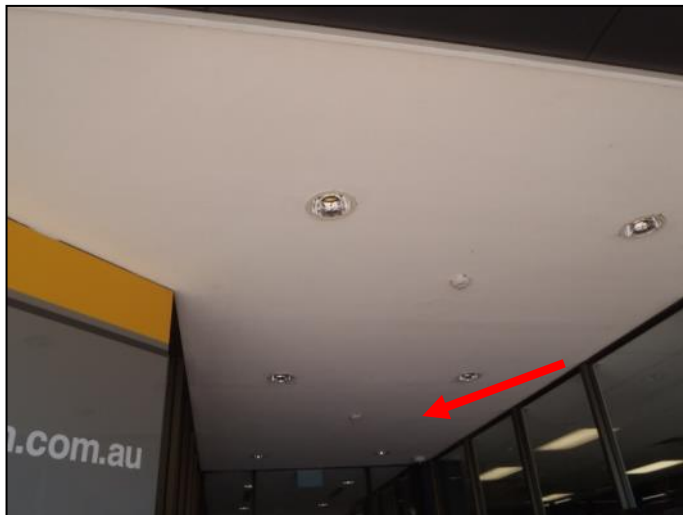
Photograph 2

FCS soffit lining to north entrance to building
