# ASBESTOS REGISTER

## LOT 2305 - POWER HOUSE

### 41 SMITH STREET

## Asbestos Register

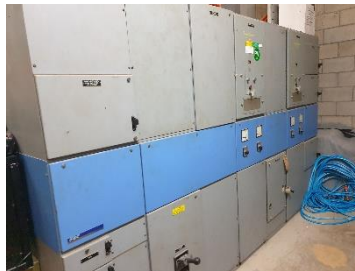
| ASBESTOS - Presumed | | | |
|---|---|---|---|
| Photo Ref | 150138 | Sample No | Visual Observation |

| Primary location / room | Secondary location / application | Material | Sample number | Result | Quantity | Labelled | Sealed | Friability | Condition | Disturbance potential | Risk rating | Comments / management recommendations | Photo reference |
|---|---|---|---|---|---|---|---|---|---|---|---|---|---|
| Electrical cupboard | Electrical switchboard panel | Bituminous material | Visual Observation | Presumed Asbestos | 1 item | Yes | Sealed | Non-Friable | Fair | Low | Low | Leave insitu and manage. | 150138 |

| ASBESTOS - Presumed | | | |

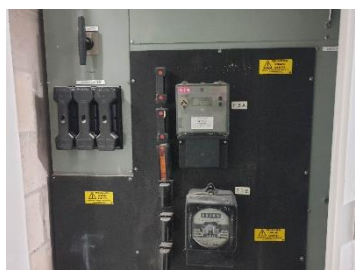
| ASBESTOS - Confirmed | | | |
|---|---|---|---|
| Photo Ref | 150153 | Sample No | Ref: WSP-NT0686-3a |

| ASBESTOS - Confirmed | | | |

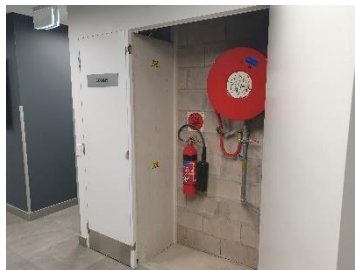
| ASBESTOS - Presumed | | | |
|---|---|---|---|
| Photo Ref | 150139 | Sample No | Visual Observation |

| ASBESTOS - Presumed | | | |

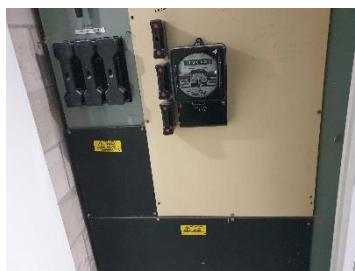
| ASBESTOS - Confirmed | | | |
|---|---|---|---|
| Photo Ref | 150160 | Sample No | Ref: WSP-NT0686-3a |

| ASBESTOS - Confirmed | | | |

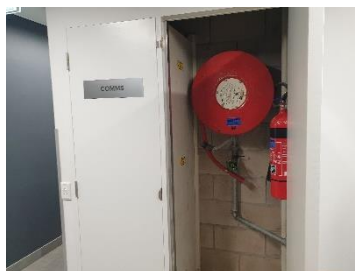
| ASBESTOS - Confirmed | | | |
|---|---|---|---|
| Photo Ref | 150152 | Sample No | Ref: WSP-NT0686-3a |

| ASBESTOS - Confirmed | | | |

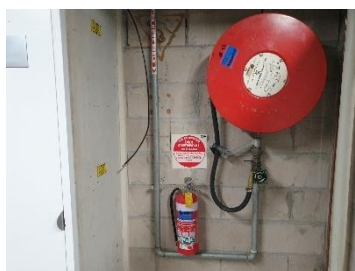
| ASBESTOS - Presumed | | | |
|---|---|---|---|
| Photo Ref | 150154 | Sample No | Visual Observation |

| ASBESTOS - Presumed | | | |

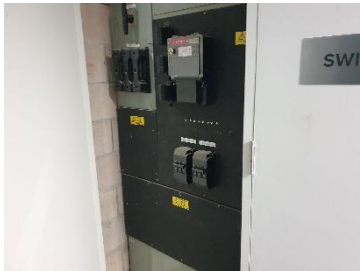
| ASBESTOS - Confirmed | | | |
|---|---|---|---|
| Photo Ref | 150141 | Sample No | Ref: WSP-NT0686-3a |

| ASBESTOS - Confirmed | | | |

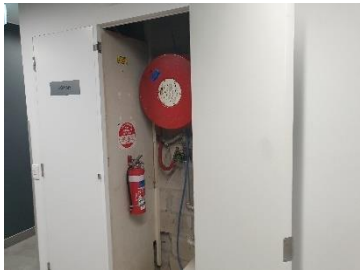
| ASBESTOS - Presumed | | | |
|---|---|---|---|
| Photo Ref | 150142 | Sample No | Visual Observation |

| ASBESTOS - Presumed | | | |

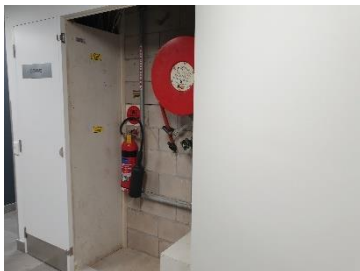
| ASBESTOS - Confirmed | | | |
|---|---|---|---|
| Photo Ref | 150163 | Sample No | Previously Sampled NT0686-5-2 |

| ASBESTOS - Confirmed | | | |

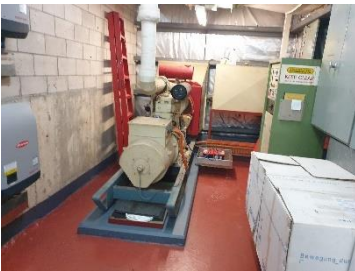
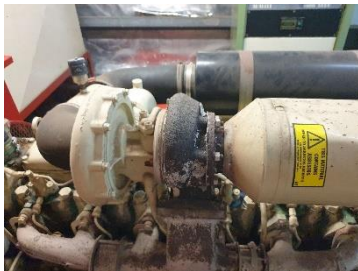
| ASBESTOS - Confirmed | | | |

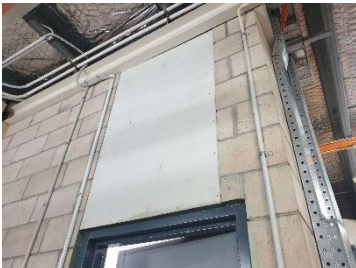
| ASBESTOS - Confirmed | | | |
|---|---|---|---|
| Photo Ref | 150161 | Sample No | WSP-347092 |

| ASBESTOS - Confirmed | | | |

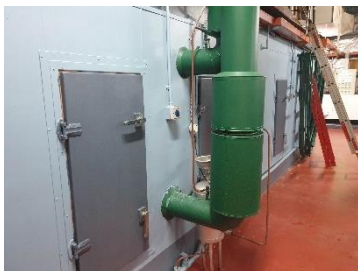
| ASBESTOS - Presumed | | | |
|---|---|---|---|
| Photo Ref | 150165 | Sample No | Visual Observation |

| ASBESTOS - Presumed | | | |
