# **ASBESTOS REGISTER**

REGISTER NO.: AS 3308

FOR THE PROPERTY AT: Katherine Central NT  
Katherine Terrace / Savannah Way,  
Katherine, NT

DATE INSPECTED: 7<sup>th</sup> December, 2010

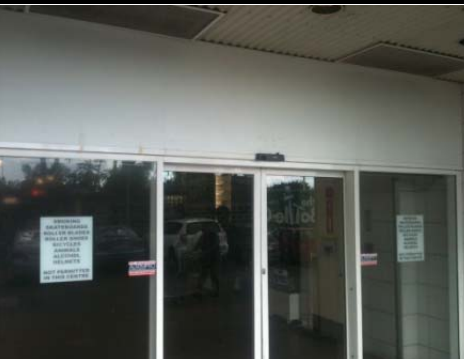
| LOCATION - DESCRIPTION | EXTENT | ASBESTOS ASSESSMENT | CONDITION | SAMPLE NO VISUAL TEST | SIGNAGE STATUS |
|---|---|---|---|---|---|
| B. External, Mall / Plaza entries, infill lining above doors / sign panel - fibre cement sheeting. ( strip painted yellow ). | Approx 5m <sup>2</sup> per entry x4. | No asbestos detected | - | Sample no. 03/MA/071210 | - |
| No asbestos detected upon laboratory analysis of sample. | | | | | |

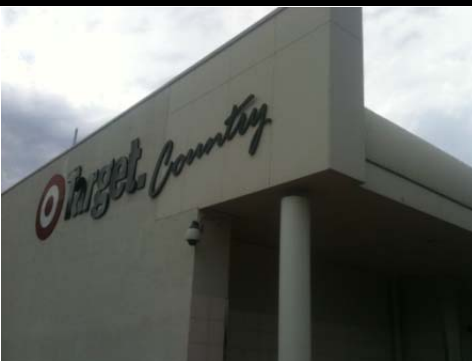
| LOCATION - DESCRIPTION | EXTENT | ASBESTOS ASSESSMENT | CONDITION | SAMPLE NO VISUAL TEST | SIGNAGE STATUS |
|---|---|---|---|---|---|
| C. External, Target Country façade cladding and verandah end wall cladding on building corners – thicksheet, – fibre cement sheeting. | Approx 100m <sup>2</sup> | No asbestos detected | - | Sample no. 04/MA/071210 | - |
| No asbestos detected upon laboratory analysis of sample. | | | | | |

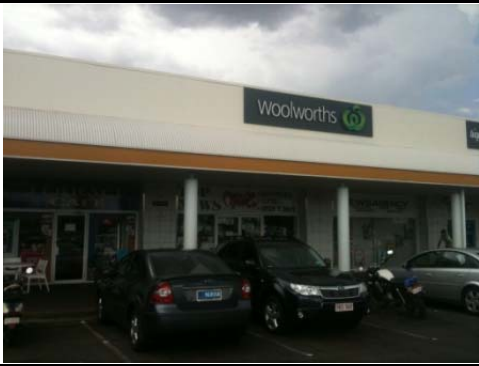
| LOCATION - DESCRIPTION | EXTENT | ASBESTOS ASSESSMENT | CONDITION | SAMPLE NO VISUAL TEST | SIGNAGE STATUS | |
|---|---|---|---|---|---|---|
| D. External, Front elevation 'Woolworths' signage panel façade cladding above verandah-fibre cement sheeting. | Approx 30m <sup>2</sup> | Presumed Non-Asbestos | - | Visual – similar to sample no. 01/MA/071210 | - | |
| No asbestos detected upon laboratory analysis of visually similar sample. Due to visually similar composition of material to sample number 01/MA/071210 and given the age of construction, presumed non-asbestos material. | | | | | | |

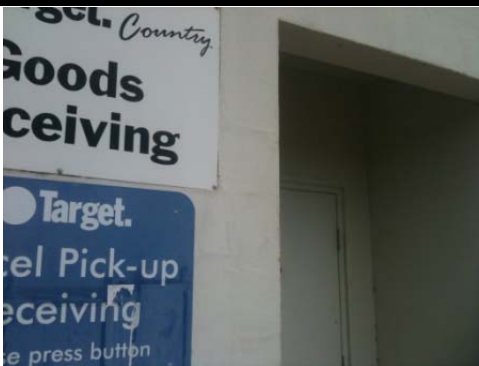
| LOCATION - DESCRIPTION | EXTENT | ASBESTOS ASSESSMENT | CONDITION | SAMPLE NO VISUAL TEST | SIGNAGE STATUS | |
|---|---|---|---|---|---|---|
| E. External, rear elevation 'Target Country - goods receiving' entry porch lining - fibre cement sheeting. | Approx 1m <sup>2</sup> | Presumed Non-Asbestos | - | Visual – similar to sample no. 01/MA/071210 | - | |
| No asbestos detected upon laboratory analysis of visually similar sample. Due to visually similar composition of material to sample number 01/MA/071210 and given the age of construction, presumed non-asbestos material. | | | | | | |

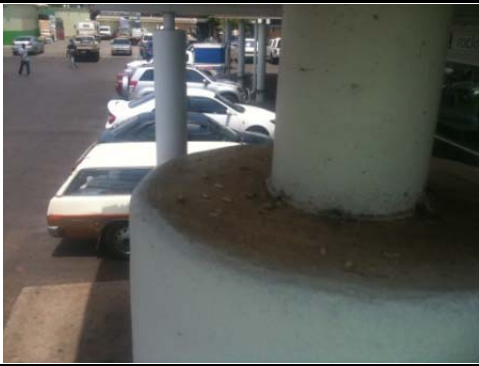
| LOCATION - DESCRIPTION | EXTENT | ASBESTOS ASSESSMENT | CONDITION | SAMPLE NO VISUAL TEST | SIGNAGE STATUS | |
|---|---|---|---|---|---|---|
| F. External, Front and side entry to mall / plaza, verandah columns – cement based circular column. | Columns, approx. 3m high, 400mm diameter | No asbestos visible | - | Visual | - | |
| Inspection of column at front elevation mall plaza entry 2, solid column detected at top of column. Note it was common to use concrete filled fibre cement pipes for this purpose, hence inspected at top of column revealed no fibre cement, presumed this column typical of others. | | | | | | |

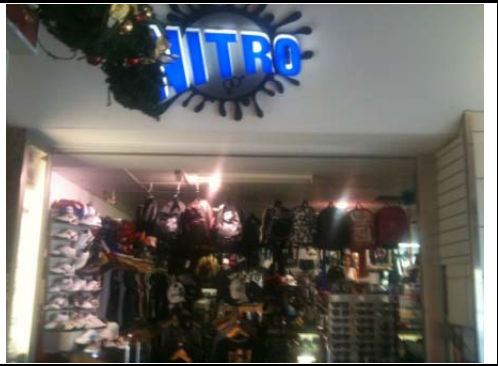
| LOCATION - DESCRIPTION | EXTENT | ASBESTOS ASSESSMENT | CONDITION | SAMPLE NO VISUAL TEST | SIGNAGE STATUS | |
|---|---|---|---|---|---|---|
| 1. Internal, Tenancy 1 'Nitro' construction and fit-out – No asbestos containing materials visible. | - | No asbestos visible | - | Visual | - | |

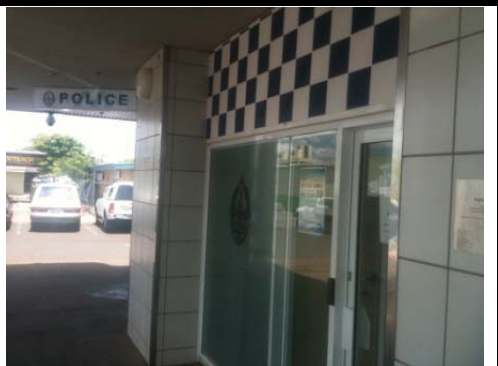
| LOCATION - DESCRIPTION | EXTENT | ASBESTOS ASSESSMENT | CONDITION | SAMPLE NO VISUAL TEST | SIGNAGE STATUS | |
|---|---|---|---|---|---|---|
| 2. Internal, Tenancy 2 'NT Police' construction and fit-out – No asbestos containing materials visible. | - | No asbestos visible | - | Visual | - | |

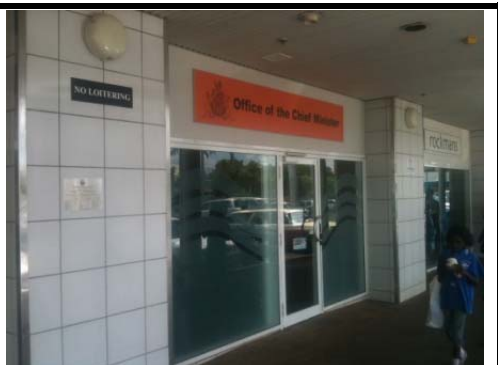
| LOCATION - DESCRIPTION | EXTENT | ASBESTOS ASSESSMENT | CONDITION | SAMPLE NO VISUAL TEST | SIGNAGE STATUS | |
|---|---|---|---|---|---|---|
| 3. Internal, Tenancy 2a 'Office of the Chief Minister' construction and fit-out – No Access provided for inspection. | - | - | Inaccessible | Visual | - | |

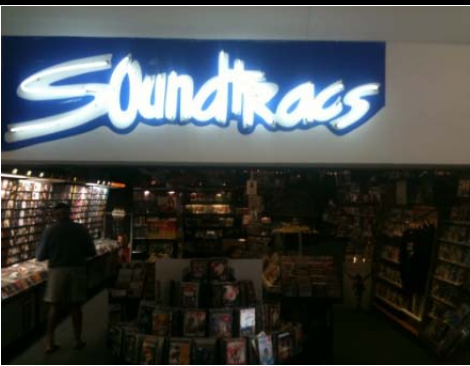
| LOCATION - DESCRIPTION | EXTENT | ASBESTOS ASSESSMENT | CONDITION | SAMPLE NO VISUAL TEST | SIGNAGE STATUS | |
|---|---|---|---|---|---|---|
| 4. Internal, Tenancy 3 'Soundtracks' construction and fit-out – No asbestos containing materials visible. | - | No asbestos visible | - | Visual | - | |

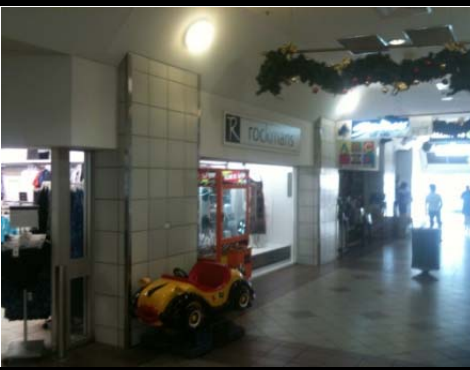
| LOCATION - DESCRIPTION | EXTENT | ASBESTOS ASSESSMENT | CONDITION | SAMPLE NO VISUAL TEST | SIGNAGE STATUS | |
|---|---|---|---|---|---|---|
| 5. Internal, Tenancy 4 'Rockmans' construction and fit-out – No asbestos containing materials visible. | - | No asbestos visible | - | Visual | - | |

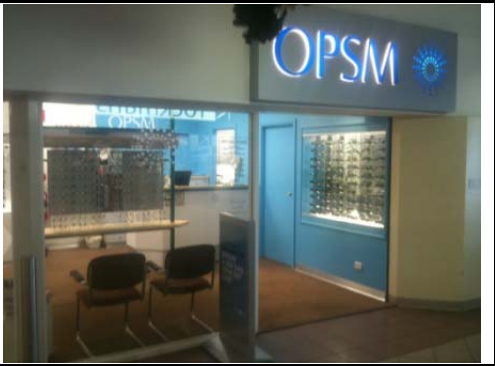
| LOCATION - DESCRIPTION | EXTENT | ASBESTOS ASSESSMENT | CONDITION | SAMPLE NO VISUAL TEST | SIGNAGE STATUS | |
|---|---|---|---|---|---|---|
| 7. Internal, Tenancy 6 'OPSM' construction and fit-out – No asbestos containing materials visible. | - | No asbestos visible | - | Visual | - | |

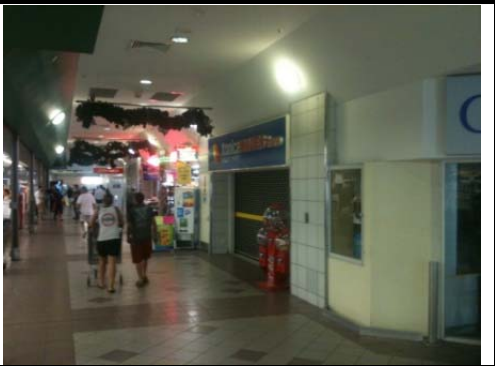
| LOCATION - DESCRIPTION | EXTENT | ASBESTOS ASSESSMENT | CONDITION | SAMPLE NO VISUAL TEST | SIGNAGE STATUS | |
|---|---|---|---|---|---|---|
| 8. Internal, Tenancy 7 'Vacant' construction and fit-out – No asbestos containing materials visible. | - | No asbestos visible | - | Visual | - | |

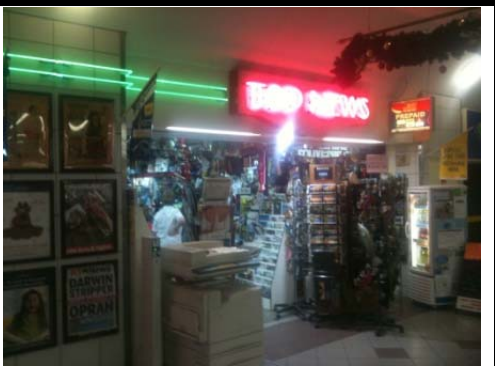
| LOCATION - DESCRIPTION | EXTENT | ASBESTOS ASSESSMENT | CONDITION | SAMPLE NO VISUAL TEST | SIGNAGE STATUS | |
|---|---|---|---|---|---|---|
| 9. Internal, Tenancy 8/9 'Top News' construction and fit-out – No asbestos containing materials visible. | - | No asbestos visible | - | Visual | - | |

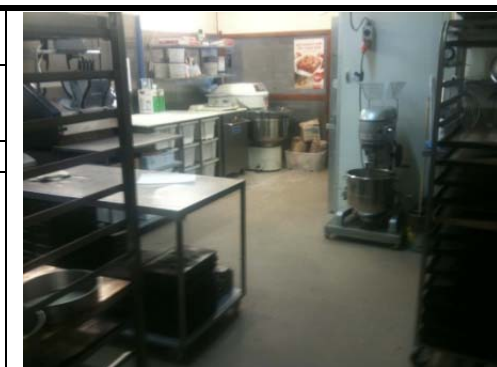
| LOCATION - DESCRIPTION | EXTENT | ASBESTOS ASSESSMENT | CONDITION | SAMPLE NO VISUAL TEST | SIGNAGE STATUS |
|---|---|---|---|---|---|
| 10. Internal, Tenancy 10/10a – assumed to be part of tenancy 12 Brumby's – No asbestos visible. | - | No asbestos visible | - | Visual | - |

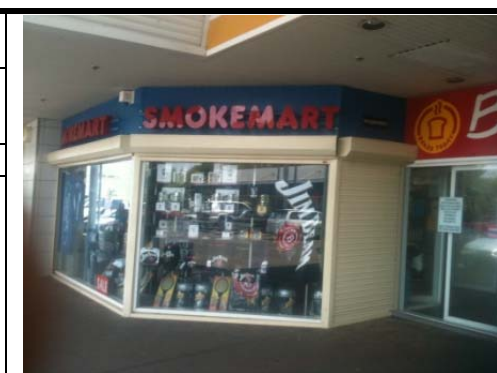
| LOCATION - DESCRIPTION | EXTENT | ASBESTOS ASSESSMENT | CONDITION | SAMPLE NO VISUAL TEST | SIGNAGE STATUS |
|---|---|---|---|---|---|
| 11. Internal, Tenancy 11 'Smoke Mart' construction and fit-out – No asbestos containing materials visible. | - | No asbestos visible | - | Visual | - |

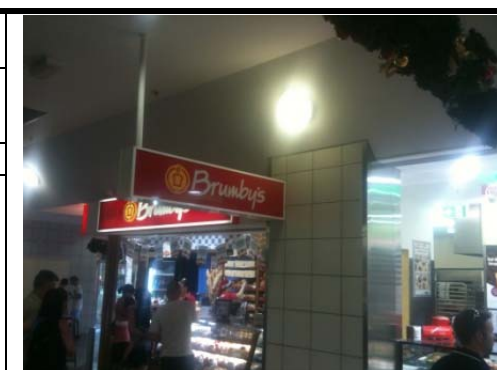
| LOCATION - DESCRIPTION | EXTENT | ASBESTOS ASSESSMENT | CONDITION | SAMPLE NO VISUAL TEST | SIGNAGE STATUS |
|---|---|---|---|---|---|
| 12. Internal, Tenancy 12 'Brumby's' construction and fit-out – No asbestos containing materials visible. | - | No asbestos visible | - | Visual | - |

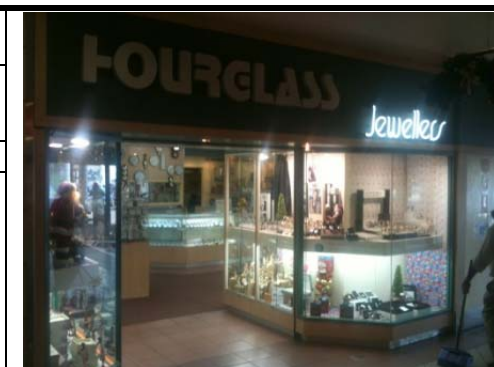
| LOCATION - DESCRIPTION | EXTENT | ASBESTOS ASSESSMENT | CONDITION | SAMPLE NO VISUAL TEST | SIGNAGE STATUS |
|---|---|---|---|---|---|
| 13. Internal, Tenancy 13/15 'Hourglass Jewellers' construction and fit-out – No asbestos containing materials visible. | - | No asbestos visible | - | Visual | - |

| <b>SURVEY FINDINGS and HAZARD MANAGEMENT RECOMMENDATIONS</b><br>No asbestos visible upon inspection. Fit-out consisted of plasterboard walls, 600mm square plasterboard ceiling tiles suspended in aluminium grid, carpet and ceramic tiles on concrete floor slab. Typical perimeter building construction is besser block walls, ceiling space inspections at random revealed non-insulated structural steel 'I' beams, steel 'z' roofing purlins, underside of glass fibre insulation blanket directly beneath sheet-metal roof, pvc downpipes, assumed typical throughout. No inspection to ceiling space in this tenancy due to inaccessibility. | | | | | |

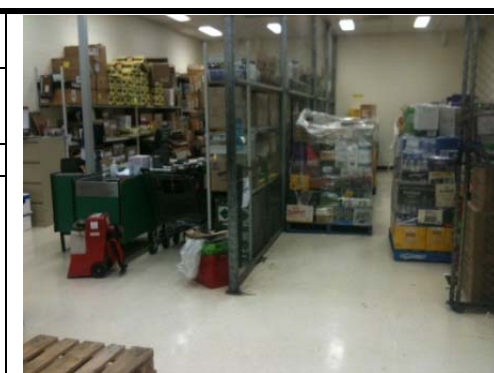
| LOCATION - DESCRIPTION | EXTENT | ASBESTOS ASSESSMENT | CONDITION | SAMPLE NO VISUAL TEST | SIGNAGE STATUS |
|---|---|---|---|---|---|
| 14. Internal, Tenancy 16 'Woolworths', liquor store floor coverings throughout shop – Vinyl Tiles ( 300mm square, off-white colour ). | Approx 5m <sup>2</sup> per entry x4. | No asbestos detected | - | Sample no. 09/MA/071210 | - |

| <b>SURVEY FINDINGS and HAZARD MANAGEMENT RECOMMENDATIONS</b><br>Damage noted at coldroom doorway and fenced area. No asbestos detected upon laboratory analysis of sample. | | | | | |

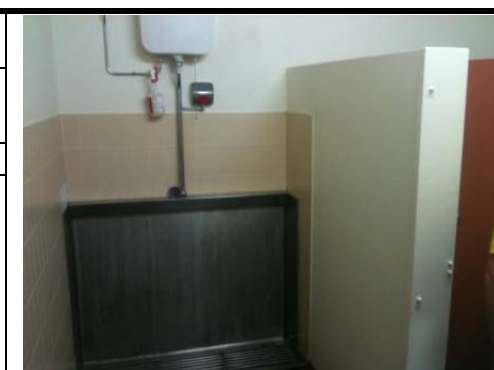
| LOCATION - DESCRIPTION | EXTENT | ASBESTOS ASSESSMENT | CONDITION | SAMPLE NO VISUAL TEST | SIGNAGE STATUS |
|---|---|---|---|---|---|
| 14. Internal, Tenancy 16 'Woolworths', staff amenities toilet partitions – fibre cement thicksheet. | Approx 20m <sup>2</sup> | No asbestos detected | - | Sample no. 10/MA/071210 | - |

| <b>SURVEY FINDINGS and HAZARD MANAGEMENT RECOMMENDATIONS</b><br>Damage noted at coldroom doorway and fenced area. No asbestos detected upon laboratory analysis of sample. | | | | | |

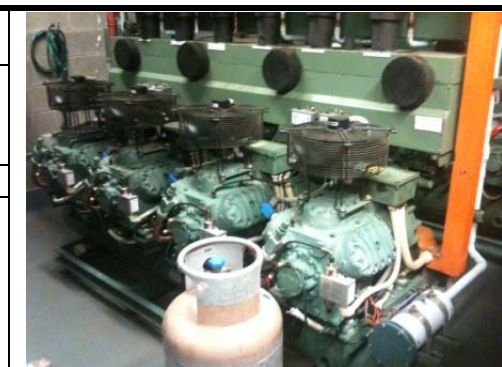
| LOCATION - DESCRIPTION | EXTENT | ASBESTOS ASSESSMENT | CONDITION | SAMPLE NO VISUAL TEST | SIGNAGE STATUS |
|---|---|---|---|---|---|
| 15. Internal, Tenancy 16 'Woolworths', mezzanine area main plantroom air-conditioning plant & equipment – gaskets, compressed fibre compound material. | - | Possible Asbestos Content | Inaccessible | Visual | - |

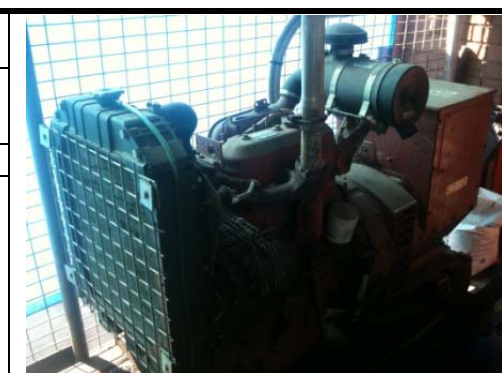
| LOCATION - DESCRIPTION | EXTENT | ASBESTOS ASSESSMENT | CONDITION | SAMPLE NO VISUAL TEST | SIGNAGE STATUS |
|---|---|---|---|---|---|
| 16. Internal, Tenancy 16 'Woolworths', loading dock generator plant & equipment – gaskets, compressed fibre compound material. | - | Possible Asbestos Content | Inaccessible | Visual | - |

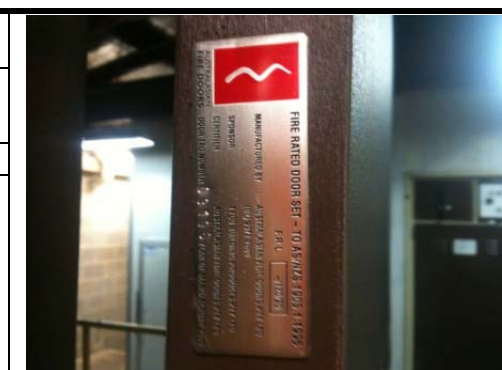
| LOCATION - DESCRIPTION | EXTENT | ASBESTOS ASSESSMENT | CONDITION | SAMPLE NO VISUAL TEST | SIGNAGE STATUS |
|---|---|---|---|---|---|
| 17. Internal, Tenancy 16 'Woolworths' mezzanine level plantroom entry fire rated doors – internal insulating core. | - | No asbestos visible | - | Visual | - |

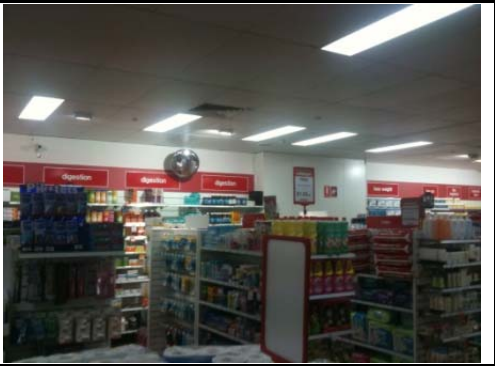
| LOCATION - DESCRIPTION | EXTENT | ASBESTOS ASSESSMENT | CONDITION | SAMPLE NO VISUAL TEST | SIGNAGE STATUS | |
|---|---|---|---|---|---|---|
| 18. Internal, Tenancy 17/18 'Chemist' construction and fit-out – No asbestos containing materials visible. | - | No asbestos visible | - | Visual | - | |

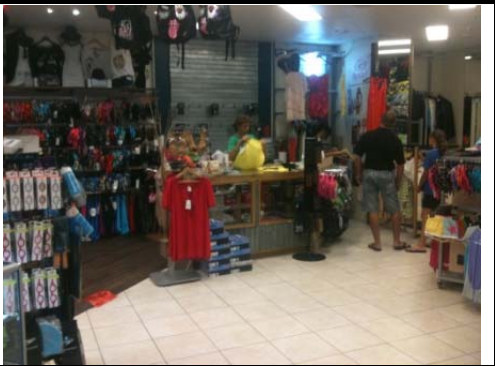
| LOCATION - DESCRIPTION | EXTENT | ASBESTOS ASSESSMENT | CONDITION | SAMPLE NO VISUAL TEST | SIGNAGE STATUS | |
|---|---|---|---|---|---|---|
| 19. Internal, Tenancy 19 'Wild Child Surf Shop' construction and fit-out – No asbestos containing materials visible. | - | No asbestos visible | - | Visual | - | |

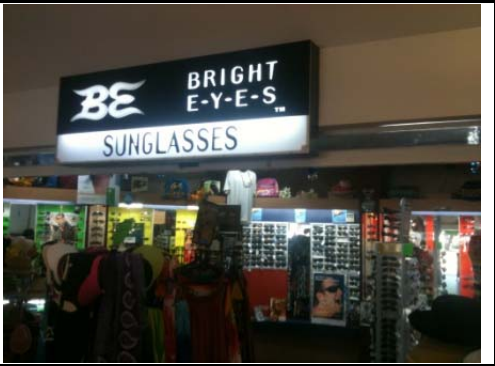
| LOCATION - DESCRIPTION | EXTENT | ASBESTOS ASSESSMENT | CONDITION | SAMPLE NO VISUAL TEST | SIGNAGE STATUS | |
|---|---|---|---|---|---|---|
| 20. Internal, Tenancy 20 'Bright Eyes Sunglasses' construction and fit-out – No asbestos containing materials visible. | - | No asbestos visible | - | Visual | - | |

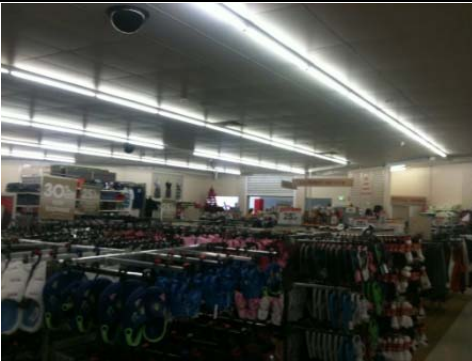
| LOCATION - DESCRIPTION | EXTENT | ASBESTOS ASSESSMENT | CONDITION | SAMPLE NO VISUAL TEST | SIGNAGE STATUS | |
|---|---|---|---|---|---|---|
| 21. Internal, Tenancy 21 'Target Country' construction and fit-out – No asbestos containing materials visible. | - | No asbestos visible | - | Visual | - | |
| <b>SURVEY FINDINGS and HAZARD MANAGEMENT RECOMMENDATIONS</b><br>No asbestos visible upon inspection. Fit-out consisted of plasterboard walls, 600mm square plasterboard ceiling tiles suspended in aluminium grid, carpet and ceramic tiles on concrete floor slab. Typical perimeter building construction is besser block walls, ceiling space inspections at random revealed non-insulated structural steel 'I' beams, steel 'z' roofing purlins, underside of glass fibre insulation blanket directly beneath sheet-metal roof, pvc downpipes, assumed typical throughout. No inspection to ceiling space in this tenancy due to inaccessibility. | | | | | | |

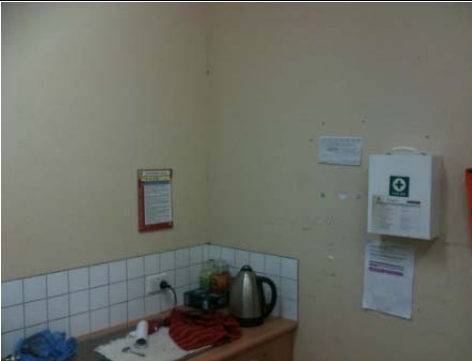
| LOCATION - DESCRIPTION | EXTENT | ASBESTOS ASSESSMENT | CONDITION | SAMPLE NO VISUAL TEST | SIGNAGE STATUS | |
|---|---|---|---|---|---|---|
| 22. Internal, Tenancy 21 'Target Country' staff amenities / kitchen wall linings – fibre cement sheeting. | - | No asbestos visible | - | Visual | - | |
| <b>SURVEY FINDINGS and HAZARD MANAGEMENT RECOMMENDATIONS</b><br>Item was visually identified at top edge of stud wall from within ceiling space as 'villaboard' fibre cement sheet consistent with wall linings detected in cleaners storeroom, assumed to be similar material and age of construction. As no asbestos detected to this other sheeting it was presumed to be the same. | | | | | | |

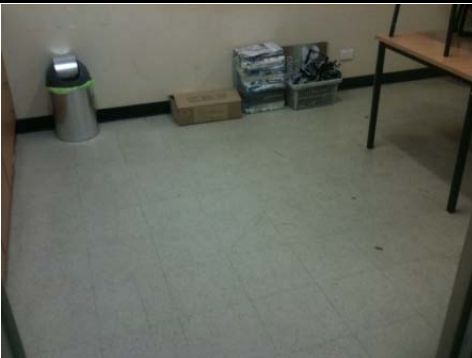
| LOCATION - DESCRIPTION | EXTENT | ASBESTOS ASSESSMENT | CONDITION | SAMPLE NO VISUAL TEST | SIGNAGE STATUS | |
|---|---|---|---|---|---|---|
| 23. Internal, Tenancy 21 'Target Country' staff amenities / kitchen floor coverings - Vinyl Tiles. | - | No asbestos detected | - | Sample no. 02/MA/071210 | - | |
| <b>SURVEY FINDINGS and HAZARD MANAGEMENT RECOMMENDATIONS</b><br>No asbestos detected upon laboratory analysis of sample. | | | | | | |

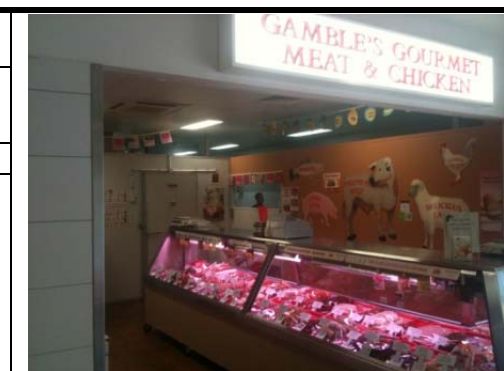
| LOCATION - DESCRIPTION | EXTENT | ASBESTOS ASSESSMENT | CONDITION | SAMPLE NO VISUAL TEST | SIGNAGE STATUS |
|---|---|---|---|---|---|
| 24. Internal, Tenancy 22 'Butchers' construction and fit-out – No asbestos containing materials visible. | - | No asbestos visible | - | Visual | - |

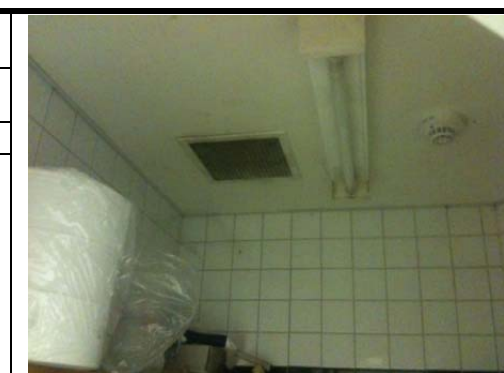
| LOCATION - DESCRIPTION | EXTENT | ASBESTOS ASSESSMENT | CONDITION | SAMPLE NO VISUAL TEST | SIGNAGE STATUS |
|---|---|---|---|---|---|
| 25. Internal, Amenities, cleaners store, and toilets ceiling linings – fibre cement sheeting. | Approx 50m <sup>2</sup> visible | No asbestos detected | - | Sample no. 06/MA/071210 | - |

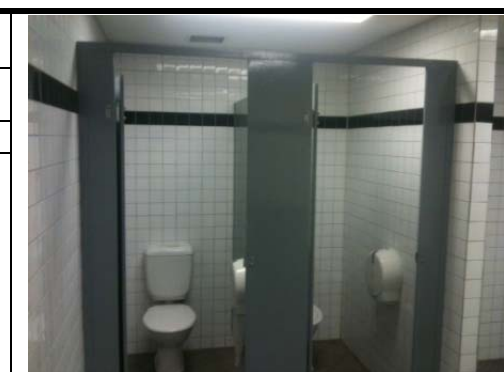
| LOCATION - DESCRIPTION | EXTENT | ASBESTOS ASSESSMENT | CONDITION | SAMPLE NO VISUAL TEST | SIGNAGE STATUS |
|---|---|---|---|---|---|
| 26. Internal, Amenities, male and female toilets dividing partitions – fibre cement thicksheet. | Approx 20m <sup>2</sup> visible | No asbestos detected | - | Sample no. 07/MA/071210 | - |

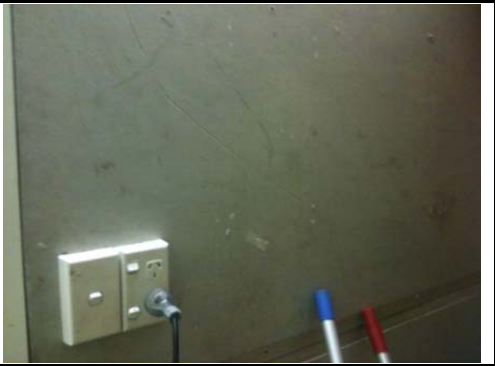
| LOCATION - DESCRIPTION | EXTENT | ASBESTOS ASSESSMENT | CONDITION | SAMPLE NO VISUAL TEST | SIGNAGE STATUS | |
|---|---|---|---|---|---|---|
| 27. Internal, Mall / Plaza cleaners storeroom wall linings - fibre cement sheeting. | Approx 20m <sup>2</sup> visible | No asbestos detected | - | Sample no. 08/MA/071210 | - | |

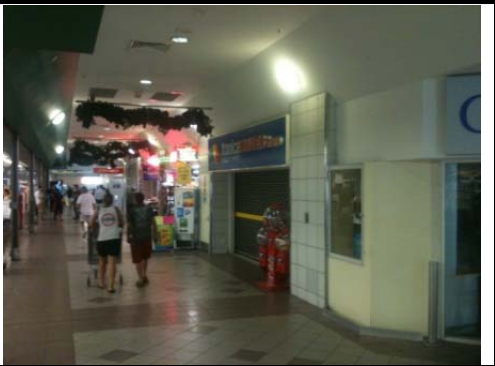
| LOCATION - DESCRIPTION | EXTENT | ASBESTOS ASSESSMENT | CONDITION | SAMPLE NO VISUAL TEST | SIGNAGE STATUS | |
|---|---|---|---|---|---|---|
| 28. Internal, Mall / Plaza ceiling linings sampled from adjacent cleaners storeroom - fibre cement sheeting. | Approx 20m <sup>2</sup> visible | No asbestos detected | - | Sample no. 05/MA/071210 | - | |

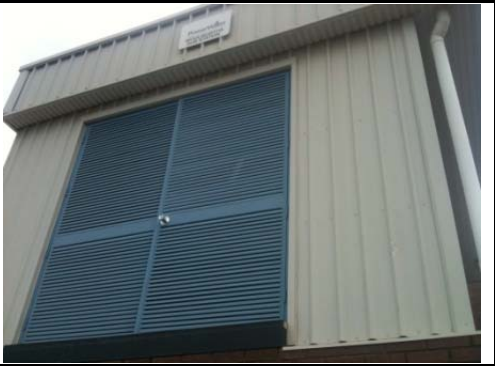
| LOCATION - DESCRIPTION | EXTENT | ASBESTOS ASSESSMENT | CONDITION | SAMPLE NO VISUAL TEST | SIGNAGE STATUS | |
|---|---|---|---|---|---|---|
| 29. Internal / External of second storey electrical sub-station – no access for inspection. | Extent not able to be confirmed | - | Inaccessible | - | - | |
