ASBESTOS REGISTER AND MANAGEMENT PLAN

Cenfurn Investments Pty. Ltd.

Palm Plaza - Palmerston NT 0830

Approved by: Paul Felvus	Prepared by: Paul Felvus	Issue Date: 25 May 2018	Status: Released
		File No: 051	Version: 1.0

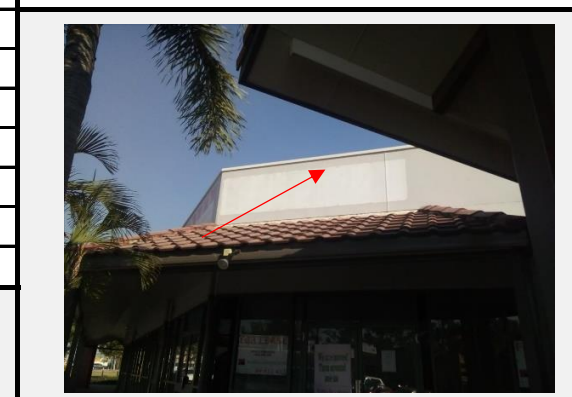
Sequence:	03	Elevation:	Ground floor
Area:	External	Friability	
Location:	Front of building	Condition:	
Position	Front fascia above awning	Sealed:	
Material Type:	Fibre cement sheet	Traffic:	
Quantity:	10	m2	Risk Likelihood:
Sample No:	Similar to Sample 2	Risk Consequence:	
Result:	No Asbestos Detected (NAD)	Risk Rating:	
Comments: Under signage

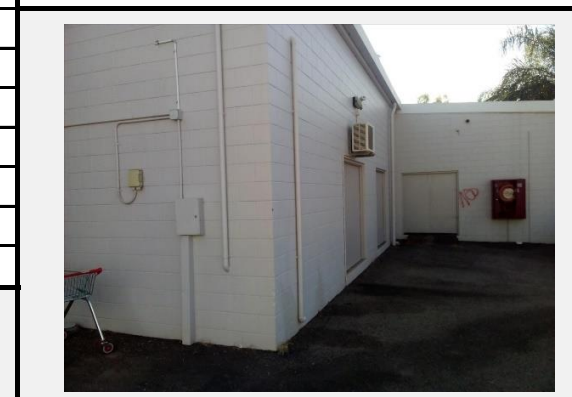
Sequence:	04	Elevation:	Ground floor
Area:	External	Friability	
Location:	Rear of building	Condition:	
Position	Wall	Sealed:	
Material Type:	Block	Traffic:	
Quantity:	N/A	Risk Likelihood:	
Sample No:	N/A	Risk Consequence:	
Result:	No Suspect Materials Detected	Risk Rating:	
Comments:

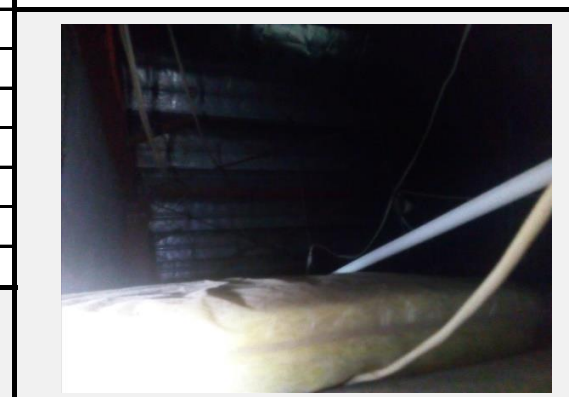
Sequence:	05	Elevation:	Ground floor
Area:	Internal	Friability	
Location:	Ceiling void	Condition:	
Position	Throughout	Sealed:	
Material Type:	Steel materials and insulation	Traffic:	
Quantity:	N/A	Risk Likelihood:	
Sample No:	N/A	Risk Consequence:	
Result:	No Suspect Materials Detected	Risk Rating:	
Comments:

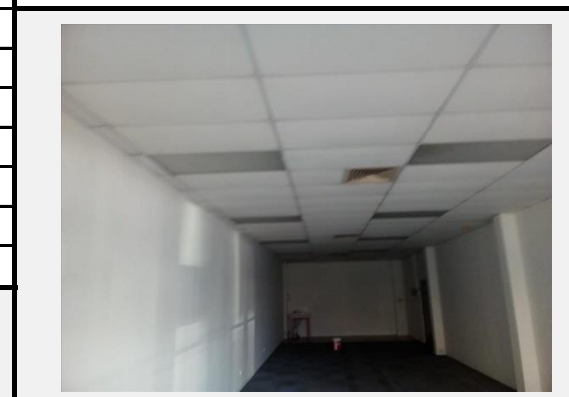
Sequence:	06	Elevation:	Ground floor
Area:	Internal	Friability	
Location:	Ceiling	Condition:	
Position	Ceiling panels	Sealed:	
Material Type:	Compressed synthetic fibre	Traffic:	
Quantity:	N/A	Risk Likelihood:	
Sample No:	N/A	Risk Consequence:	
Result:	No Suspect Materials Detected	Risk Rating:	
Comments:

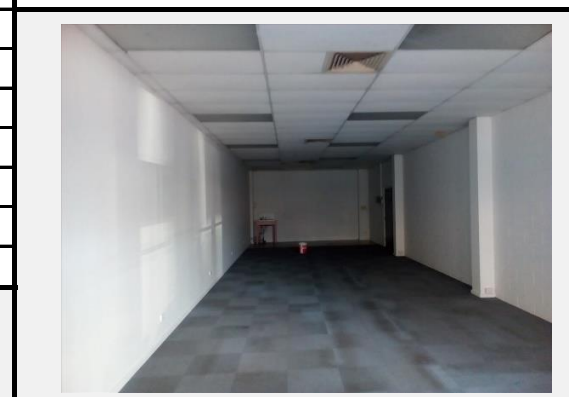
Sequence:	07	Elevation:	Ground floor
Area:	Internal	Friability	
Location:	Wall	Condition:	
Position	Throughout	Sealed:	
Material Type:	Plasterboard, timber and block	Traffic:	
Quantity:	N/A	Risk Likelihood:	
Sample No:	N/A	Risk Consequence:	
Result:	No Suspect Materials Detected	Risk Rating:	
Comments:

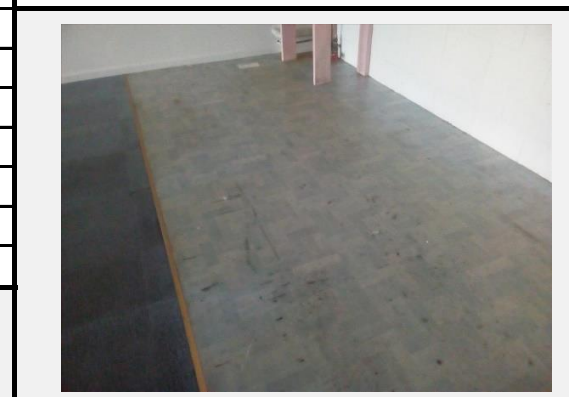
Sequence:	08	Elevation:	Ground floor
Area:	Internal	Friability	
Location:	Kitchenette	Condition:	
Position	Floor	Sealed:	
Material Type:	Vinyl sheet	Traffic:	
Quantity:	N/A	Risk Likelihood:	
Sample No:	N/A	Risk Consequence:	
Result:	No Suspect Materials Detected	Risk Rating:	
Comments:

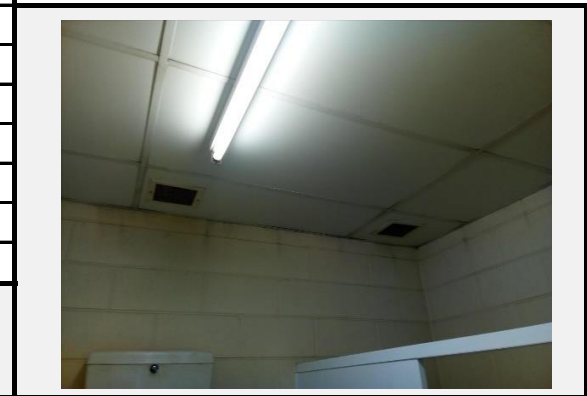
Sequence:	09	Elevation:	Ground floor
Area:	Internal/External	Friability	
Location:	Male and female ablutions	Condition:	
Position	Ceiling panels	Sealed:	
Material Type:	Plasterboard	Traffic:	
Quantity:	N/A	Risk Likelihood:	
Sample No:	N/A	Risk Consequence:	
Result:	No Suspect Materials Detected	Risk Rating:	
Comments: Combined male and female ablutions in body corporate controlled areas used by tenants.

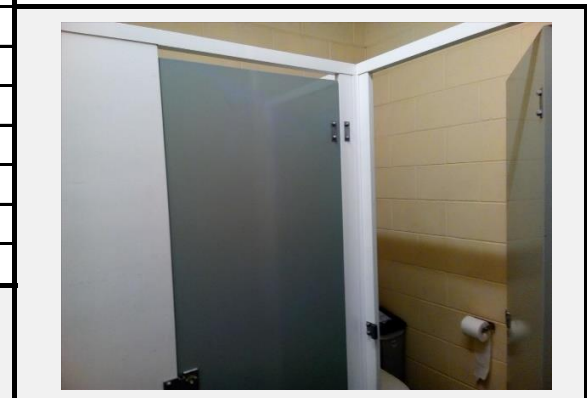
Sequence:	10	Elevation:	Ground floor
Area:	Internal/External	Friability	
Location:	Male and female ablutions	Condition:	
Position	Cubicle partitions and doors	Sealed:	
Material Type:	Fibre cement sheet	Traffic:	
Quantity:	24 m2	Risk Likelihood:	
Sample No:	3	Risk Consequence:	
Result:	No Asbestos Detected (NAD)	Risk Rating:	
Comments: Combined male and female ablutions in body corporate controlled areas used by tenants.

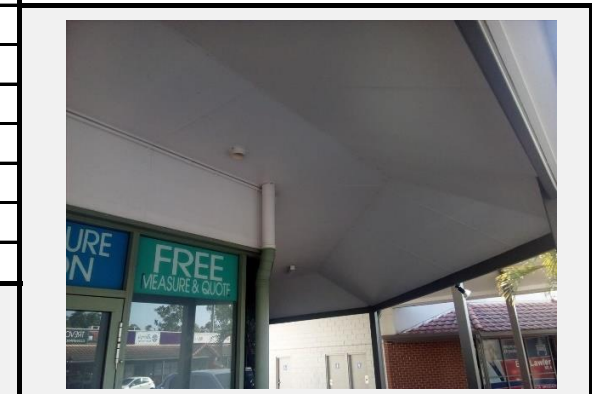
Sequence:	01	Elevation:	Ground floor
Area:	External	Friability	
Location:	Front of building	Condition:	
Position	Soffits	Sealed:	
Material Type:	Fibre cement sheet	Traffic:	
Quantity:	30	m2	Risk Likelihood:
Sample No:	1	Risk Consequence:	
Result:	No Asbestos Detected (NAD)	Risk Rating:	
Comments:

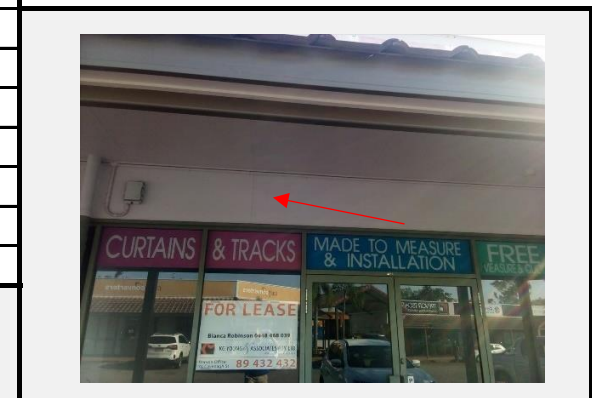
Sequence:	02	Elevation:	Ground floor
Area:	External	Friability	
Location:	Front of building	Condition:	
Position	Fascia panels	Sealed:	
Material Type:	Fibre cement sheet	Traffic:	
Quantity:	5	m2	Risk Likelihood:
Sample No:	2	Risk Consequence:	
Result:	No Asbestos Detected (NAD)	Risk Rating:	
Comments:			
Located under signage

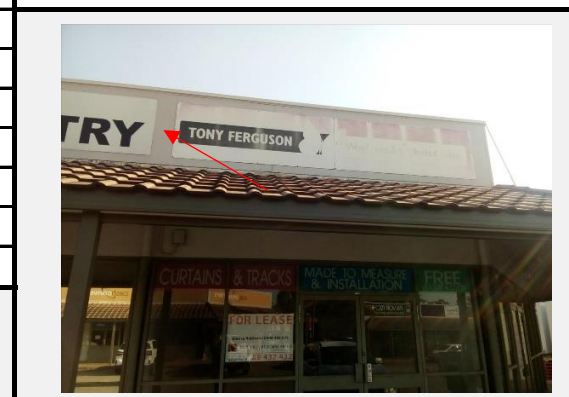
Sequence:	03	Elevation:	Ground floor
Area:	External	Friability	
Location:	Front of building	Condition:	
Position	Front fascia above awning	Sealed:	
Material Type:	Fibre cement sheet	Traffic:	
Quantity:	10	m2	Risk Likelihood:
Sample No:	Similar to Sample 2	Risk Consequence:	
Result:	No Asbestos Detected (NAD)	Risk Rating:	
Comments: Under signage

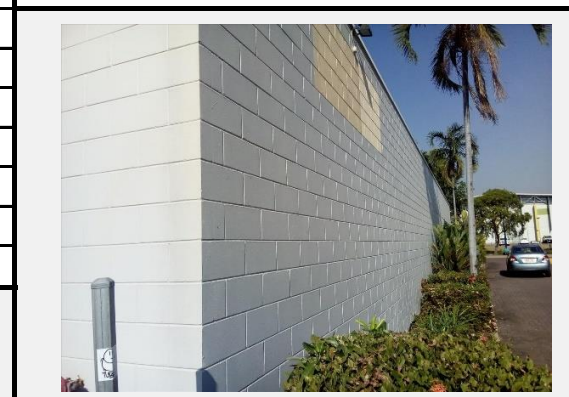
Sequence:	04	Elevation:	Ground floor
Area:	External	Friability	
Location:	Rear of building	Condition:	
Position	Wall	Sealed:	
Material Type:	Block	Traffic:	
Quantity:	N/A		Risk Likelihood:
Sample No:	N/A	Risk Consequence:	
Result:	No Suspect Materials Detected	Risk Rating:	
Comments:

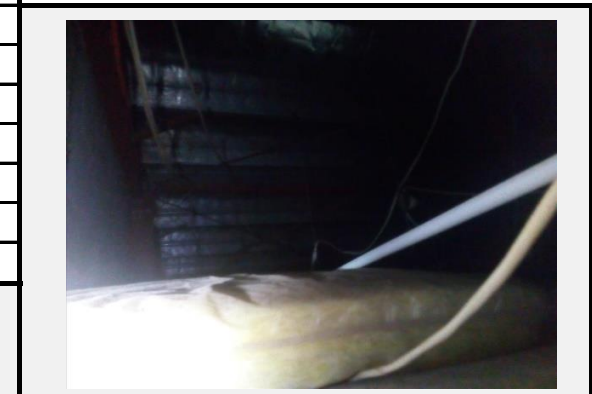
Sequence:	05	Elevation:	Ground floor
Area:	Internal	Friability	
Location:	Ceiling void	Condition:	
Position	Throughout	Sealed:	
Material Type:	Steel materials and insulation	Traffic:	
Quantity:	N/A	Risk Likelihood:	
Sample No:	N/A	Risk Consequence:	
Result:	No Suspect Materials Detected	Risk Rating:	
Comments:

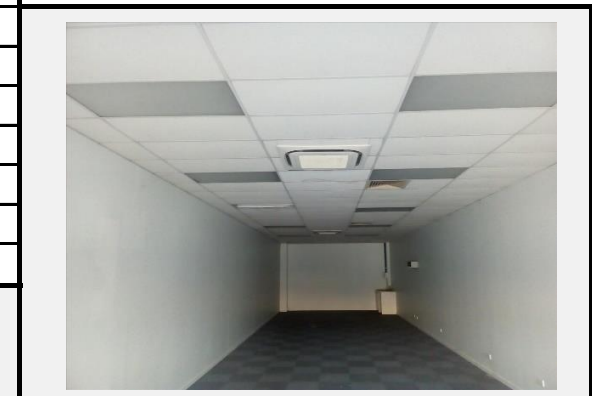
Sequence:	06	Elevation:	Ground floor
Area:	Internal	Friability	
Location:	Ceiling	Condition:	
Position	Ceiling panels	Sealed:	
Material Type:	Compressed synthetic fibre	Traffic:	
Quantity:	N/A	Risk Likelihood:	
Sample No:	N/A	Risk Consequence:	
Result:	No Suspect Materials Detected	Risk Rating:	
Comments:

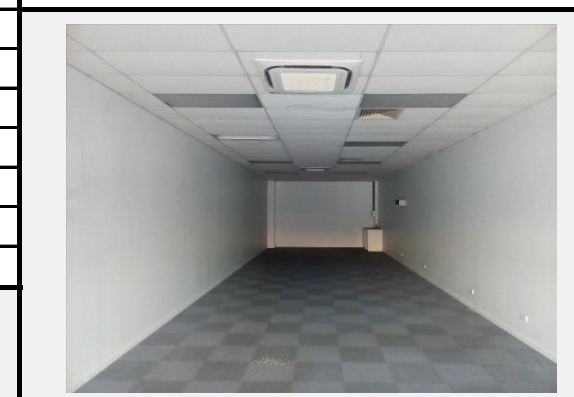
Sequence:	07	Elevation:	Ground floor
Area:	Internal	Friability	
Location:	Wall	Condition:	
Position	Throughout	Sealed:	
Material Type:	Plasterboard, timber and block	Traffic:	
Quantity:	N/A	Risk Likelihood:	
Sample No:	N/A	Risk Consequence:	
Result:	No Suspect Materials Detected	Risk Rating:	
Comments:

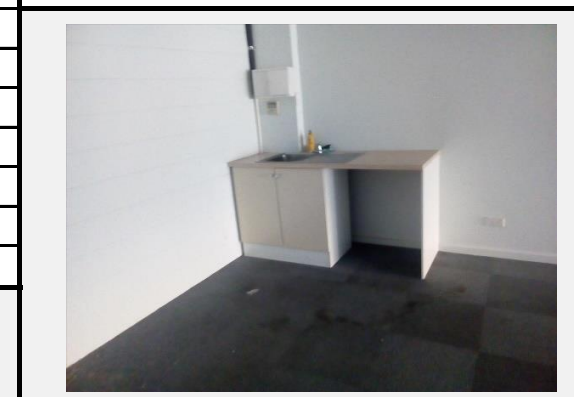
Sequence:	08	Elevation:	Ground floor
Area:	Internal	Friability	
Location:	Kitchenette	Condition:	
Position	Fittings and fixtures	Sealed:	
Material Type:	Timber and stainless steel	Traffic:	
Quantity:	N/A	Risk Likelihood:	
Sample No:	N/A	Risk Consequence:	
Result:	No Suspect Materials Detected	Risk Rating:	
Comments:

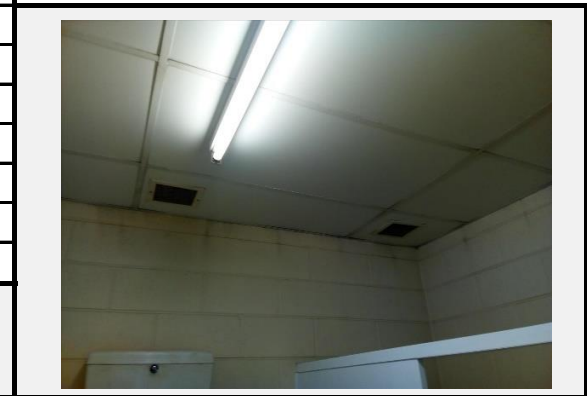
Sequence:	09	Elevation:	Ground floor
Area:	Internal/External	Friability	
Location:	Male and female ablutions	Condition:	
Position	Ceiling panels	Sealed:	
Material Type:	Plasterboard	Traffic:	
Quantity:	N/A	Risk Likelihood:	
Sample No:	N/A	Risk Consequence:	
Result:	No Suspect Materials Detected	Risk Rating:	
Comments: Combined male and female ablutions in body corporate controlled areas used by tenants.

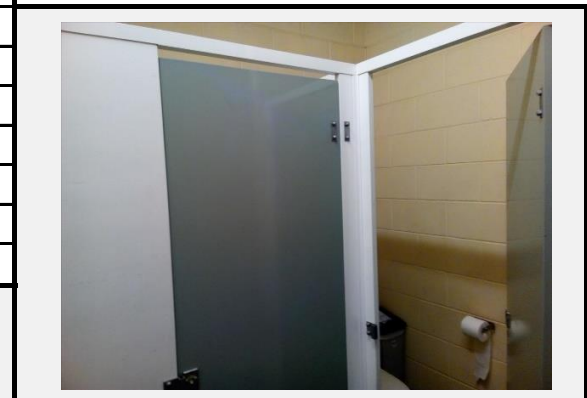
Sequence:	10	Elevation:	Ground floor
Area:	Internal/External	Friability	
Location:	Male and female ablutions	Condition:	
Position	Cubicle partitions and doors	Sealed:	
Material Type:	Fibre cement sheet	Traffic:	
Quantity:	24 m2	Risk Likelihood:	
Sample No:	3	Risk Consequence:	
Result:	No Asbestos Detected (NAD)	Risk Rating:	
Comments: Combined male and female ablutions in body corporate controlled areas used by tenants.

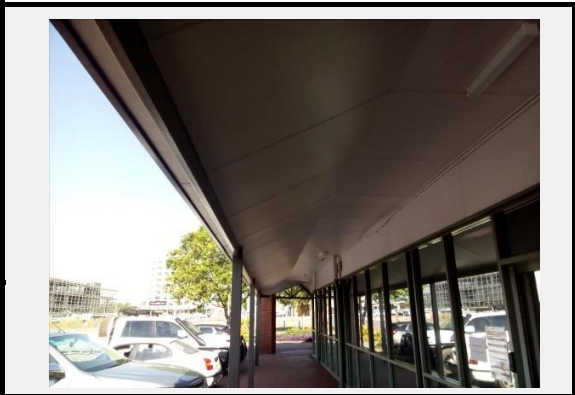
Sequence:	01	Elevation:	Ground floor
Area:	External	Friability	
Location:	Front of building	Condition:	
Position	Soffits	Sealed:	
Material Type:	Fibre cement sheet	Traffic:	
Quantity:	30	m2	Risk Likelihood:
Sample No:	1	Risk Consequence:	
Result:	No Asbestos Detected (NAD)	Risk Rating:	
Comments:

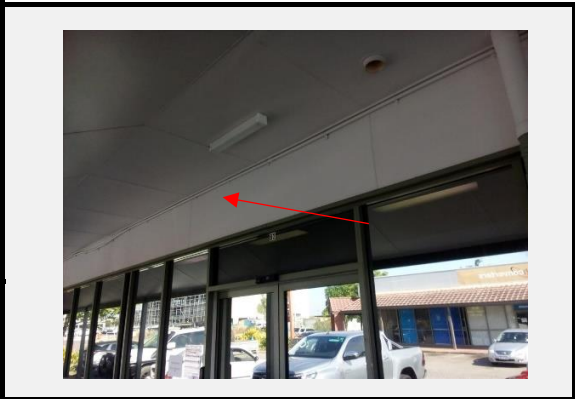
Sequence:	02	Elevation:	Ground floor
Area:	External	Friability	
Location:	Front of building	Condition:	
Position	Fascia panels	Sealed:	
Material Type:	Fibre cement sheet	Traffic:	
Quantity:	5	m2	Risk Likelihood:
Sample No:	2	Risk Consequence:	
Result:	No Asbestos Detected (NAD)	Risk Rating:	
Comments:			
Located under signage

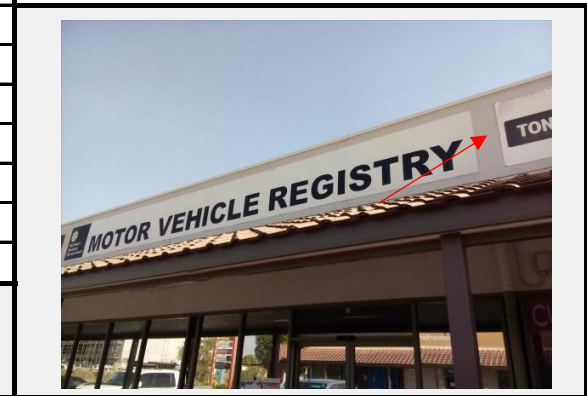
Sequence:	03	Elevation:	Ground floor
Area:	External	Friability	
Location:	Front of building	Condition:	
Position	Front fascia above awning	Sealed:	
Material Type:	Fibre cement sheet	Traffic:	
Quantity:	50	m2	Risk Likelihood:
Sample No:	Similar to Sample 2	Risk Consequence:	
Result:	No Asbestos Detected (NAD)	Risk Rating:	
Comments: Under signage

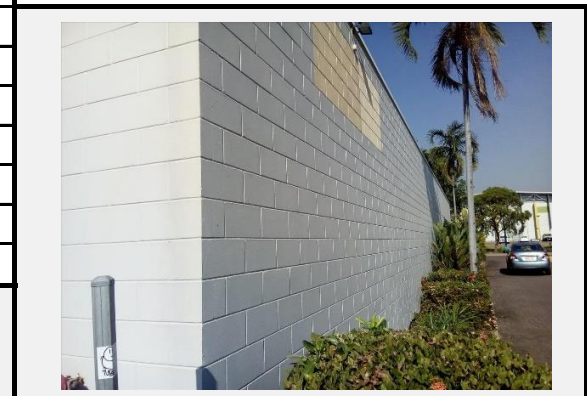
Sequence:	04	Elevation:	Ground floor
Area:	External	Friability	
Location:	Rear of building	Condition:	
Position	Wall	Sealed:	
Material Type:	Block	Traffic:	
Quantity:	N/A		Risk Likelihood:
Sample No:	N/A	Risk Consequence:	
Result:	No Suspect Materials Detected	Risk Rating:	
Comments:

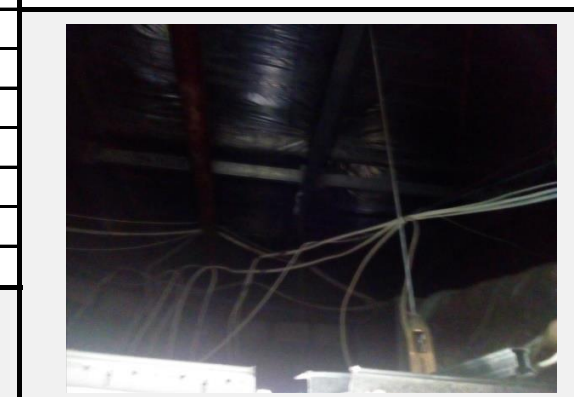
Sequence:	05	Elevation:	Ground floor
Area:	Internal	Friability	
Location:	Ceiling void	Condition:	
Position	Throughout	Sealed:	
Material Type:	Steel materials and insulation	Traffic:	
Quantity:	N/A	Risk Likelihood:	
Sample No:	N/A	Risk Consequence:	
Result:	No Suspect Materials Detected	Risk Rating:	
Comments:

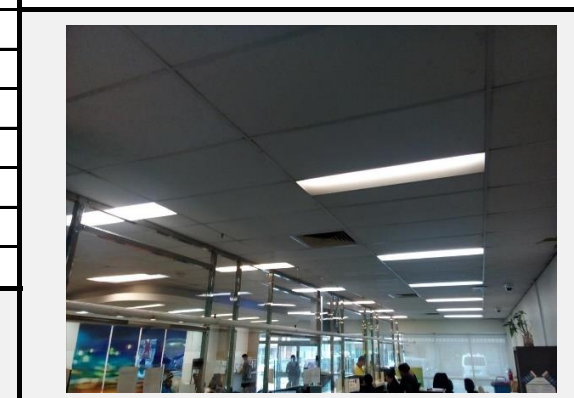
Sequence:	06	Elevation:	Ground floor
Area:	Internal	Friability	
Location:	Ceiling	Condition:	
Position	Ceiling panels and linings	Sealed:	
Material Type:	Plasterboard & compressed fibre	Traffic:	
Quantity:	N/A	Risk Likelihood:	
Sample No:	N/A	Risk Consequence:	
Result:	No Suspect Materials Detected	Risk Rating:	
Comments:

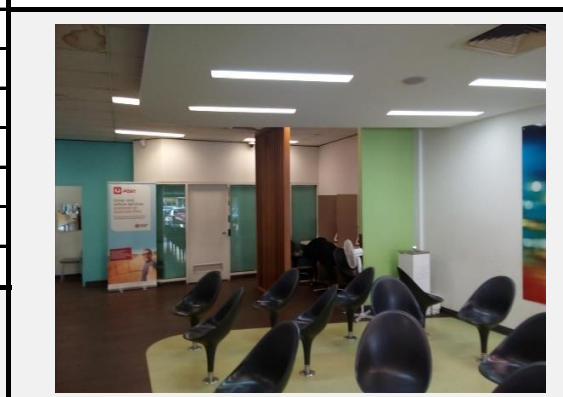
Sequence:	07	Elevation:	Ground floor
Area:	Internal	Friability	
Location:	Wall	Condition:	
Position	Throughout	Sealed:	
Material Type:	Plasterboard and block	Traffic:	
Quantity:	N/A	Risk Likelihood:	
Sample No:	N/A	Risk Consequence:	
Result:	No Suspect Materials Detected	Risk Rating:	
Comments:

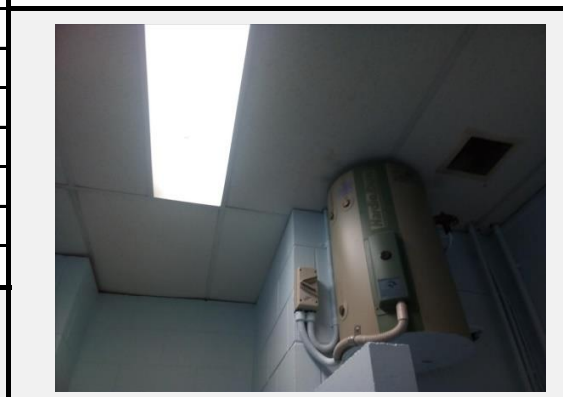
Sequence:	08	Elevation:	Ground floor
Area:	Internal	Friability	
Location:	Male and female ablutions	Condition:	
Position	Ceiling panels	Sealed:	
Material Type:	Compressed fibre	Traffic:	
Quantity:	N/A	Risk Likelihood:	
Sample No:	N/A	Risk Consequence:	
Result:	No Suspect Materials Detected	Risk Rating:	
Comments:			
Body corporate areas

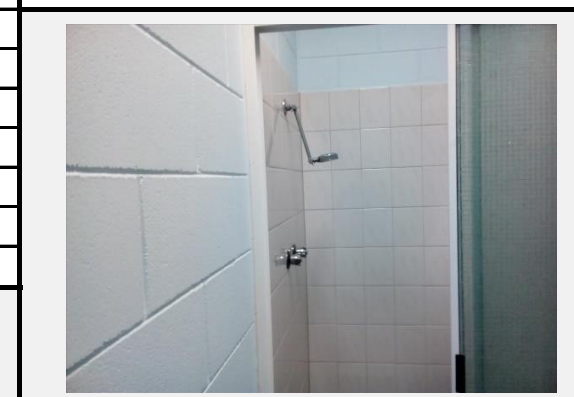
Sequence:	09	Elevation:	Ground floor
Area:	Internal	Friability	
Location:	Male and female ablutions	Condition:	
Position	Walls	Sealed:	
Material Type:	Block and plasterboard	Traffic:	
Quantity:	N/A	m2	Risk Likelihood:
Sample No:	N/A		Risk Consequence:
Result:	No Suspect Materials Detected		Risk Rating:
Comments:

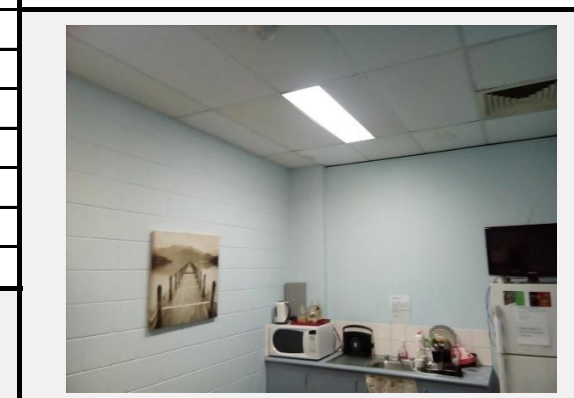
Sequence:	10	Elevation:	Ground floor
Area:	Internal	Friability	
Location:	Staff room	Condition:	
Position	Ceiling panels	Sealed:	
Material Type:	Compressed fibre	Traffic:	
Quantity:	N/A	m2	Risk Likelihood:
Sample No:	N/A		Risk Consequence:
Result:	No Suspect Materials Detected		Risk Rating:
Comments:

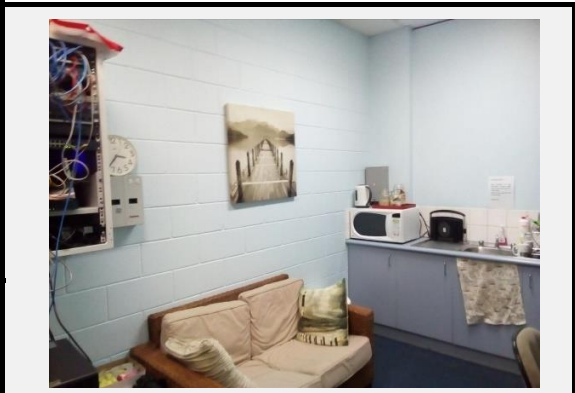
Sequence:	11	Elevation:	Ground floor
Area:	Internal	Friability	
Location:	Staff room	Condition:	
Position	Ceiling panels	Sealed:	
Material Type:	Compressed fibre	Traffic:	
Quantity:	N/A	m2	Risk Likelihood:
Sample No:	N/A		Risk Consequence:
Result:	No Suspect Materials Detected		Risk Rating:
Comments:

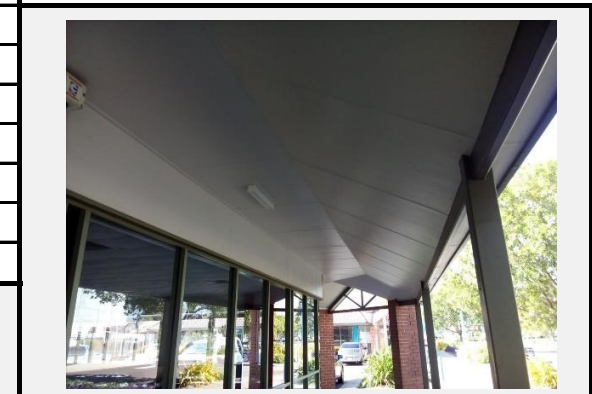
Sequence:	01	Elevation:	Ground floor
Area:	External	Friability	
Location:	Front of building	Condition:	
Position	Soffits	Sealed:	
Material Type:	Fibre cement sheet	Traffic:	
Quantity:	60	m2	Risk Likelihood:
Sample No:	1	Risk Consequence:	
Result:	No Asbestos Detected (NAD)	Risk Rating:	
Comments:

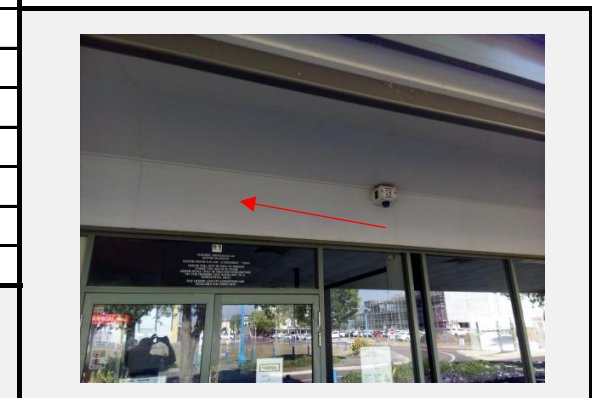
Sequence:	02	Elevation:	Ground floor
Area:	External	Friability	
Location:	Front of building	Condition:	
Position	Fascia panels	Sealed:	
Material Type:	Fibre cement sheet	Traffic:	
Quantity:	5	m2	Risk Likelihood:
Sample No:	2	Risk Consequence:	
Result:	No Asbestos Detected (NAD)	Risk Rating:	
Comments:			
Located under signage

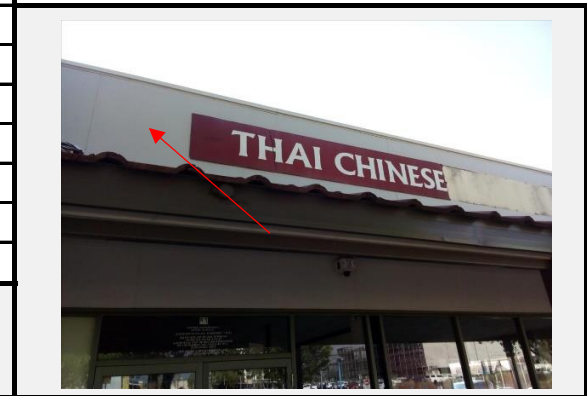
Sequence:	03	Elevation:	Ground floor
Area:	External	Friability	
Location:	Front of building	Condition:	
Position	Front fascia above awning	Sealed:	
Material Type:	Fibre cement sheet	Traffic:	
Quantity:	50	m2	Risk Likelihood:
Sample No:	Similar to Sample 2	Risk Consequence:	
Result:	No Asbestos Detected (NAD)	Risk Rating:	
Comments: Under signage

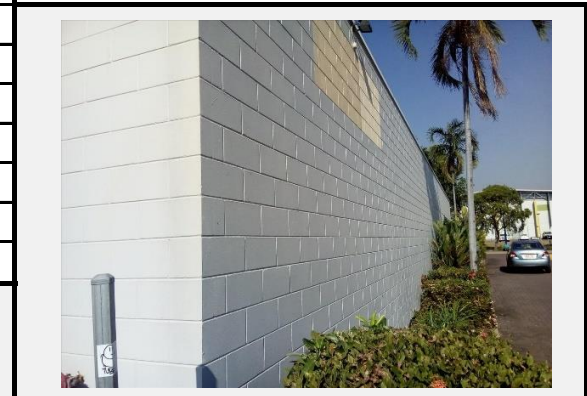
Sequence:	04	Elevation:	Ground floor
Area:	External	Friability	
Location:	Rear of building	Condition:	
Position	Wall	Sealed:	
Material Type:	Block	Traffic:	
Quantity:	N/A		Risk Likelihood:
Sample No:	N/A	Risk Consequence:	
Result:	No Suspect Materials Detected	Risk Rating:	
Comments:

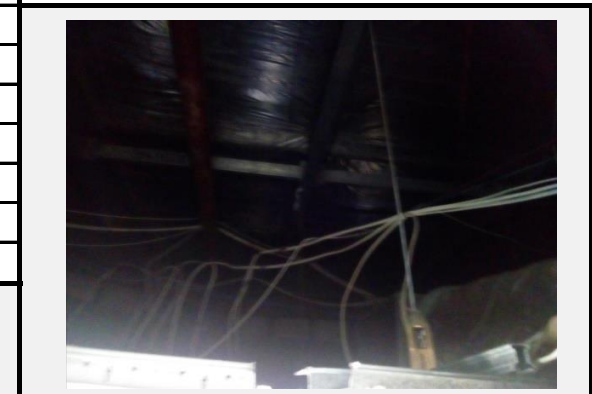
Sequence:	05	Elevation:	Ground floor
Area:	Internal	Friability	
Location:	Ceiling void	Condition:	
Position	Throughout	Sealed:	
Material Type:	Steel materials and insulation	Traffic:	
Quantity:	N/A	Risk Likelihood:	
Sample No:	N/A	Risk Consequence:	
Result:	No Suspect Materials Detected	Risk Rating:	
Comments:

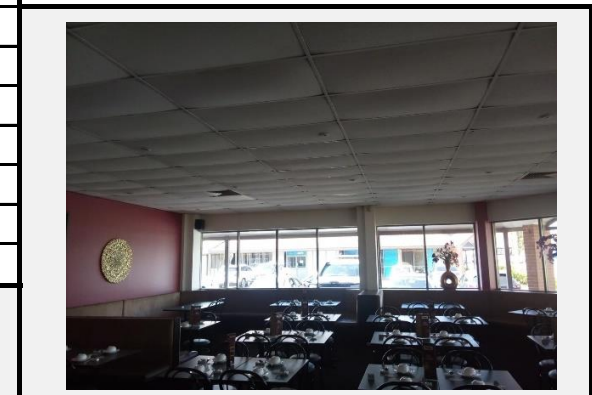
Sequence:	06	Elevation:	Ground floor
Area:	Internal	Friability	
Location:	Ceiling	Condition:	
Position	Ceiling panels and linings	Sealed:	
Material Type:	Plasterboard & compressed fibre	Traffic:	
Quantity:	N/A	Risk Likelihood:	
Sample No:	N/A	Risk Consequence:	
Result:	No Suspect Materials Detected	Risk Rating:	
Comments:

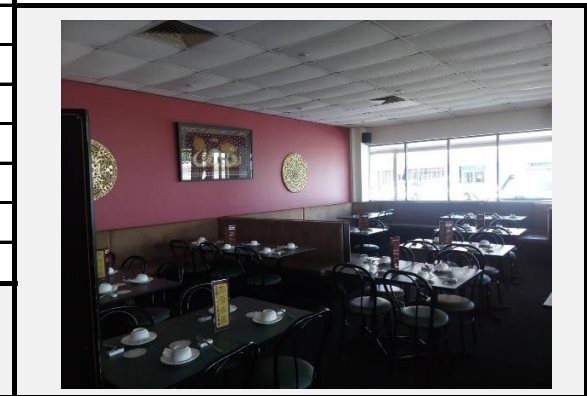
Sequence:	07	Elevation:	Ground floor
Area:	Internal	Friability	
Location:	Wall	Condition:	
Position	Throughout	Sealed:	
Material Type:	Plasterboard and block	Traffic:	
Quantity:	N/A	Risk Likelihood:	
Sample No:	N/A	Risk Consequence:	
Result:	No Suspect Materials Detected	Risk Rating:	
Comments:

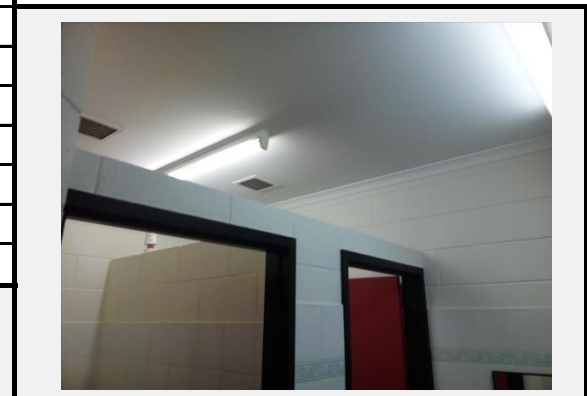
Sequence:	08	Elevation:	Ground floor
Area:	Internal	Friability	
Location:	Male and female ablutions	Condition:	
Position	Ceiling lining	Sealed:	
Material Type:	Plasterboard	Traffic:	
Quantity:	N/A	Risk Likelihood:	
Sample No:	N/A	Risk Consequence:	
Result:	No Suspect Materials Detected	Risk Rating:	
Comments:			
Body corporate areas

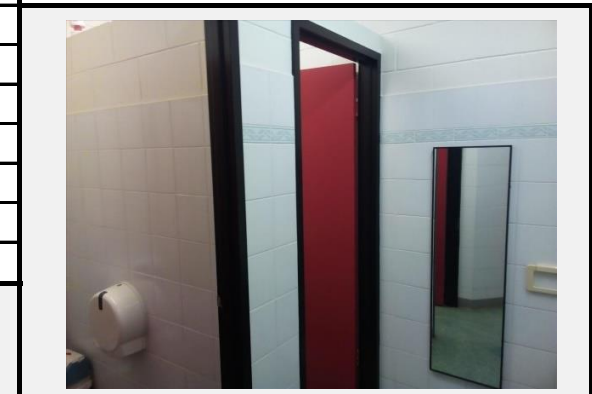
Sequence:	09	Elevation:	Ground floor
Area:	Internal	Friability	
Location:	Male and female ablutions	Condition:	
Position	Walls	Sealed:	
Material Type:	Block and plasterboard	Traffic:	
Quantity:	N/A	m2	Risk Likelihood:
Sample No:	N/A		Risk Consequence:
Result:	No Suspect Materials Detected		Risk Rating:
Comments:

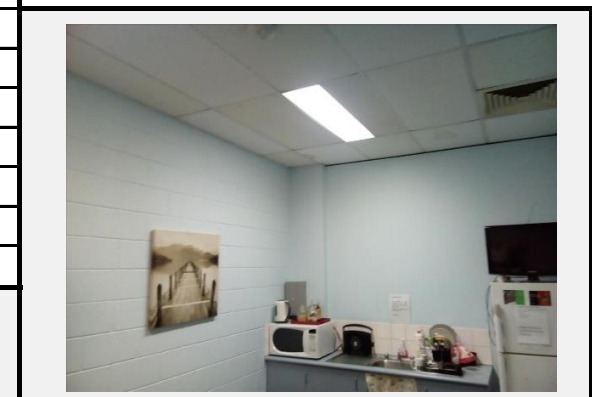
Sequence:	10	Elevation:	Ground floor
Area:	Internal	Friability	
Location:	Staff room	Condition:	
Position	Ceiling panels	Sealed:	
Material Type:	Compressed fibre	Traffic:	
Quantity:	N/A	m2	Risk Likelihood:
Sample No:	N/A		Risk Consequence:
Result:	No Suspect Materials Detected		Risk Rating:
Comments:

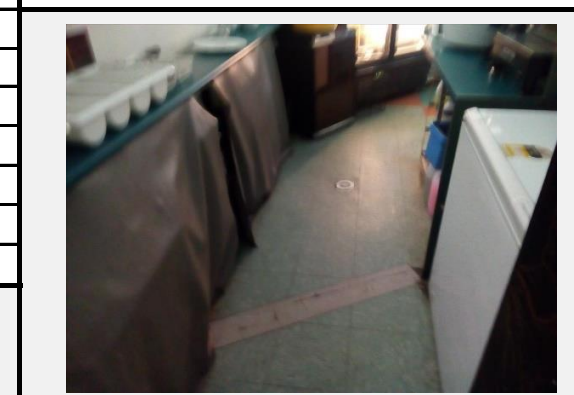
Sequence:	11	Elevation:	Ground floor
Area:	Internal	Friability	
Location:	Throughout	Condition:	
Position	Floors	Sealed:	
Material Type:	Blue vinyl tile	Traffic:	
Quantity:	75	m2	Risk Likelihood:
Sample No:	3		Risk Consequence:
Result:	No Asbestos Detected (NAD)		Risk Rating:

Comments:
Mixture of tiles in use. Blue tiles were original finish and damaged tiles have been replaced by tenant with various other tiles.
