ASBESTOS MANAGEMENT PLAN

Northern Territory Parks and Wildlife Crocodile and Weeds Management 1979 Wallaby Holtze Rd. Yarrowonga NT 0830

Approved by: Paul Felvus	Prepared by: Paul Felvus	Issue Date: November 2017	Status: Released
		File No: 018	Version: 1.0

No. 40 Lot 1979 Wallaby Holtze Rd. Yarrowonga NT 0830

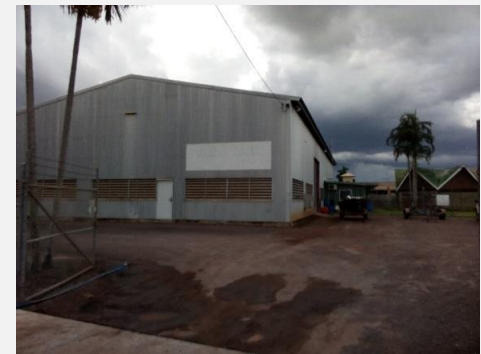
Building ID:	Shed		
Sequence:	001	Friability	
Location:	Other (refer to comments)	Condition:	
Position	Site ID Image	Sealed:	
Material Type:		Traffic:	
Quantity:		Risk Likelihood:	
Sample No:		Risk Consequence:	
Result:		Risk Rating:

Comments:
Site ID photo

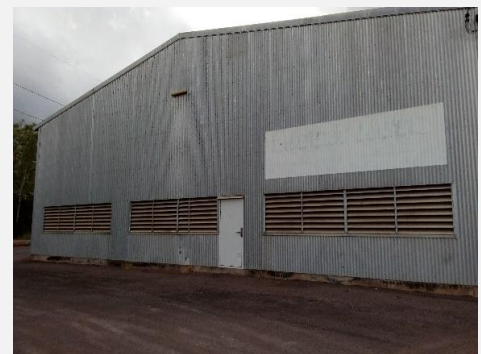
Building ID:	Shed		
Sequence:	002	Friability	
Location:	Internal/External	Condition:	
Position	Walls	Sealed:	
Material Type:	Corrugated steel sheeting	Traffic:	
Quantity:	N/A	Risk Likelihood:	
Sample No:	N/A	Risk Consequence:	
Result:	No Asbestos Detected (NAD)	Risk Rating:

Comments:
No suspect materials detected

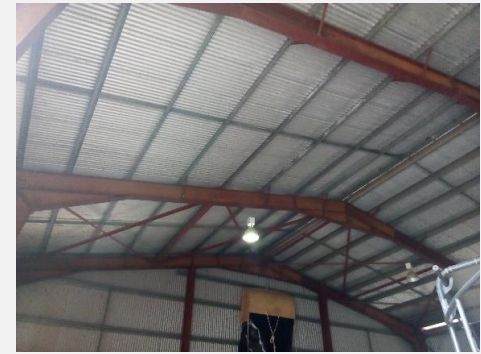
Building ID:	Shed		
Sequence:	003	Friability	
Location:	Internal/External	Condition:	
Position	Roof sheeting	Sealed:	
Material Type:	Corrugated steel sheeting	Traffic:	
Quantity:	N/A	Risk Likelihood:	
Sample No:	N/A	Risk Consequence:	
Result:	No Asbestos Detected (NAD)	Risk Rating:

Comments:
No suspect materials detected

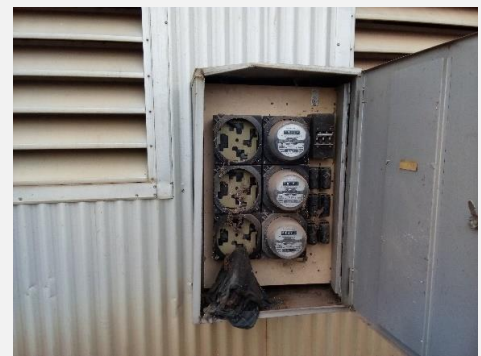
Building ID:	Shed		
Sequence:	004	Friability	
Location:	External	Condition:	
Position	Electrical component box	Sealed:	
Material Type:	Electrical backing board	Traffic:	
Quantity:	N/A	Risk Likelihood:	
Sample No:	N/A	Risk Consequence:	
Result:	No Asbestos Detected (NAD)	Risk Rating:

Comments:
No suspect materials detected

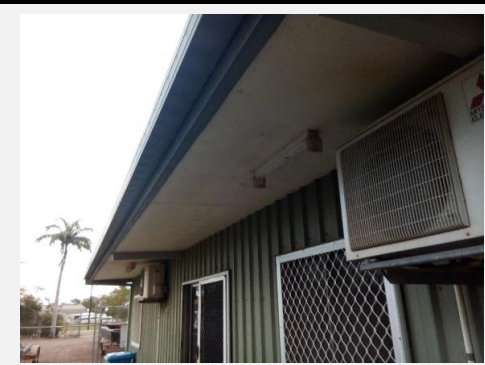
Building ID:	Offices	
Sequence:	005	Friability
Location:	External	Condition:
Position	Eaves/soffit	Sealed:
Material Type:	Fibre cement sheet	Traffic:
Quantity:	12	m2
Sample No:	1	Risk Likelihood:
Result:	No Asbestos Detected (NAD)	Risk Consequence:
		Risk Rating:

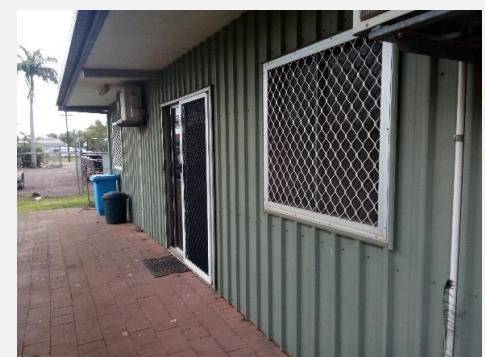
Building ID:	Offices	
Sequence:	006	Friability
Location:	External	Condition:
Position	Walls	Sealed:
Material Type:	Steel sheeting	Traffic:
Quantity:	N/A	Risk Likelihood:
Sample No:	N/A	Risk Consequence:
Result:	No Asbestos Detected (NAD)	Risk Rating:

No suspect materials detected

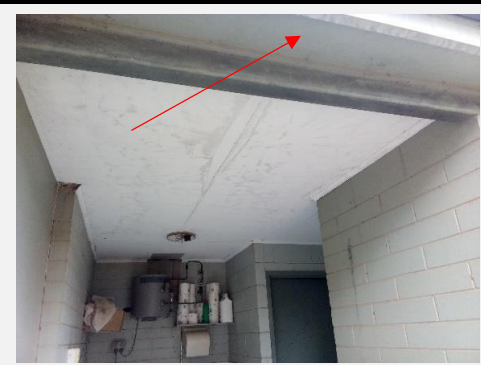
Building ID:	Ablutions	
Sequence:	007	Friability
Location:	External	Condition:
Position	Eaves linings	Sealed:
Material Type:	Fibre cement sheet	Traffic:
Quantity:	10	m2
Sample No:	6	Risk Likelihood:
Result:	No Asbestos Detected (NAD)	Risk Consequence:
		Risk Rating:

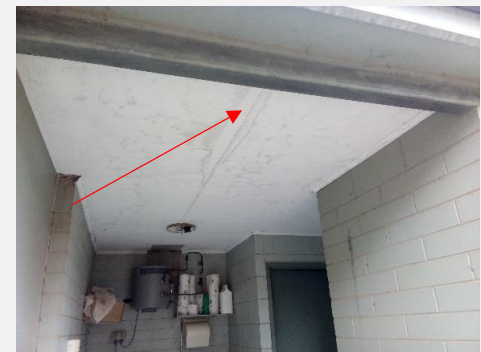
Building ID:	Ablutions	
Sequence:	008	Friability
Location:	Internal/External	Condition:
Position	Laundry ceiling lining	Sealed:
Material Type:	Fibre cement sheet	Traffic:
Quantity:	10	m2
Sample No:	4	Risk Likelihood:
Result:	No Asbestos Detected (NAD)	Risk Consequence:
		Risk Rating:

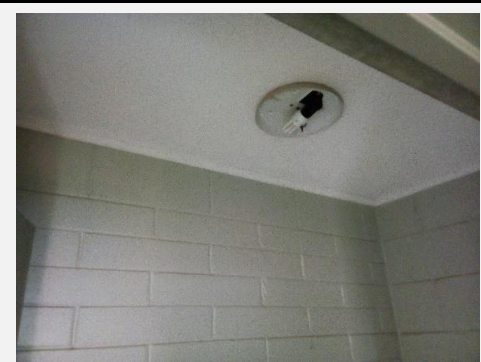
Building ID:	Ablutions	
Sequence:	009	Friability
Location:	Internal	Condition:
Position	Male ablutions ceiling lining	Sealed:
Material Type:	Fibre cement sheeting	Traffic:
Quantity:	2.5	m2
Sample No:	Similar to sample 5	Risk Likelihood:
Result:	No Asbestos Detected (NAD)	Risk Consequence:
		Risk Rating:

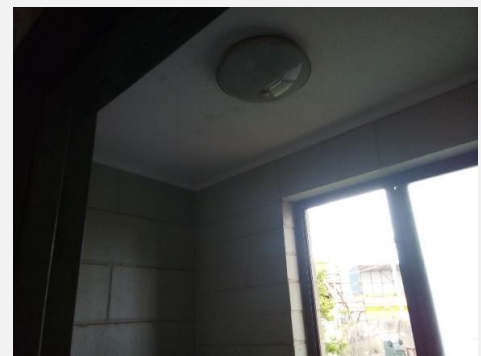
Building ID:	Ablutions	
Sequence:	010	Friability
Location:	Internal	Condition:
Position	Female ablutions ceiling lining	Sealed:
Material Type:	Fibre cement sheeting	Traffic:
Quantity:	2.5	m2
Sample No:	5	Risk Likelihood:
Result:	No Asbestos Detected (NAD)	Risk Consequence:
		Risk Rating:

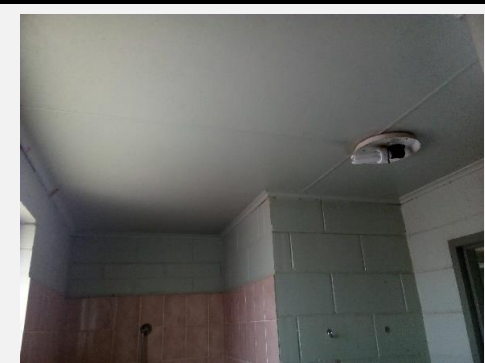
Building ID:	Ablutions	
Sequence:	011	Friability
Location:	Internal	Condition:
Position	Showers ceiling lining	Sealed:
Material Type:	Fibre cement sheeting	Traffic:
Quantity:	8	m2
Sample No:	3	Risk Likelihood:
Result:	No Asbestos Detected (NAD)	Risk Consequence:
		Risk Rating:

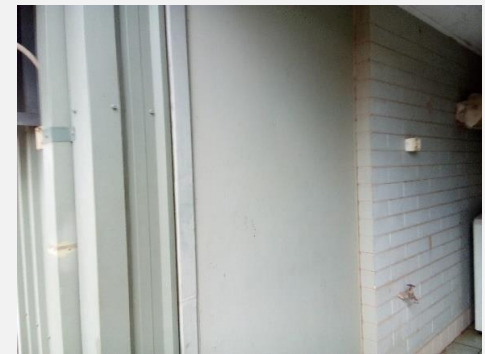
Building ID:	Ablutions	
Sequence:	012	Friability
Location:	Internal/External	Condition:
Position	Wall lining	Sealed:
Material Type:	Fibre cement sheeting	Traffic:
Quantity:	5	m2
Sample No:	2	Risk Likelihood:
Result:	No Asbestos Detected (NAD)	Risk Consequence:
		Risk Rating:

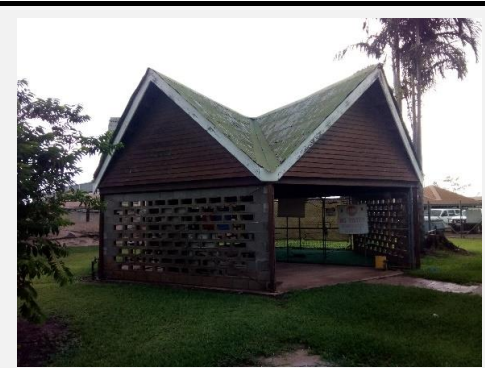
Building ID:	External recreation area		
Sequence:	013	Friability	
Location:	Internal/External	Condition:	
Position	Throughout	Sealed:	
Material Type:	Timber, steel and concrete block	Traffic:	
Quantity:	N/A	Risk Likelihood:	
Sample No:	N/A	Risk Consequence:	
Result:	No Asbestos Detected (NAD)	Risk Rating:

No suspect materials detected
