**RANDAZZO C & G DEVELOPMENTS  
ASBESTOS REGISTER & MANAGEMENT PLAN  
PR078 – 47 Mitchell St, Darwin City NT 0800**

**Status of asbestos containing materials at 47 Mitchell St, Darwin City NT 0800**

| PROJECT DETAILS | |
|---|---|
| Asbestos Register and Management Plan | |
| Site Address | 47 Mitchell St, Darwin City NT 0800 |

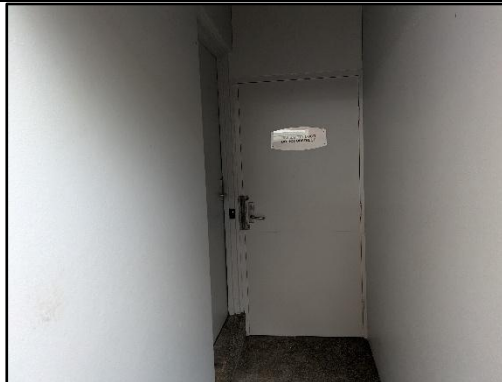
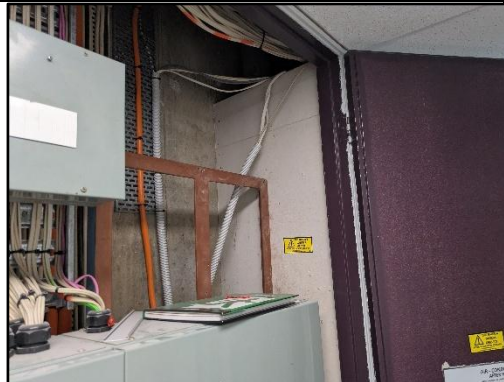
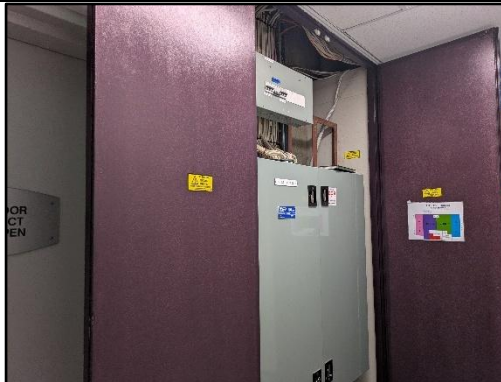
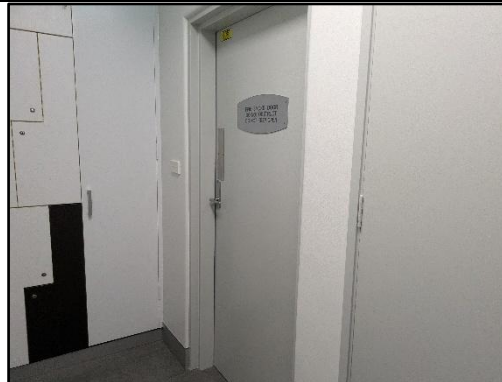
| | 007 | Ground Level - Northwest - Fire doors (2 of) | | 015 | Level 2 - Communications cupboard - Wall lining | | 016 | Level 2 - Communications cupboard - Inner door lining | | 019 | Level 2 - Foyer, each side of lifts - Fire doors (2 of) |

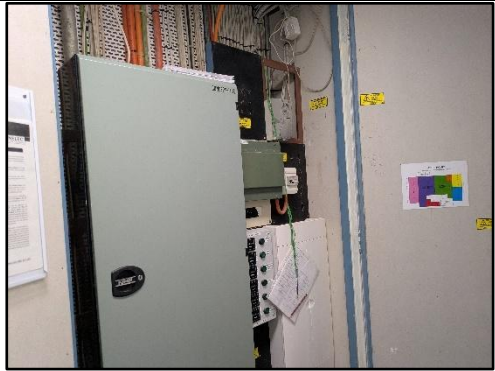
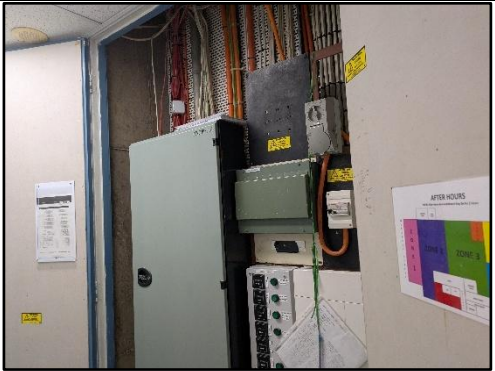
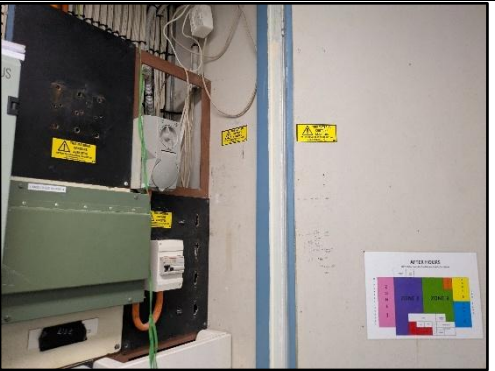
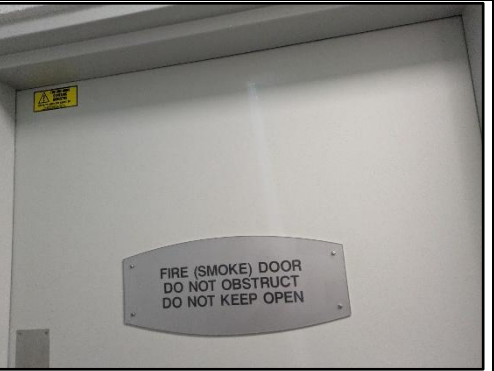
| | 027 | Level 4 - Communications cupboard - Wall lining | | 028 | Level 4 - Communications cupboard - Inner door lining | | 029 | Level 4 - Communications cupboard - Backing Board | | 031 | Level 4 - Foyer, each side of lifts - Fire doors (2 of) |

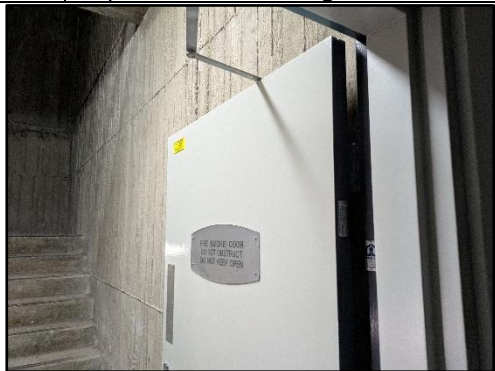
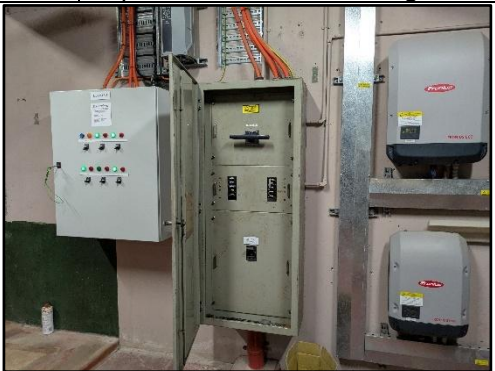
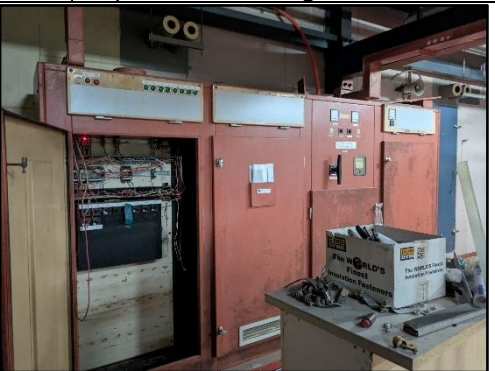
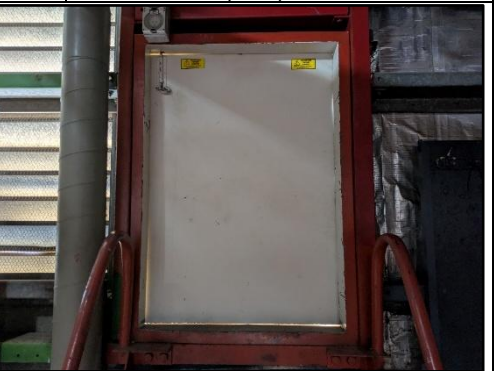
| | 049 | Level 7 - Foyer, each side of lifts - Fire doors (2 of) | | 052 | Level 8 - Plant room - Distribution board - Small | | 053 | Level 8 - Plant room - Distribution board - Large | | 054 | Level 8 - Plant room - Fire door to roof |
