ACE BODY CORPORATE MANGEMENT
ASBESTOS MANAGEMENT PLAN
82 WOODS ST. DARWIN

REPORT PREPARED FOR:
Ace Body Corporate Management
October 2017

Title:	Asbestos Management Plan – 82 Woods St. Darwin
Project Manager:	Paul Felvus
Prepared by:	Paul Felvus
Reviewed by:	Laura Smith
Approved by:	Laura Smith
Version:	1.0
Client:	Ace Body Corporate Management
Client Contact:	Cathy Orr
Contact Details:	P: 08 8981 8025 E: darwin@acebodycorp.com.au

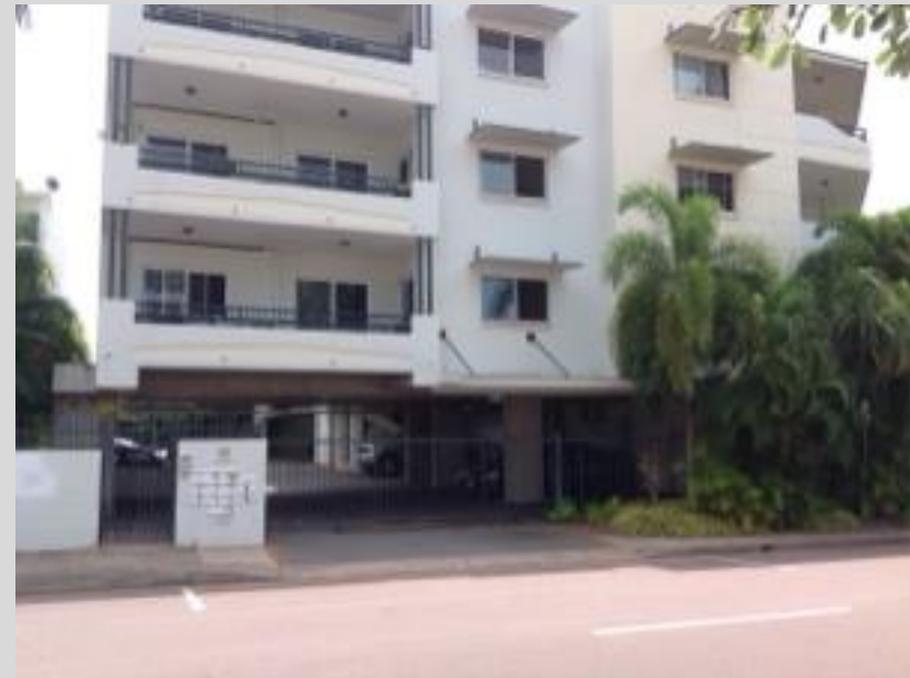
Location Details		Material Details		Results / Management Details		Photographs
Building ID:	External	Material Type:	Cement Based	Status:	Not Present (Tested)

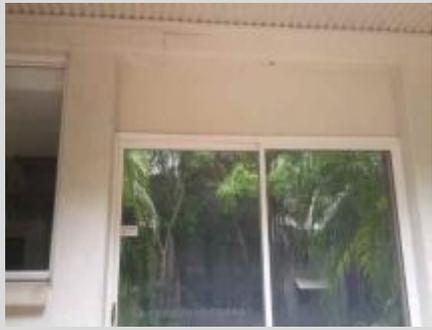
Elevation:	Ground Floor	Quantity:	1.5 - m2	Sample #:	37902	
Position Installed:	Fascia	Condition:	-	Sample Result:	No Asbestos Detected	
Primary Location:	Above sliding door on Shepherd St.	Friability:	-	Risk Rating:	-	
Secondary Location:	-	Surface Treatment:	-	Recommendation:	-	
Comments:						Urgent Action Required?
						-

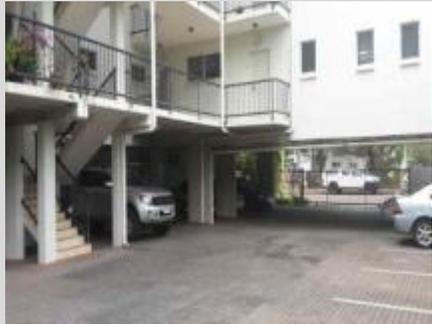
Location Details		Material Details		Results / Management Details		Photographs
Building ID:	External	Material Type:	Other - Refer to Comments	Status:	Not Present (Not Tested)

Elevation:	Ground Floor	Quantity:	-	Sample #:	-	
Position Installed:	Other - Refer to Comments	Condition:	-	Sample Result:	-	
Primary Location:	Carpark and common areas	Friability:	-	Risk Rating:	-	
Secondary Location:	-	Surface Treatment:	-	Recommendation:	-	
Comments:	No suspect materials detected					Urgent Action Required?
						-

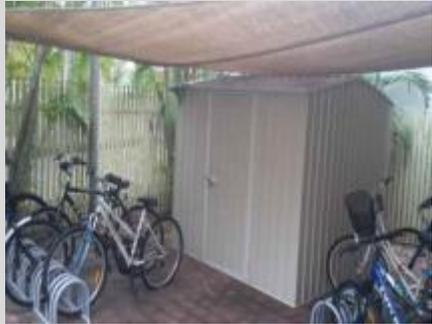
Location Details		Material Details		Results / Management Details		Photographs
Building ID:	External	Material Type:	Other - Refer to Comments	Status:	Not Present (Not Tested)

Elevation:	Ground Floor	Quantity:	-	Sample #:	-	
Position Installed:	Other - Refer to Comments	Condition:	-	Sample Result:	-	
Primary Location:	Garden shed	Friability:	-	Risk Rating:	-	
Secondary Location:	-	Surface Treatment:	-	Recommendation:	-	
Comments:	No suspect materials detected					Urgent Action Required?
						-

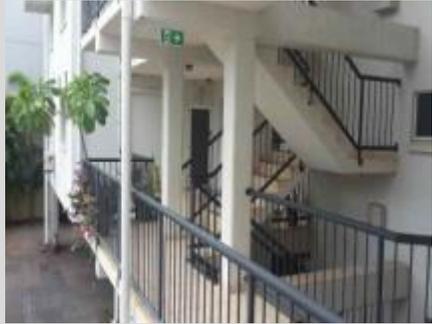
Location Details		Material Details		Results / Management Details		Photographs
Building ID:	External	Material Type:	Other - Refer to Comments	Status:	Not Present (Not Tested)

Elevation:	Level 1	Quantity:	-	Sample #:	-	
Position Installed:	Other - Refer to Comments	Condition:	-	Sample Result:	-	
Primary Location:	Stairs and common areas	Friability:	-	Risk Rating:	-	
Secondary Location:	-	Surface Treatment:	-	Recommendation:	-	
Comments:	No suspect materials detected					Urgent Action Required?
						-

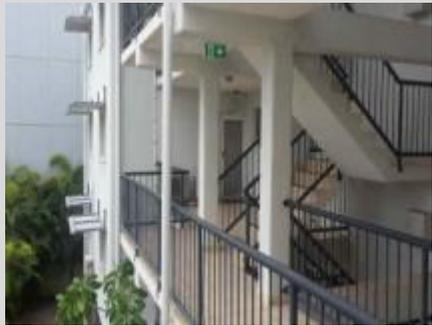
Location Details		Material Details		Results / Management Details		Photographs
Building ID:	External	Material Type:	Other - Refer to Comments	Status:	Not Present (Not Tested)

Elevation:	Level 2	Quantity:	-	Sample #:	-	
Position Installed:	Other - Refer to Comments	Condition:	-	Sample Result:	-	
Primary Location:	Stairs and common areas	Friability:	-	Risk Rating:	-	
Secondary Location:	-	Surface Treatment:	-	Recommendation:	-	
Comments:	No suspect materials detected					Urgent Action Required?
						-

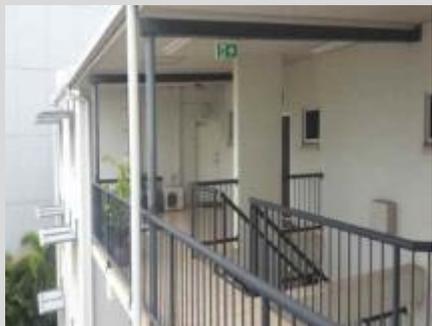
Location Details		Material Details		Results / Management Details		Photographs
Building ID:	External	Material Type:	Other - Refer to Comments	Status:	Not Present (Not Tested)

Elevation:	Level 3	Quantity:	-	Sample #:	-	
Position Installed:	Other - Refer to Comments	Condition:	-	Sample Result:	-	
Primary Location:	Stairs and common areas	Friability:	-	Risk Rating:	-	
Secondary Location:	-	Surface Treatment:	-	Recommendation:	-	
Comments:	No suspect materials detected					Urgent Action Required?
						-
