# ASBESTOS MANAGEMENT PLAN

LOT 2305 - POWER HOUSE  
41 SMITH STREET  
DARWIN NT 0800

## Asbestos Management Plan

Lot 2305 - Power House, 41 Smith Street, Darwin NT 0800

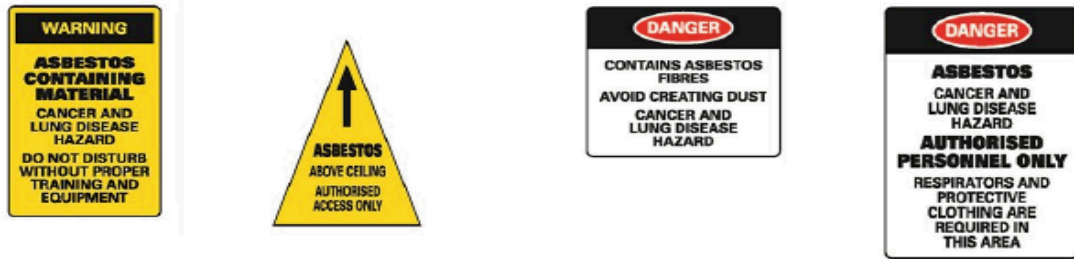
Figure 3.1 Asbestos warning signs

Asbestos warning signs must comply with the requirement of *AS 1319-1994 Safety Signs for the Occupational Environment* for size, illumination, location and maintenance. Warning signs may include some of the following examples:

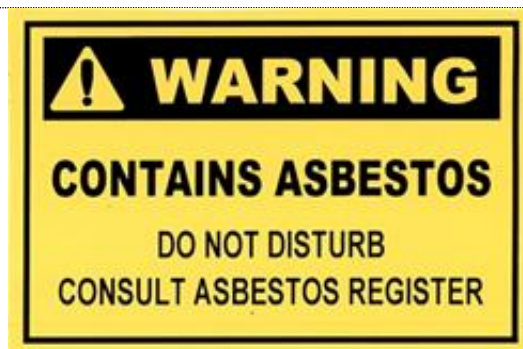
Figure A.1 Example asbestos warning label

- The owner of a workplace must determine if ACM are present in the workplace. This is usually undertaken through a visual inspection of the property.
- Upon identifying ACM, a risk assessment must be undertaken and must consider the following:
  - Friability
  - Condition
  - Location
  - Surrounding activities that could disturb the asbestos
- Where ACM is identified, it should be removed if removal is reasonably practicable. Where it is not reasonably practicable to remove, it must, depending on the level of risk, be either repaired, maintained and/or protected from future damage.
- ACM that is to remain in use (i.e. *in-situ*) must, when reasonably practicable, be labelled. An example of a warning label is shown below:
