Asbestos Close Out Report

YFD02310 – Independent Asbestos Assessor Service for
ACM Removal Works

Lot 397 Wurrumiyanga, Northern Territory, 0822

Asbestos Removal Works 19th – 21st August 2024

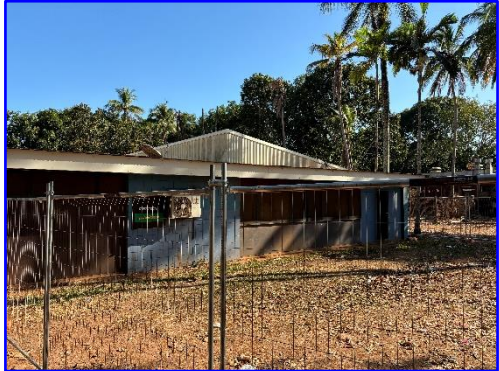
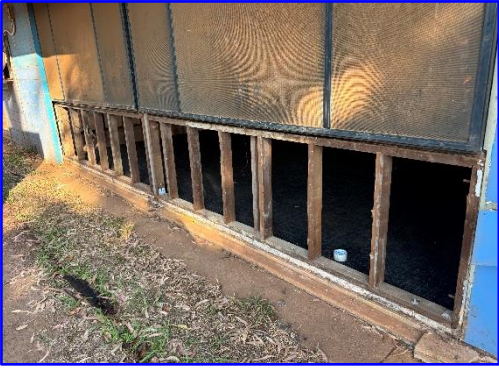
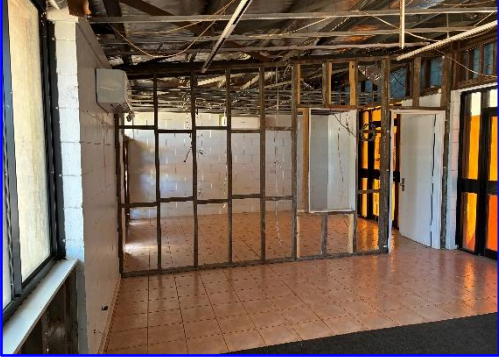
Site Address: Suburb & State:	Northern Territory Government Centre Lot 397 Wurruminyanga Northern Territory 0822	
Inspection Date:	Wednesday, 21 August 2024	
Client:	DIPL Marco Sperti DarwinIC.ProjectAdministrationDIPL@nt.gov.au	
Asbestos Removalist, Supervisor & Email:	ANT Asbestos Solutions Chris Power chris.p@a-n-t.com.au	
Licensed Asbestos Assessor:	Rex Coleman Licensed Asbestos Assessor Asbestos Assessor NTWS-AA-480583	
Trakondy Project Manager:	Mark Kondakov Licensed Asbestos Assessor Licence No: NTWS-AA-456703	
Description of Works Undertaken:	Removal of asbestos containing cement sheet internal wall linings, suspended ceiling tiles and external wall lining in Lot 397, Wurruminyanga as per the approved scope of works.

Limitations / Comments:	This Asbestos Clearance Certificate applies to the removal of the above detailed asbestos containing cement sheet and suspended ceiling tiles only. Other asbestos containing materials may remain within the site, as this inspection was based on the approved scope of works only – which was the removal the small section of the asbestos containing cement sheet detailed above.

At the time the visual inspection (detailed above) was conducted, there was no visual asbestos residue/debris from asbestos removal work in the work area, in the immediate vicinity of the work area, or in the waste transit route where the work was carried out.

This **visual inspection** along with asbestos airborne fibre monitoring confirms that the area described above is **fit for re-occupation**.

Asbestos Register:	The sites asbestos register/project files should be updated to reflect the works undertaken as detailed within this clearance certificate.
