# **ASBESTOS REGISTER**

REGISTER NO.: AS 3308

FOR THE PROPERTY AT: Katherine Central NT  
Katherine Terrace / Savannah Way,  
Katherine, NT

DATE INSPECTED: 7<sup>th</sup> December, 2010

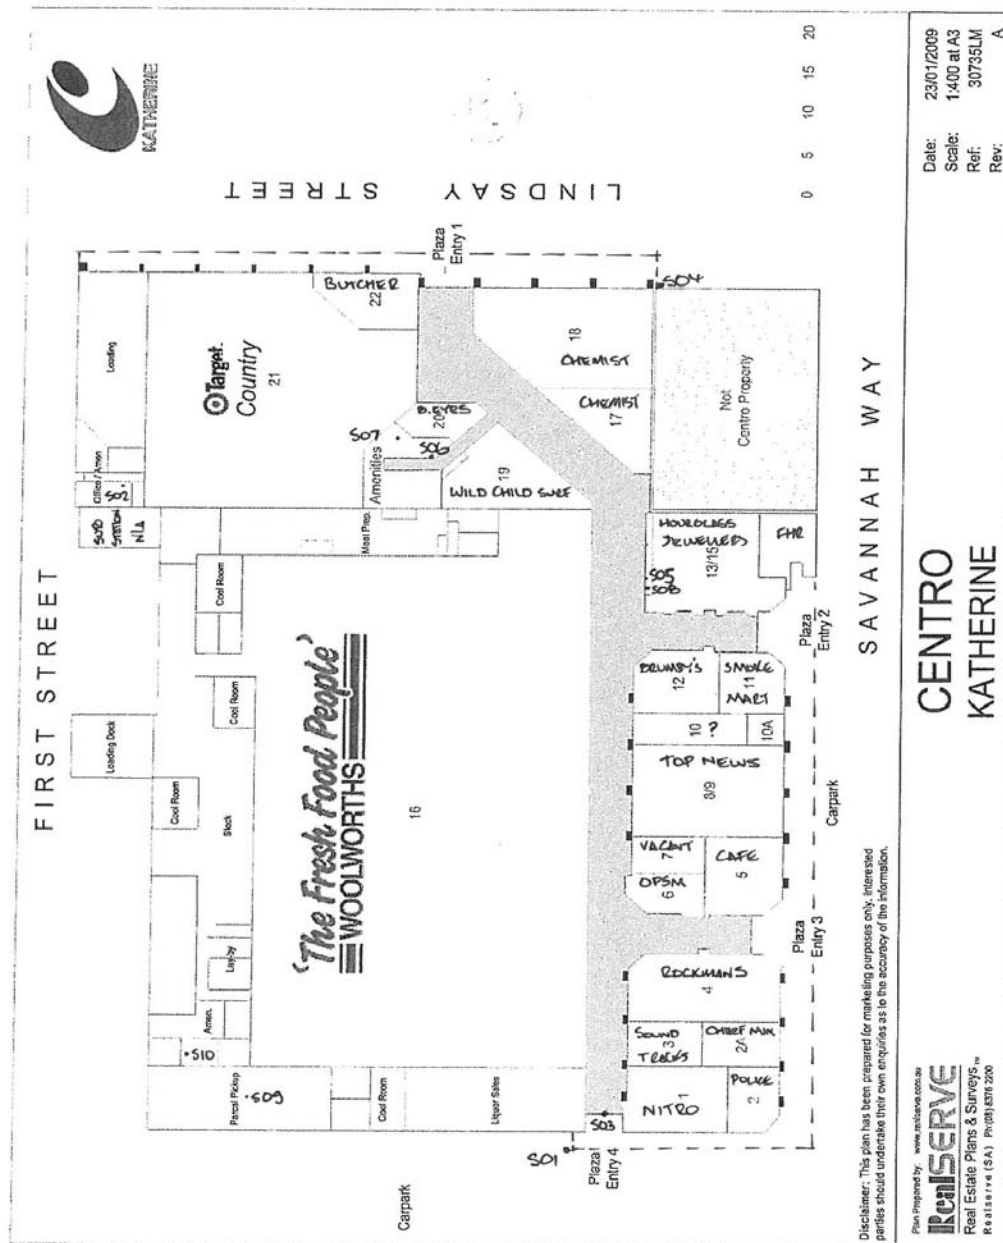
1. = no.'s indicate location of internal asbestos containing materials, refer to asbestos register location schedule

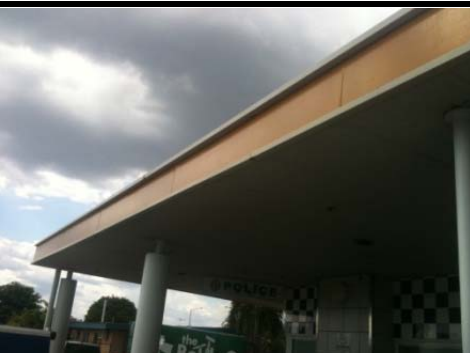
| LOCATION - DESCRIPTION | EXTENT | ASBESTOS ASSESSMENT | CONDITION | SAMPLE NO VISUAL TEST | SIGNAGE STATUS |
|---|---|---|---|---|---|
| B. External, Mall / Plaza entries, infill lining above doors / sign panel - fibre cement sheeting. ( strip painted yellow ). | Approx 5m <sup>2</sup> per entry x4. | No asbestos detected | - | Sample no. 03/MA/071210 | - |
