# ASBESTOS MANAGEMENT PLAN

AMP NT0686

RCG Centre, 47 Mitchel St, Darwin, 0800

January 2015

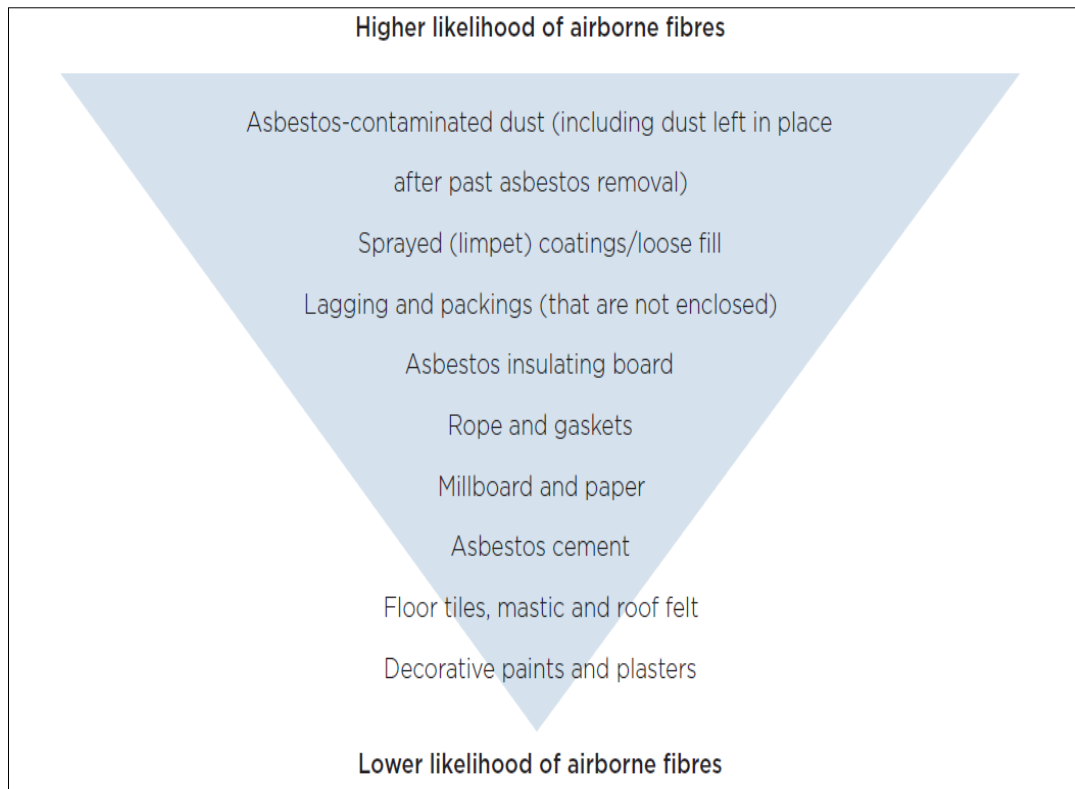
The following list ranks different types of asbestos according to the likelihood that airborne asbestos can be released into the air if it has deteriorated or been disturbed. The potential risk to health is greater for items higher up the list if people are exposed to airborne asbestos, but any ACM can produce asbestos fibres if they are disturbed.

**Figure 1: Extract from the SafeWork Australia Code of Practice: "How to Manage and Control Asbestos in the Workplace (December 2011)"**

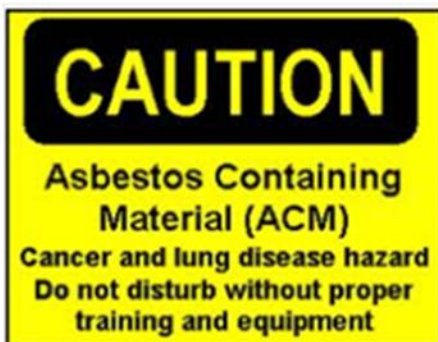
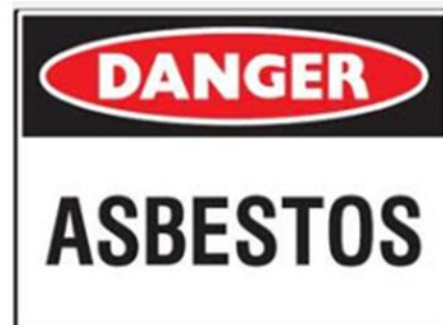
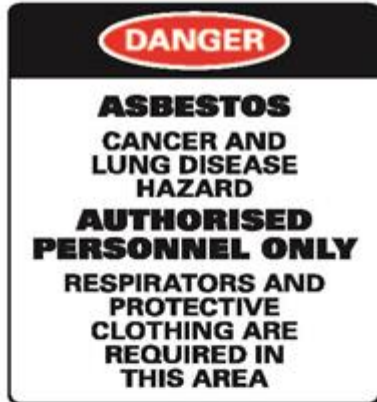
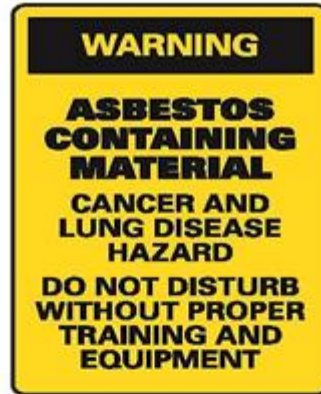
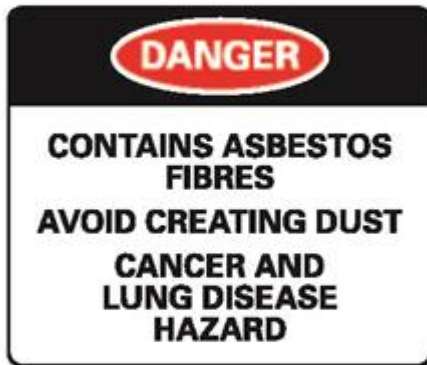
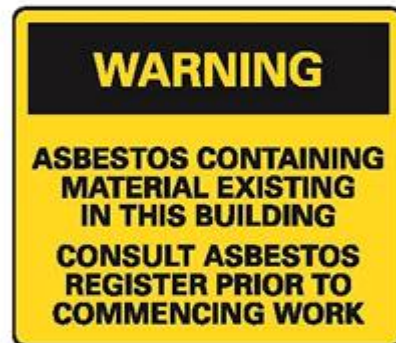
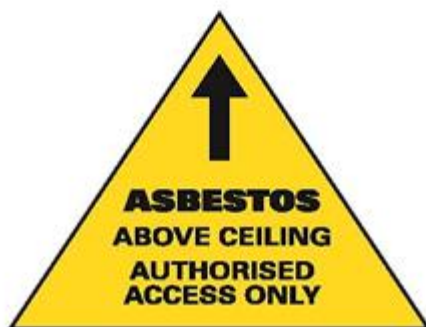
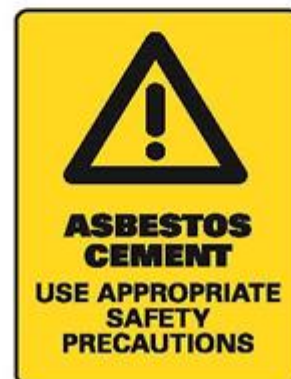
Below are typical of signage found in commercial buildings.

Randazzo C&G Developments has an acceptable quantity of complying general awareness warning signs in place. Warning signs that have been wrongly removed, encapsulated or painted over should be replaced. All labels should comply with *AS1319 Safety Signs for the Occupational Environment*.
